Trimbloid X

By Keith Bouchard, E.I.T.

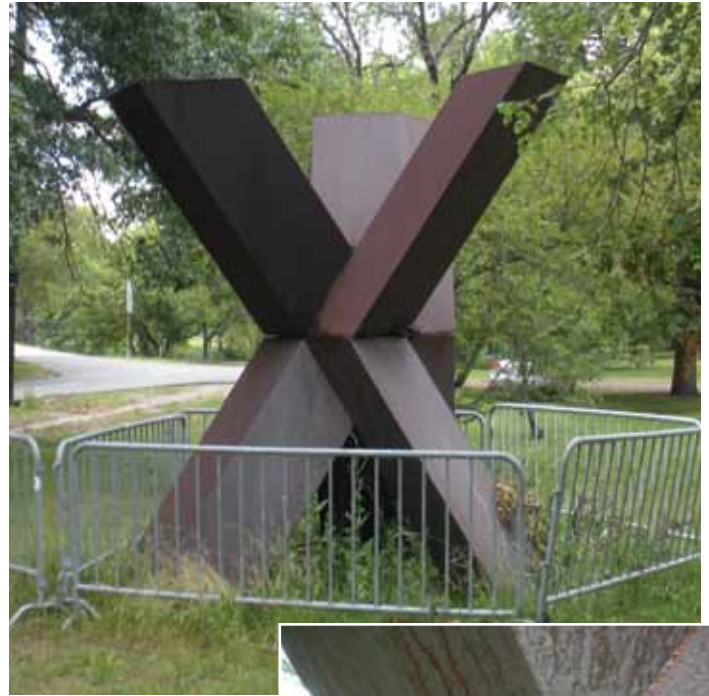
Above: Trimbloid X on Boston's Esplanade.

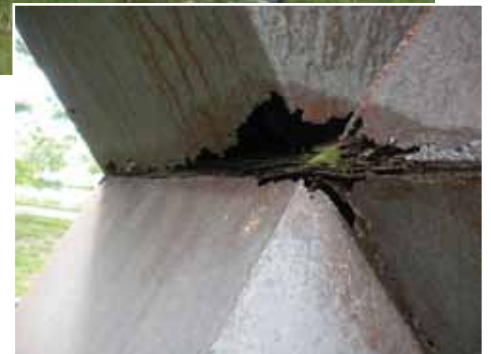
The natural shape of Trimbloid X funnels water to the center of the sculpture, where no means are provided to whisk it away. The standing water eventually ate through the center of the object, allowing moisture and organic matter into the hollow "legs" and accelerating deterioration. Add years of delayed maintenance and the result is what you'll see if you stroll down the Esplanade today – gaping holes in the side of the sculpture, trails of corrosion down the legs, and protective fencing to keep the public away from its sharp, rusty edges.

Right: Corroded Steel at the Center of the Sculpture.

Through consultation with steel fabricators and the Massachusetts DCR, CBI recommended that the object be disassembled and repaired in the shop with new weathering steel patches. Coating the sculpture with a patina-colored paint was not recommended, as there was concern that it would interfere too much with the "industrial" look of the original sculpture. The existing patina on salvaged parts of the sculpture to remain will need to be sand-blasted off to attempt to match the

new steel. The owner was warned that, even with this measure, there is no guarantee that the original steel will closely resemble the repair steel. As one steel supplier noted, different batches of weathering steel are like "trees in a forest: they all basically look the same but no two are alike." However, with the severe level of deterioration present on the object and the limited budget, this is likely the best the owner can do short of completely re-sculpting the piece. ■
