Repair of Columns with FRP Laminates

By Mo Ehsani, Ph.D., P.E., S.E., Majid Farahani, P.E. and Eric Raatz, P.E.

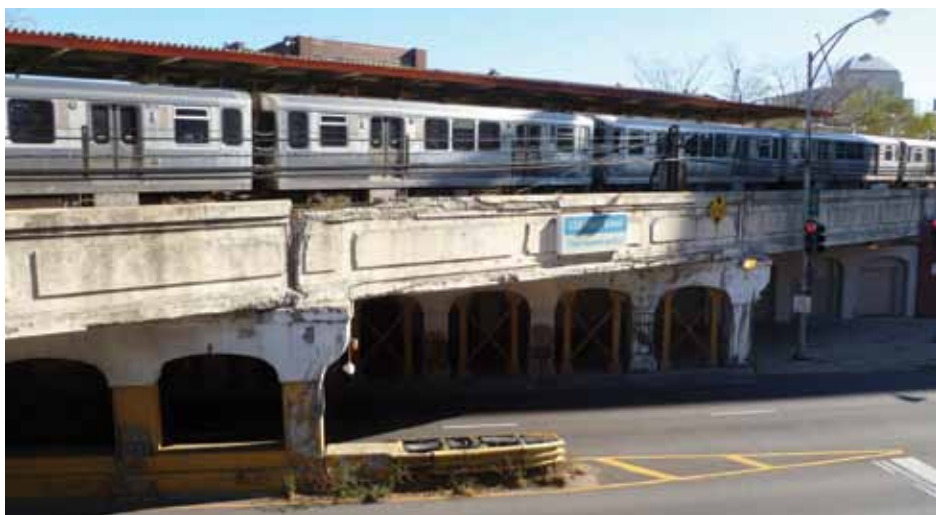
Figure 1: Corrosion-damaged concrete piles in Chicago being assisted with steel trusses.

Loss of load-carrying capacity in columns and piles in bridges is a major concern worldwide. In coastal regions, the dry-wet cycles lead to corrosion of reinforcing steel in concrete piles and bridge piers. In cold climates, the use of deicing chemicals results in corrosion of steel. *Figure 1* shows one of many such cases in Chicago where reinforced concrete columns are severely weakened by corrosion and steel trusses have been added to carry the load. Similarly, in industrial facilities such as mines, aggressive chemicals cause premature corrosion of steel columns.

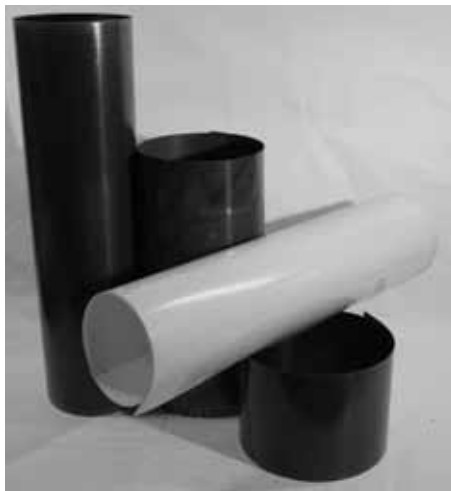
Figure 2: Carbon and glass FRP laminates.

The laminates are 4 to 5 feet wide and are supplied in rolls as long as 300 feet. The tensile strength of these laminates ranges between 60,000 and 155,000 psi depending on the number of layers of fabrics and the orientation of the fibers.

Unlike the wet layup system, the laminates are stiff enough to stand on their own (*Figure 2*). In the field, an appropriate length of the laminate is cut and wrapped around the deteriorated column to create a structural shell that is not bonded to the host column. A thin layer of epoxy is brushed over the overlapping portion of the laminate to create a two- or three-ply shell in the field – similar to a sonotube. The annular space between the shell and the host column is filled with resin or grout to make the host column and the shell work compositely.

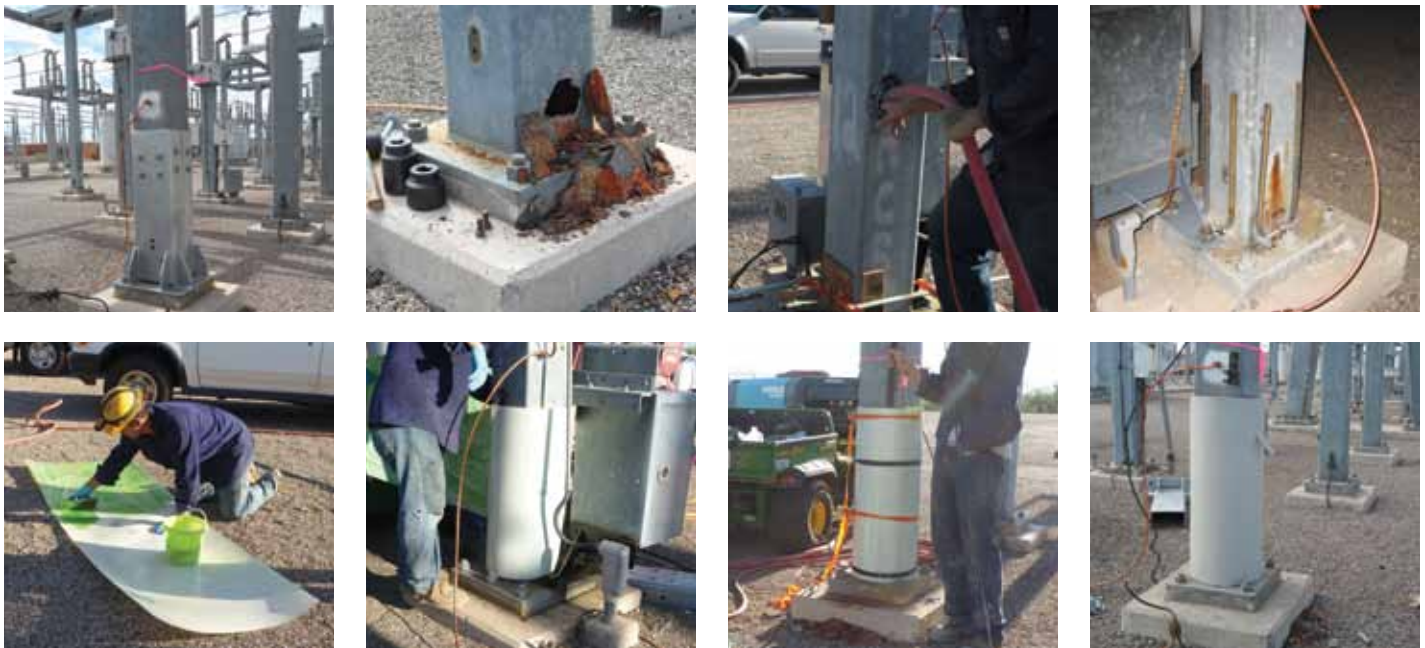
Figure 3: Repair of steel poles at TEP substations: original repair concept; corroded pole; filling the pole with grout; reinforcing steel welded to base plate; applying epoxy to the laminate, wrapping it around the pole and holding it with straps while grout is placed; finished and painted jacket.

There are several different structure types within Tucson Electric Power Company (TEP) substations that are typically constructed with galvanized 10- x10-inch hollow steel tubes (HSS). Due to improper drainage, moisture from rainwater is trapped inside the tubes and causes significant corrosion near the base of the structures. *Figure 3* shows a typical HSS where the corroding steel has been scraped off and removed from the inside face of the pole. Earlier attempts to remedy the problem called for steel plates that were externally bolted to the lower 3-feet of the structures (*Figure 3*). However, these repairs would hide the corroded portion of the structures from view and inspection, while the corrosion process continued inside the poles.

The repair of the poles with laminates was aimed at strengthening the lower 3 feet of the structures. An access port about 3 inches in diameter was cut at an elevation of 33 inches from the base. All loose rust was removed from inside the structure and the openings were temporarily sealed with plywood and clamps. A non-shrink high-strength grout was mixed and pumped into the structure from the access port. Four No. 5 U-shaped reinforcing bars were welded to the base plate; these bars were primarily for enhanced flexural capacity of the structure.

Due to its dielectric properties, a glass laminate with tensile strength of 62000 psi and thickness of 0.026 inch was used. A 3-foot wide x 8.5-foot long piece of laminate was used for each structure. A special two-component epoxy was mixed in the field and applied to an approximately 5-foot long section of the laminate. The mixed epoxy has a paste-like consistency and is applied with a trowel to a thickness of 20-30 mil. The laminate is then wrapped loosely around the structure to create a two-ply shell. The 8.5-foot length of the laminate allows creation of a two-ply 15-inch diameter shell with 8 inches of overlap beyond the starting point.

At this stage, before the epoxy cures, ratchet straps must be used to hold the shell in the desired shape. A 1-inch diameter PVC pipe was installed to make sure no rain water will accumulate inside the structure. The bottom edge of the jacket was sealed with tape atop the base plate.

Grout was placed into the shell form. Consolidation of the grout was completed with a small vibrator and the top of the grout was finished with a trowel. Before the grout sets, the hydrostatic pressure from the grout pushes the inner layer of the jacket outward against the outer layer and forces the two plies of the laminate to be tightly pressed against each other. After several hours, the ratchet straps were removed and the exterior of the shell was painted. All of these repairs were performed while the substation remained fully operational.

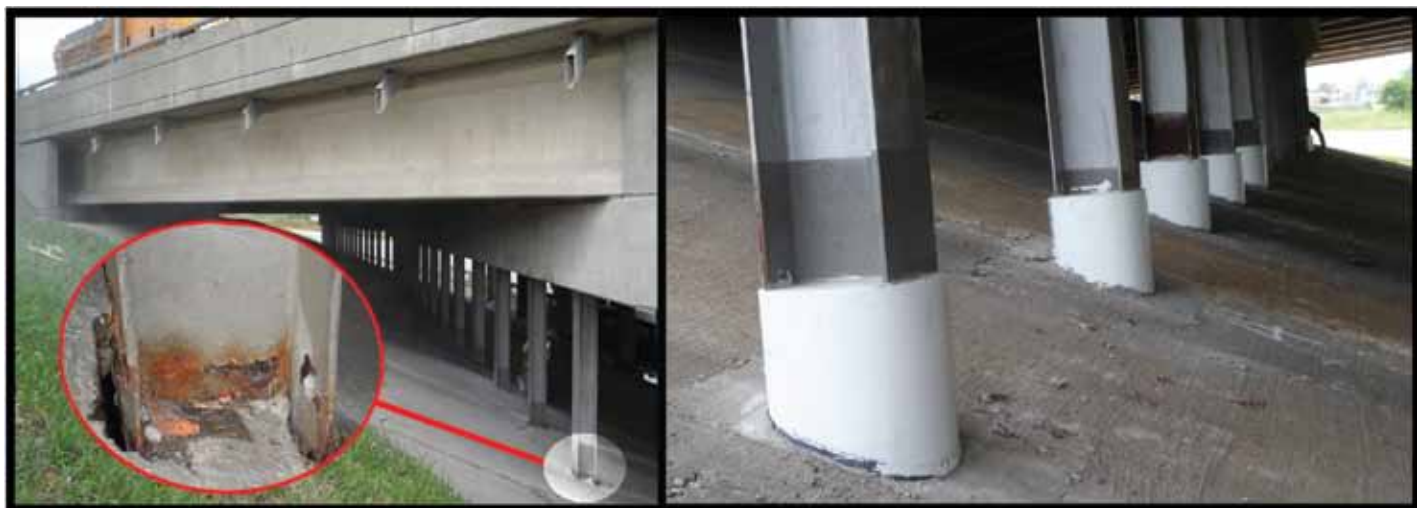
Figure 4: The I-70/I-270 interchanges in St. Louis, MO where 49 corroded bridge piling were recently repaired with FRP laminates.

A similar approach was used to repair 49 steel H piling in four bridges at the intersection of I-70 and I-270 in St. Louis, MO (Ehsani and Croarkin, 2011). Routine inspections had resulted in lowering the substructure condition

rating of this bridge to poor (National Bridge Inspection rating of 4 on a 9 point scale). This meant these bridges were considered Structurally Deficient due to the number of piling with significant section loss (Figure 4). The repairs were completed in just two weeks, improving all four bridges to a Satisfactory Condition Rating (NBI rating of 6). All of this was affordable enough to be funded with the region's operations budget, and repairs took place on one of the busiest highways in Missouri without causing any delays or distractions to the traveling public.
