The Academy of Music and its Ballroom Restoration

Lessons from the Past
By Constantine G. Doukakis, P.E.
and Amanda Gibney Weko

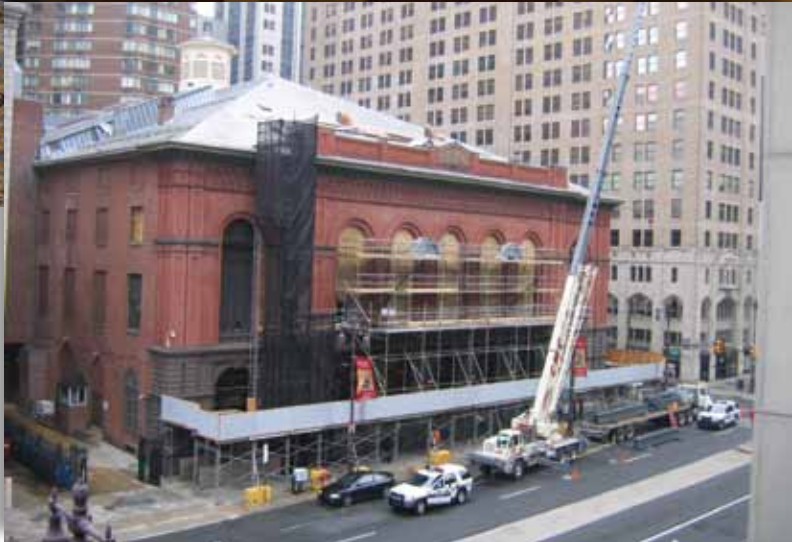
Construction underway at the Academy of Music.

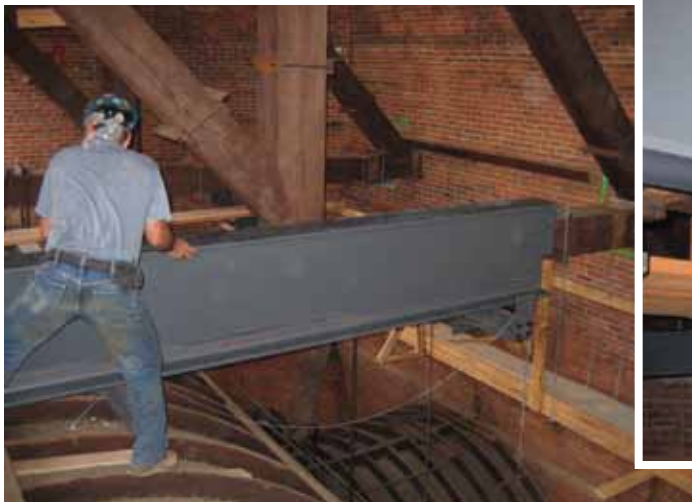
New steel was inserted in the attic to support the historic timber roof trusses.

The renovation involved extensive structural engineering, completed to seamlessly integrate with and support the historic building fabric. As structural engineer of record, Keast & Hood Co. designed repairs and supplemental framing. New steel beams were threaded through the roof to support original timber roof trusses. Additional steel framing was engineered to support new chandeliers.

The structural scope for the Ballroom restoration took place primarily in the attic, where sections of large steel beams (W24 x 84s) were first temporarily suspended from, and then moment-spliced together adjacent to, existing timber roof trusses. This methodology avoided the need for shoring towers or penetration through the historic plaster ceiling. The steel beams were pocketed into the interior wall and set upon an existing ledge in the brick front wall, where a new high-strength concrete bearing pad was installed to spread the load. New channels span between the W24 steel beams, just above the bottom chords of the timber trusses. A saddle assembly picks up the historic trusses, relegating the old system to the role of load collector, while the new steel supports the roof. Also, a sideways restraint detail was designed to keep the beams from moving north-south.

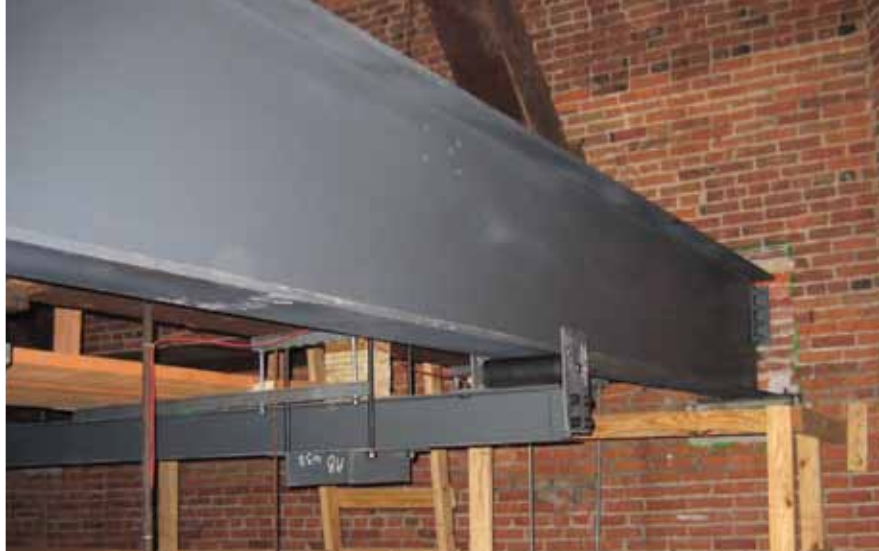
Detail of the framing and roller supports to guide W24 girders into their bearing pockets.

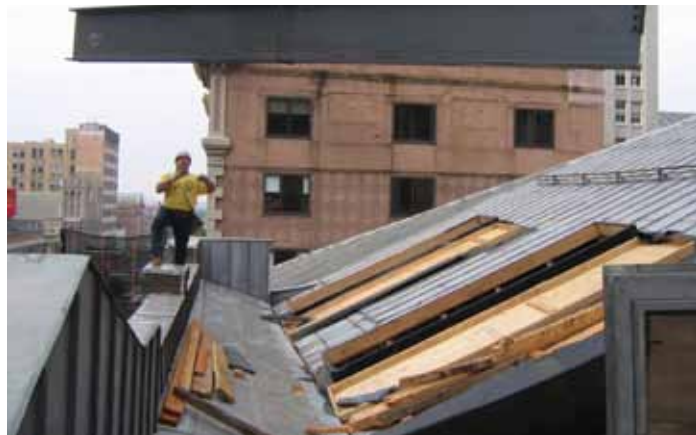
Rooftop view of steel being inserted into the Academy of Music attic.

In order to access the framing, temporary roof hatches were cut consistent with 1996 structural modifications performed in the auditorium. Upon project completion, the roof was re-sheathed with lead-coated copper.

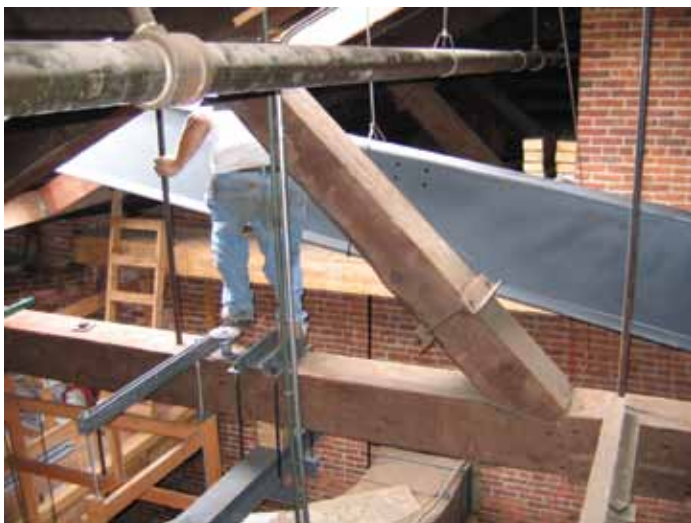
Attic view showing construction crew guiding new steel into place.

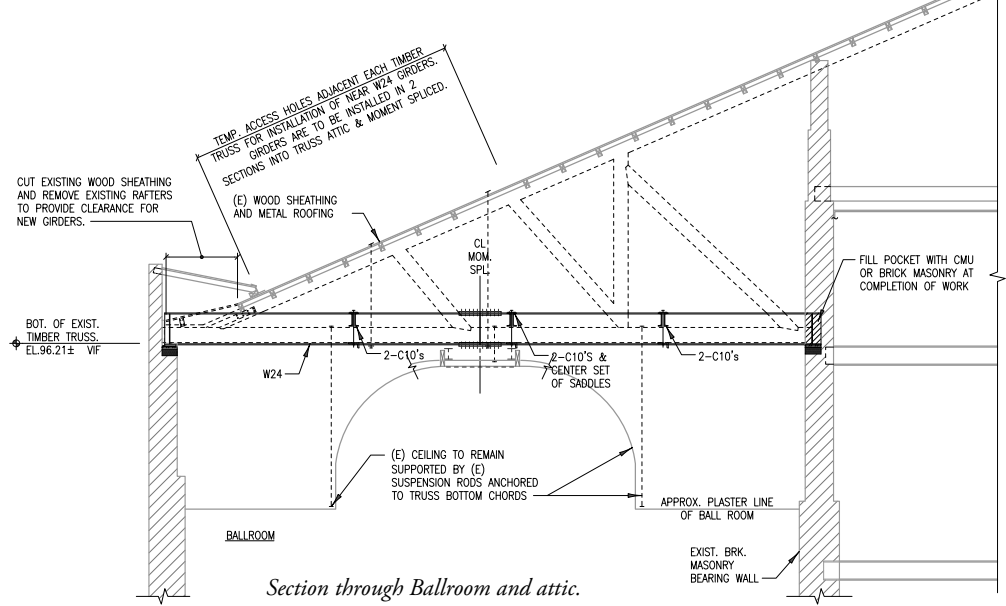
Section through Ballroom and attic.

Replication and installation of 12 chandeliers plus wall sconces required additional support framing. Keast & Hood Co. designed a detail mirrored on each end of the room in which joists were sistered where a portion of the exterior rafter had been removed for the steel beam installation. Framing was added above the ceiling joists to support the chandeliers and within the masonry to support sconces. Sconces that cantilevered from a single point were ensured that they would not sag.
