Stainless Steel Replacement

Community Swimming Pool for the City of South Gate, California

By Richard Hess, S.E., SECB, F. ASCE

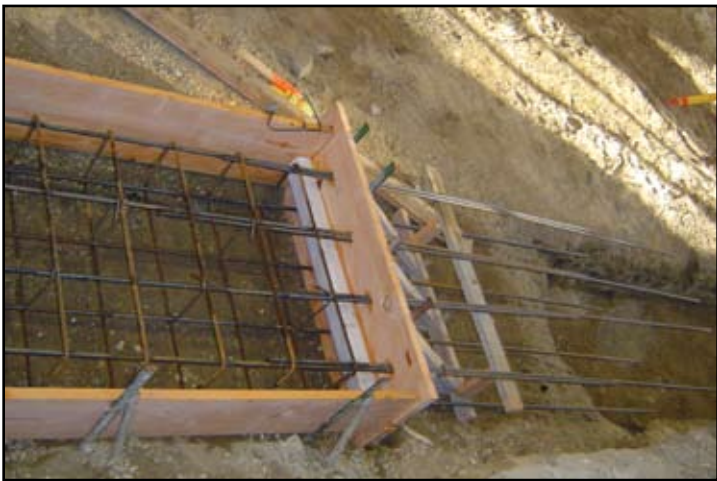
Figure 3: Footing reinforcing at step down to deep end of pool.

Figures 2 and 3 (page 34) show the site after the original pool was removed and shoring was installed to support the building structure. *Figures 4 and 5* (pages 34 and 35) show stages of footing and slab

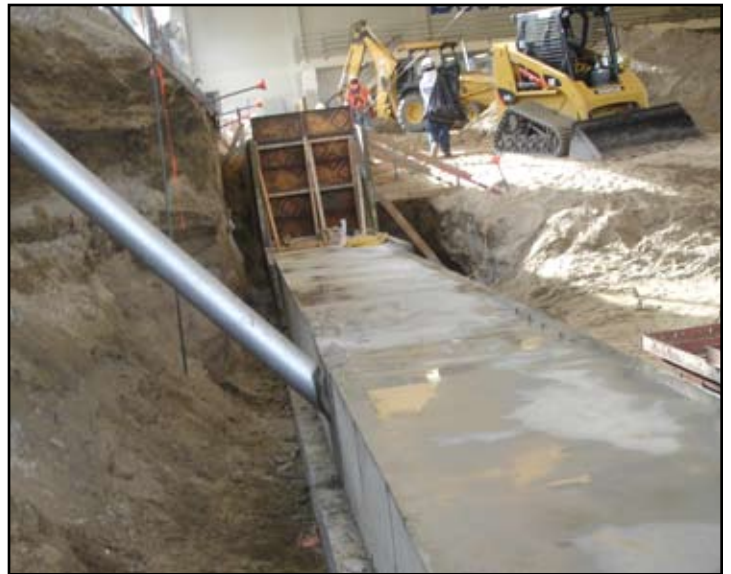
Figure 4: Footing poured, encasing base of shoring strut to be left in place.

construction, including the incorporation of the shoring base into the pool foundation.

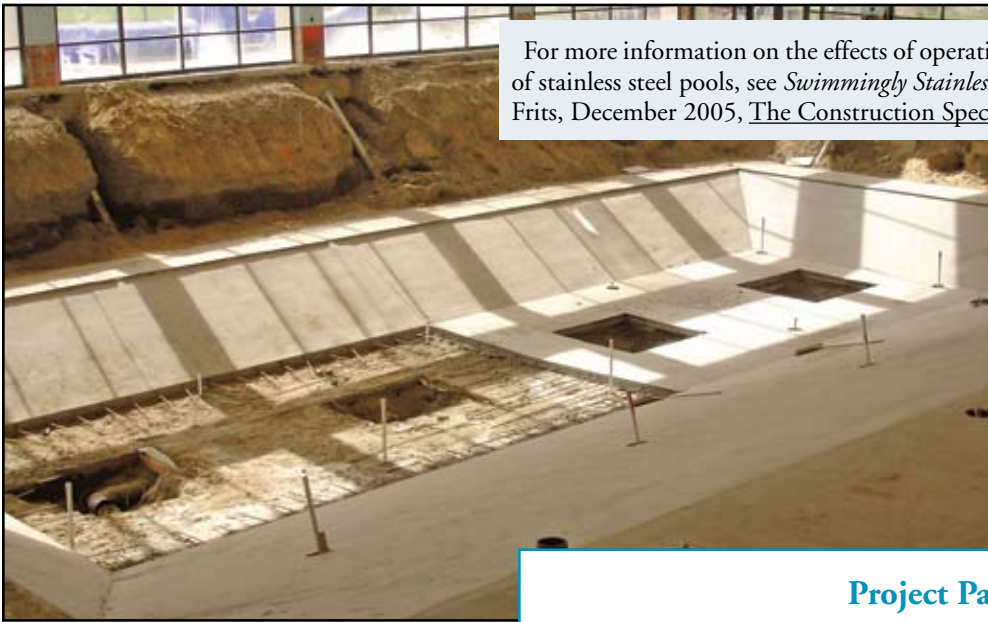
Figure 5: Foundations and partial slab at deep end of pool - showing diagonal shoring struts for building foundation.

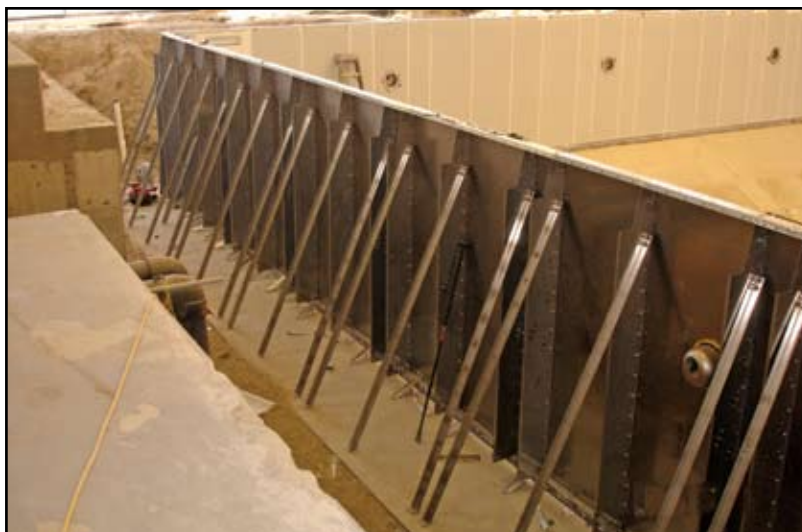
Figure 6: Stainless steel pool wall panels in place with partial supporting struts at deep end of pool.

Figure 6 shows some of the deep end panels in place with a single strut at each joint. Once these are in place, they are adjusted for height and side fit, and if required by the dimension of the pool, the remaining open space is measured for the final fit in pieces to close the perimeter.
