By James W. Niehoff, P.E.

# Augercast Piles in Hawaii

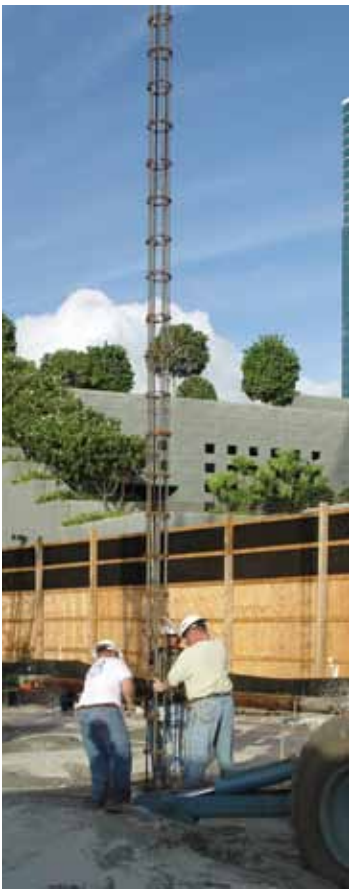
Figure 2: Pilot Hole Drilling.

Prior to pile construction, a series of boreholes were drilled with the crane mounted drill rig to confirm that the augers could penetrate the weak coral formations (Figure 3). Then, two load tests were performed on piles extending into both the shallow and deeper coral formations to confirm design capacity. Since the coral is irregularly shaped and contains numerous small voids and channels, grout formed an integral bond with the foundation materials. Side shear capacities of up to 6,000 pounds per square foot were developed in the coral strata. Both load tests demonstrated satisfactory support capacity and production pile installation was begun.

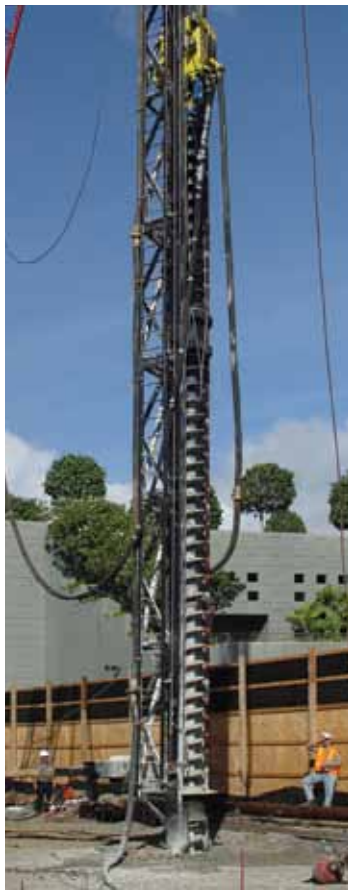
Figure 3: Installation of Reinforcing Cage.

Augercast piles are installed by drilling a borehole with a continuous flight, hollow-stem auger to a depth compatible with proper support, and then pumping high strength grout through the auger tip as the auger is withdrawn. A steel reinforcing cage is subsequently installed in the pile from the top, through the fluid grout, to resist lateral loads and to provide for connections to the pile cap (Figure 2, page 24). Support is derived by side shear resistance as well as end bearing. This pile type is particularly well suited to sites underlain by dense granular soils or weak bedrock materials, where high side friction can be developed between the fluid grout and the irregular sides of the borehole. Augercast piles typically range in diameter from 14 inches to 40 inches, and can support compressive loads ranging from 100 to over 1000 tons per pile.

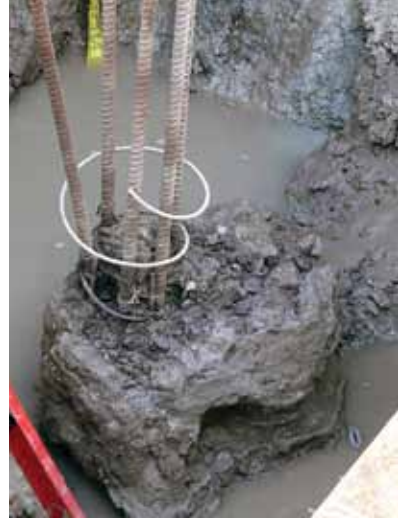
Figure 4: Pile with Settled Grout.

While the voids in the coral formations in the Waikiki area are beneficial to the development of side shear resistance for augercast pile foundations, they can cause problems as well. Grout volumes for piles installed in typical soil and rock profiles within mainland U.S. sites generally range from 110 to 140 percent of the theoretical volume of the pile. In porous coral formations, it is not unusual for grout volumes to range from 180 to 200 percent of the theoretical volume of the pile.

A short time after completion of the Hokua project, augercast piles were selected for use in the redevelopment of several city blocks in Waikiki. The local geotechnical engineer selected standard specifications for augercast pile installation that referenced a grout take factor of 145 percent. The pile installation contractor followed this specification and installed piles in a normal manner. Following installation of the reinforcing cages, the pile tops were covered with plywood sheeting to protect the fluid grout and to eliminate a hazard to workers. However, upon removing the sheeting several days later, the grout was observed to have dropped in some of the drilled boreholes to a level several feet below the groundwater table. The reinforcing cages had been pulled downward and distorted by the dropping grout (Figure 4). Ultimately, all of the installed piles required assessment by pile integrity testing and several required replacement at a cost of several hundred thousand dollars.
