# Use of Shrinkage-Compensating Concrete in Post-Tensioned Buildings

Part Two: A Four-Building Survey  
By Kenneth B. Bondy, S.E., FACI

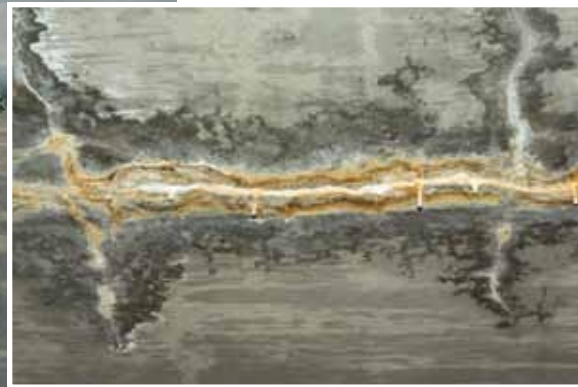
Figure 1: Efflorescence at crack on L1 slab soffit.

were measured and repaired in the 480,000 square feet of floor area in both structures. Prior to repair, some of the cracks allowed the passage of water through the slab, resulting in unsightly efflorescence at the slab soffit and potential damage to cars below (Figure 1).

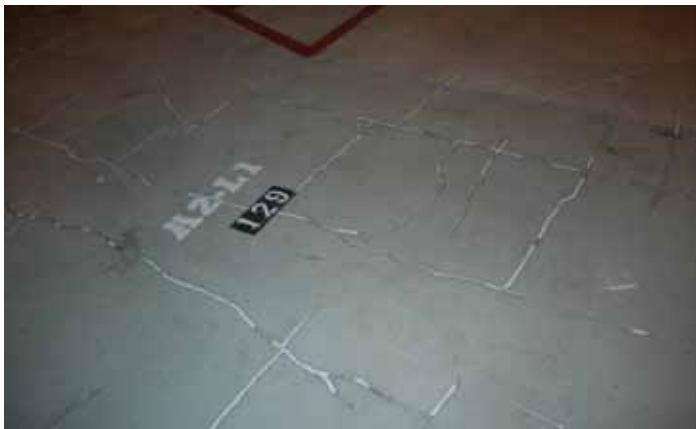
Figure 2: Typical repaired cracks on structure A2 Level L1.

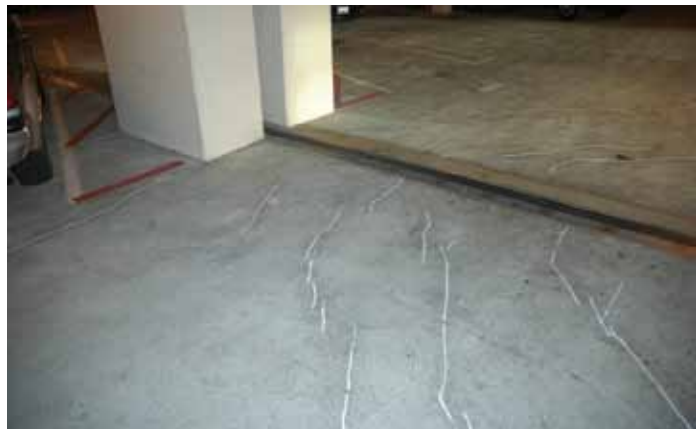
Figure 3: Top of slab near expansion joint, structure A2 Level L1.

Figure 3 (page 27) shows the top of the slab at a double column straddling the expansion joint at the L1 level. Diagonal cracks radiate off the columns in an orientation consistent with RTS on either side of the expansion joint. Figure 4 shows the top of the slab on the L2 level, exactly one floor above the location shown in Figure 3. The slab is crack free at this location.

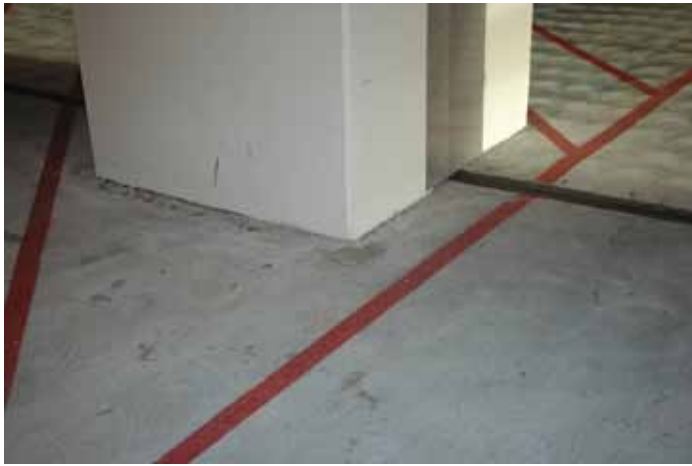
Figure 4: Same Location as Figure 3, One Floor Up On Level L2.

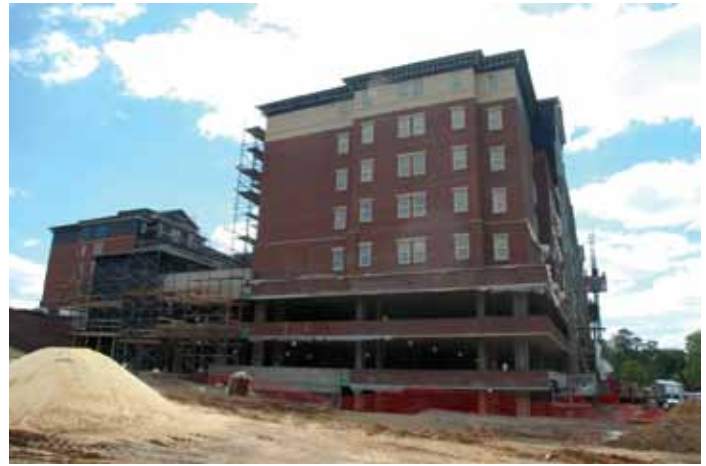
The photograph in Figure 5 was taken in April, 2009 when the building was structurally complete but architectural finish work was still underway.

Figure 5: North elevation showing three lower parking levels and five upper residential levels.

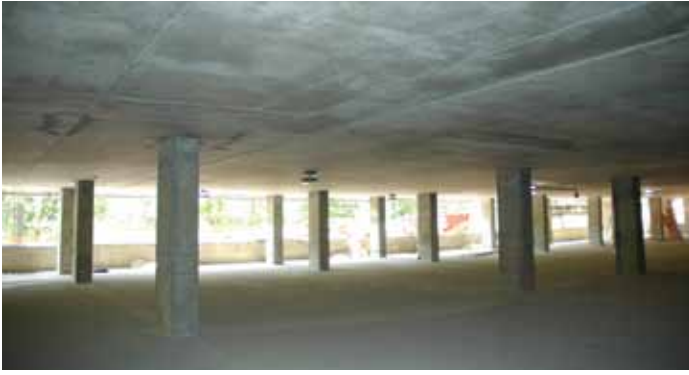
*Soffit of First Level slab (standing on slab-on-ground) looking northwest. The first supported level is the most susceptible to RTS cracking.*

Construction started in 2007 and the building was completed in 2009. During an onsite inspection of the parking level slabs in April 2009, they were found to be in excellent condition. No cracking was evident related to RTS or applied load. Careful observation of the far corners of each of the sections separated by the expansion joint – where the most RTS cracking could be expected – revealed these critical areas to be crack-free. An experienced observer of post-tensioned slabs would rate the performance and condition of these large slabs as outstanding.

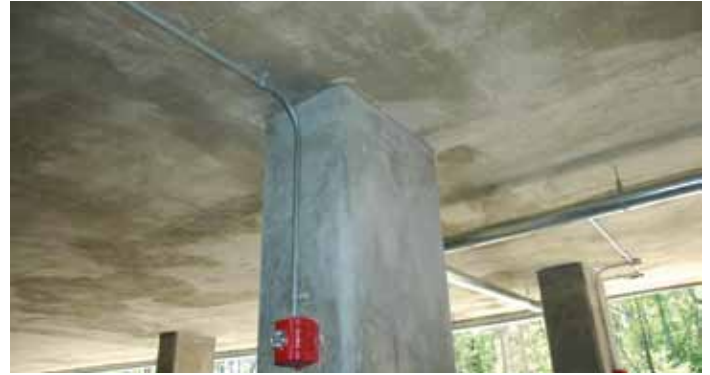
*Slab-column joint at First Level near northwest corner of slab.*
