Inventory Inspection of the Mike O'Callaghan-Pat Tillman Memorial Bridge

By Craig Smart, P.E. and Dave Severns, P.E.

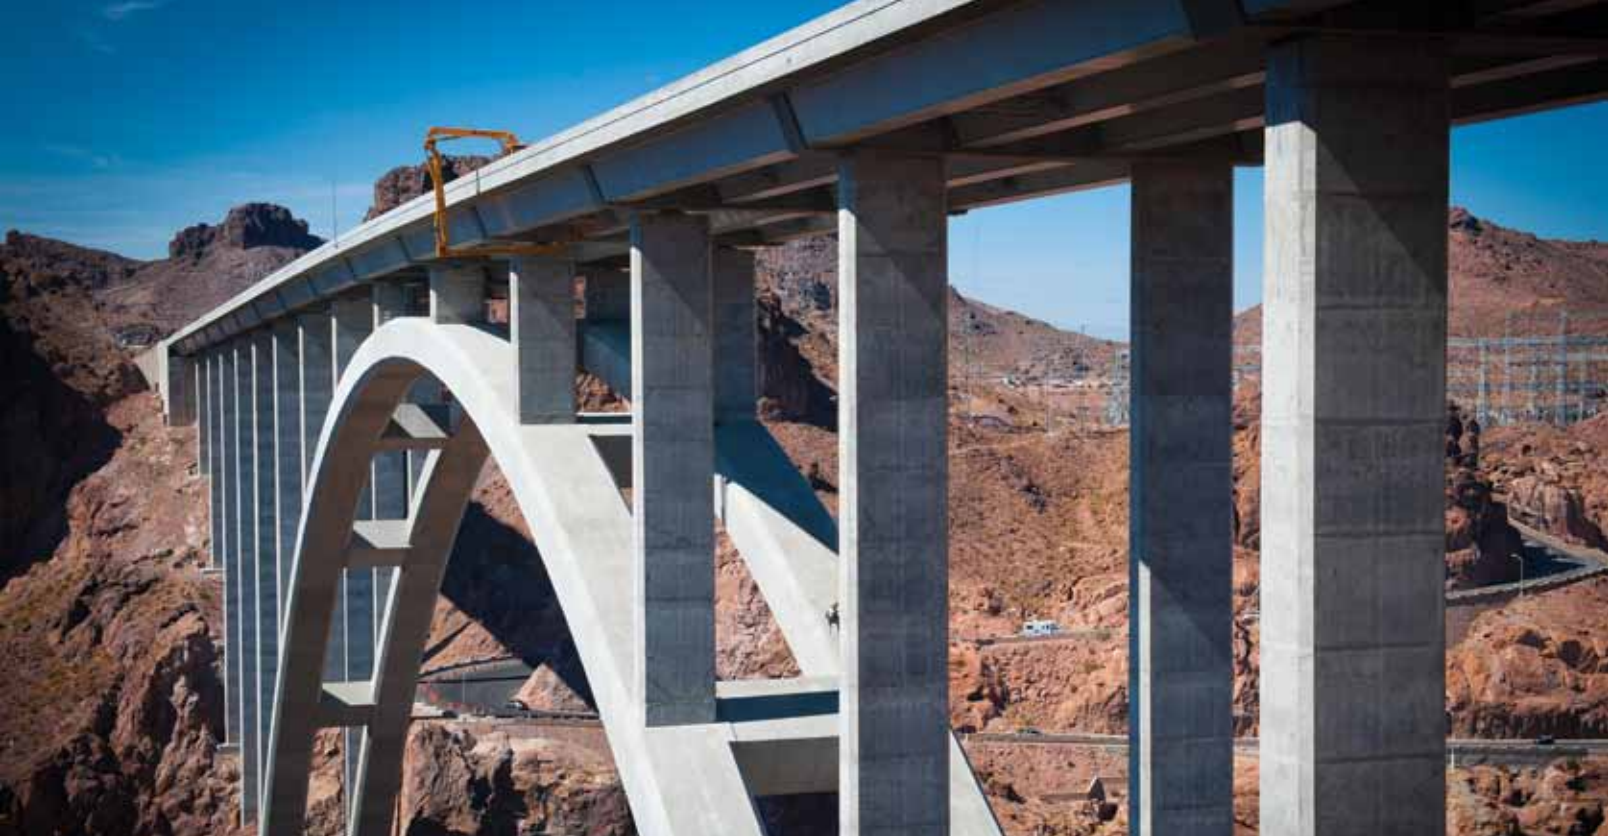
Figure 1: HDR bridge inspection team leader, Craig Smart, inspects the spandrel columns from ropes while NDOT inspectors access the steel tub girders. Courtesy of HDR, photographer Keith Philpott.

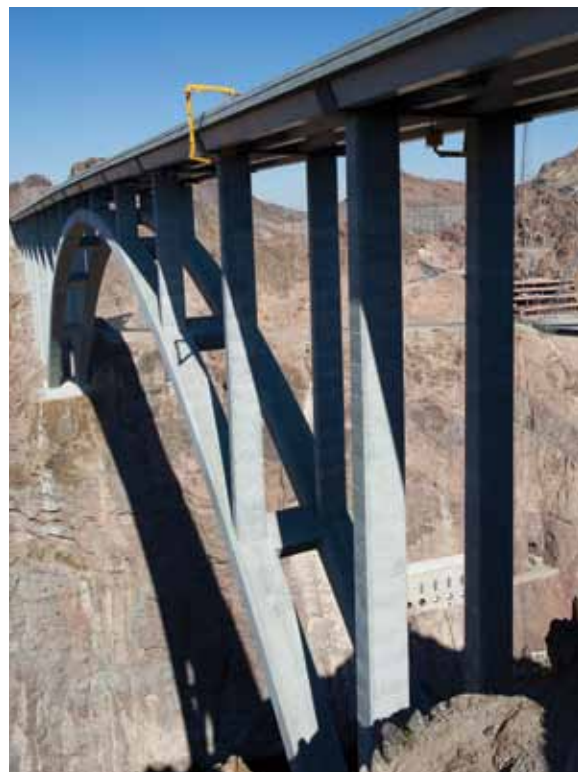
Figure 2: Underbridge inspection trucks work simultaneously on each side of the bridge to facilitate inspection and rope access work. Courtesy of HDR, photographer Keith Philpott.

The steel tub girders were inspected by NDOT personnel, using both visual and Non-Destructive Testing methodologies. Access to the inspection platforms interconnecting pairs of girders was provided via the NDOT UBITs, working simultaneously from each side of the bridge (Figure 2, page 19). While the NDOT inspectors performed their tasks, Mistras Ropeworks technicians rigged rope anchor points for the rope access inspection work. In order to minimize load on the UBIT platforms and to maximize the number of people in the buckets, ropes were pre-rigged and staged on the bridge deck prior to connecting to the anchors and deploying them over the side of the bridge. HDR rope access bridge inspectors were then deployed to the rope locations via the NDOT UBITs to begin inspection of the spandrel columns and arch ribs (Figure 3).

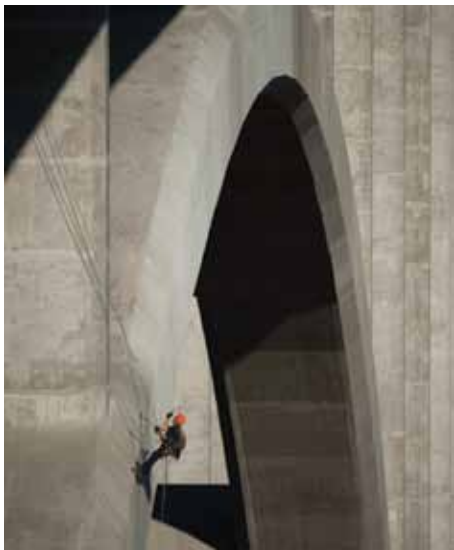
Figure 3: HDR inspector, Craig Smart, utilizes industrial rope access techniques following SPRAT guidelines to gain access to the arch rib and spandrel columns that would otherwise be outside of the reach of traditional inspection equipment. Courtesy of HDR, photographer Frank Huster.

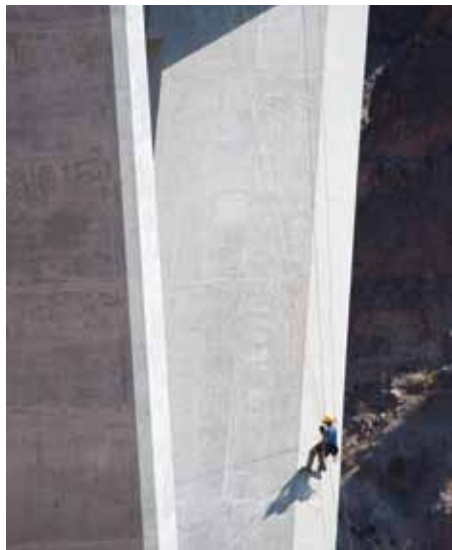
Figure 4: HDR inspector, Al Nelson, inspects the concrete arch rib utilizing a rope-to-rope transfer. Courtesy of HDR, photographer Keith Philpott.

The spandrel columns and arch ribs were inspected utilizing a rope access technique called a rope-to-rope transfer (Figure 4). The maneuver involves the inspector transferring from one two-rope system to a second two-rope system. In the process of the transfer, the inspector is able to position himself along the geometry of the arch in order to perform a thorough inspection. Diagram 1 shows the process of
