A Case Study in Detailing By Benjamin A. Mohr, P.E. and Stephen K. Harris, S.E.

The authors faced this dilemma in different forms during design of the J. Paul Leonard and Sutro Library at San Francisco State University. The design included a complete seismic upgrade of the existing building, a four-story building expansion featuring architecturally exposed structural steel, and an adjacent new building housing a high-density automated retrieval system for the majority of the library's collection. Both the existing and new buildings are concrete shear wall structures.

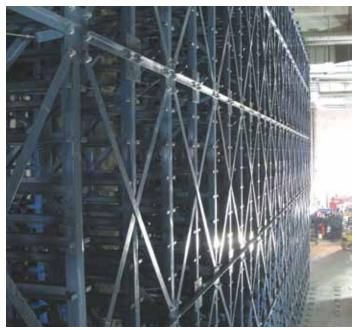
Figure 1: Installation of the high-density automated storage system.

For the top mat, rather than using the typical convention for specifying reinforcing steel (e.g., simply specifying #9 bars at 12-inch on center, each way), the location of each bar was specifically dimensioned such that it would avoid the locations of the post-installed anchors by a comfortable margin. (This was only possible because the exact

locations of all the posts for the storage racks were known in advance.) This solution was successful; the contractor installed 6,700 anchors without hitting a single bar. *Figure 1* shows the steel storage racks under construction; the anchor bolts are visible in the bottom right.

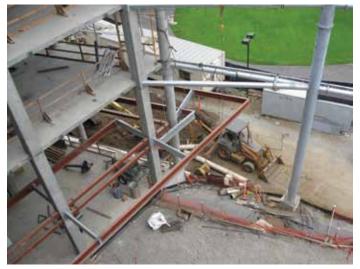
Figure 4: Canopy framing with bolted splices.

ever, in this case, the steel beams spanned between new concrete columns. In order to accommodate the uncertain distance between the columns, bolted splices near the inflection points of the steel beams were specified. Shim thickness at each splice were specified as 3/8-inch plus/ minus 3/8 inch.

Figure 4 shows the canopy framing. Portions of the galvanized members remain exposed in the final condition. Primed painted members will remain entirely enclosed in the final condition. Close collaboration between the steel and concrete subcontractors was crucial to the success of this installation.

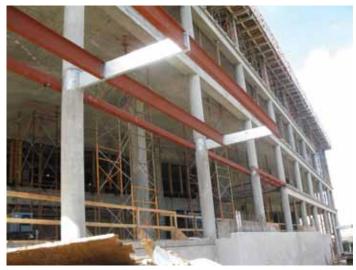
Figure 6: Steel collars installed in concrete columns.

In order to meet the first challenge, a circular steel collar was designed, constructed from a 20-inch diameter HSS. The outside diameter of the HSS matched the inside diameter of the fiberglass forms. Welding of small steel tabs to the outside of the collars at the exact elevation of the top of the fiberglass forms was specified. This set the collar at the correct elevation, and prevented it from sliding down into the form. Structural steel bolts were also specified in lieu of welded headed studs. The bolts are attached to nuts that are welded to the inside of the collar. (These nuts are in addition to those used to attach the steel cantilevers to the collar.) The contractor was able to remove these bolts during placement of the reinforcing cage in the column form and reinstall the bolts after the cage was in place. Figure 5 shows the steel collars on-site, prior to installation. Figure 6 shows the installed collars and steel cantilevers.
