Concrete “Paint” Arrests Cofferdam Corrosion at Submarine Pier

By Brian Robinson, P.E.

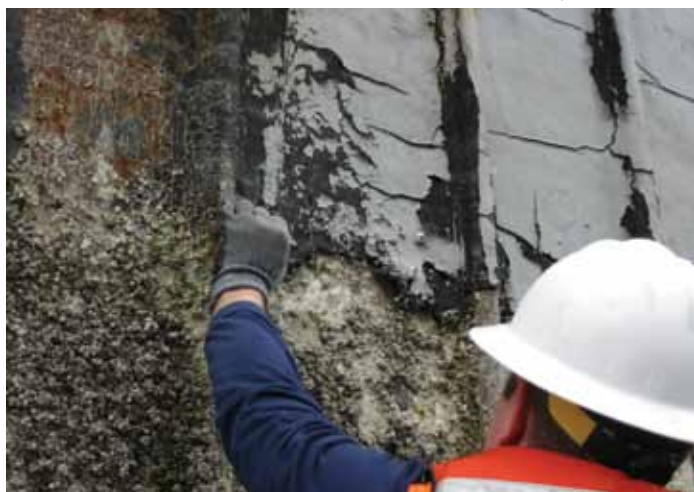
Figure 2: Existing failing cofferdam coating.

The owner considered a number of coating systems to mitigate further sheet pile corrosion: a high performance marine coating, thermal spray aluminum, copper-nickel cladding, and a concrete facing. Due to the considerable durability and low life-cycle cost, the owner chose a concrete facing extending from the top of the cofferdams to two-feet below Mean Lower Low Water as the preferred repair alternative. The owner called for a concrete service life of at least 50 years. Considering the cofferdam pile structure appeared to be performing well and did not exhibit excessive corrosion, the concrete facing would not be structural, but rather would provide an overlay to passivate and protect the steel cofferdam.

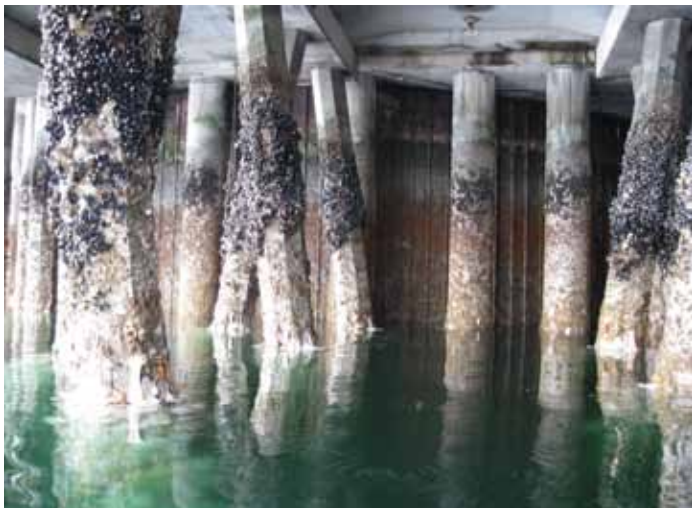
Figure 3: Existing concrete piers in close proximity to the cofferdam wall face.

- Under-pier access was substantially restricted due to the close spacing of existing concrete piling.
- The curvature of the wall face would present a formwork challenge.

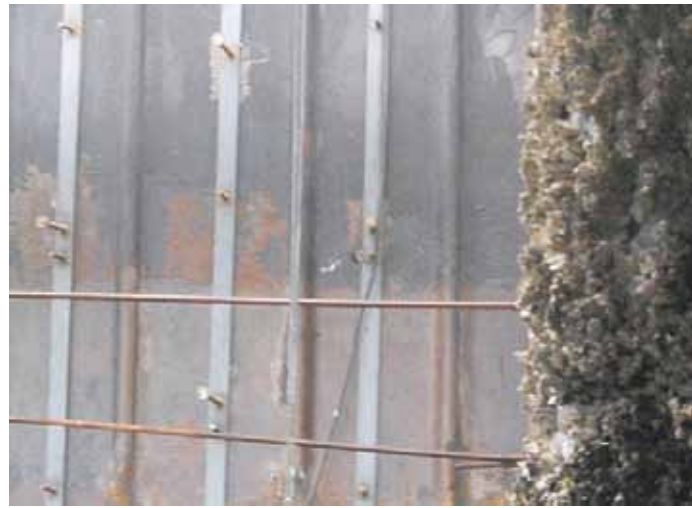
Figure 4: Pre-fabricated welded headed stud rails. Courtesy of Seaward Marine.

- Welded headed studs were pre-fabricated on steel bars, which were then fillet welded to the sheet pile face (Figure 4, page 27). Considering the large number of WHS's on project, this would save substantial time by minimizing layout and welding time in the field, some of which had to be done under water by divers.

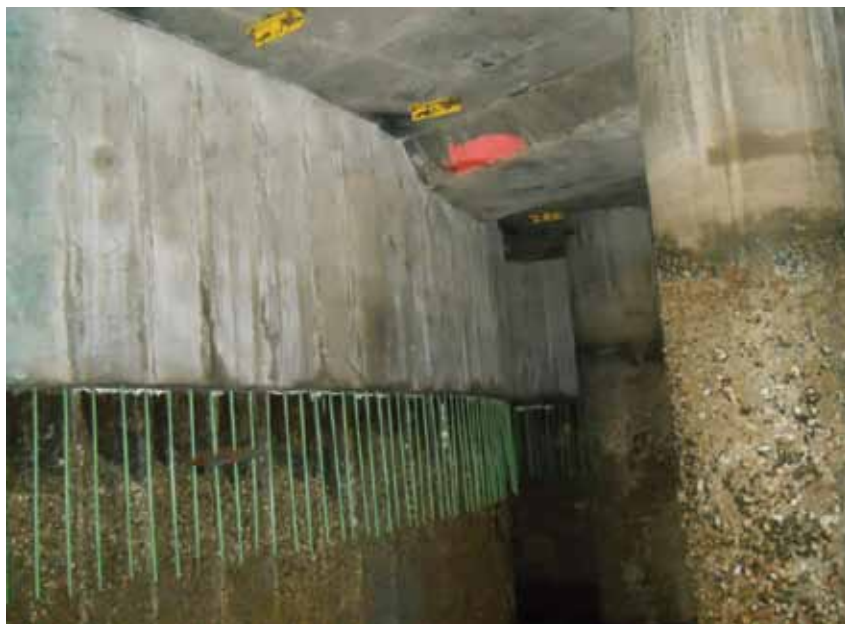
Figure 5: Completed "upper" facing under the pier. Courtesy of Seaward Marine.

- To more easily accommodate the in-water construction restriction, the contractor implemented a horizontal cold joint, which broke the facing into "uppers" and "lowers." This would allow the contractor to pour the "lowers" when in-water construction was allowed and could continue construction above-water on the "uppers" between the fish windows. Figure 5 shows a completed "upper" in an under-pier condition. The only changes required to accommodate this configuration were a minor modification to the welded headed stud layout at the cold joint and the implementation of epoxy-coated vertical bars, at the joint locations only.

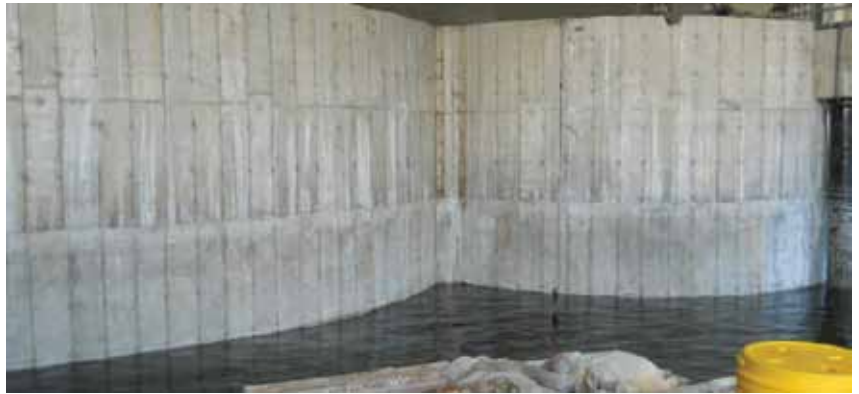
Figure 6: Completed cell and arc facing. Courtesy of Seaward Marine.

and under-pier work. Cores were taken of the test wall segment to measure specific gravity, chloride ion penetration resistance, voids, and compressive strength. Additionally, it was an opportunity to evaluate the cracking at specific concrete ages. Figure 6 shows a typical cell and arc with completed "uppers" and "lowers." The test wall was a success and remained as a permanent part of the facing. After the test wall was approved by the owner, the contractor constructed the project faster than expected, allowing it to be finished ahead of schedule. During the last on-site observation, the facing appeared to be performing very well and very few cracks have formed. As you might expect, the owner is very pleased with this outcome.
