The Japan Tohoku Tsunami of March, 2011

Part 2: Preliminary Findings on Tsunami Effects on Structures

By Gary Chock, S.E.

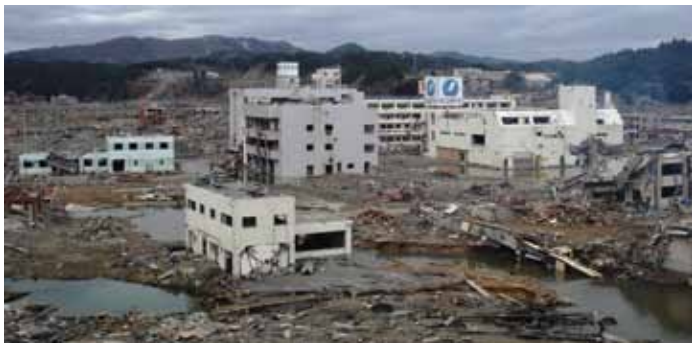
Figure 3: Minamisanriku Post-Tsunami Aerial Photograph. Courtesy of Ioan Nistor, ASCE.

Figures 3 and 4 show the town of Minamisanriku, with inundated depths of 15 meters (49.2 feet), highlighting the survival of several low to mid-rise reinforced concrete buildings.

a significant proportion of the surviving buildings did not appear to have significant structural damage. This provides some encouragement regarding the potential resilience of larger modern buildings having robust seismic designs with scour and uplift-resistant foundations.

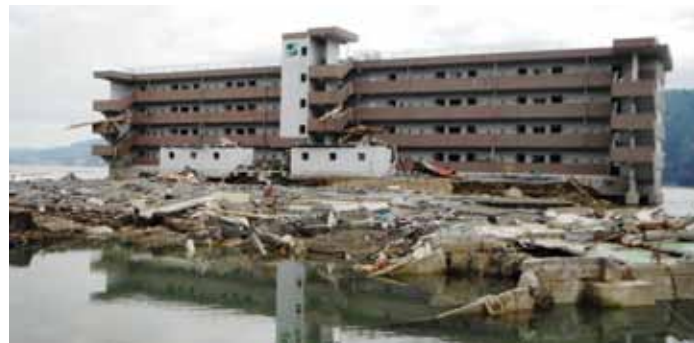
Figure 4: Minamisanriku designated vertical evacuation apartment building. Courtesy of David Kriebel, ASCE.

One of the Minamisanriku vertical evacuation buildings was a four-story shoreline apartment building with a roof height 15.25 meters (50 feet) above sea level. However, the tsunami reached 15.8 meters (51.8 feet) above sea level and it actually overtopped its roof level. Those who evacuated to the roof, which had been designed for access/occupancy, remained safe. This building was oriented perpendicular to the flow, which scoured almost a complete moat around the structure. However, it has a pile foundation system and was not structurally damaged despite being completely inundated and having no “breakaway” walls.

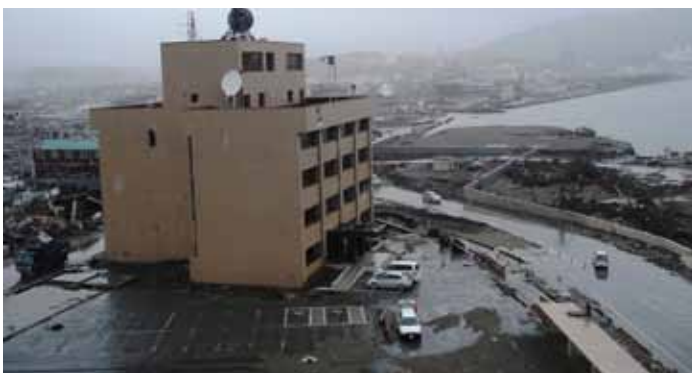
Several other tall mid-rise reinforced concrete buildings that served as tsunami evacuation buildings were visited. They performed well, the evacuees furnishing a number of spectacular videos of tsunami flow destroying neighboring buildings around them. The Kesennuma Port Authority Building (Figure 5) served as a vertical evacuation building from the 3rd floor upward, which was inundated to 8.25 meters (27 feet) above local grade. Most other neighboring low-rise industrial buildings in the port area were swept away.

Figure 5: Kesennuma Port Authority Building. Courtesy of Ioan Nistor, ASCE.

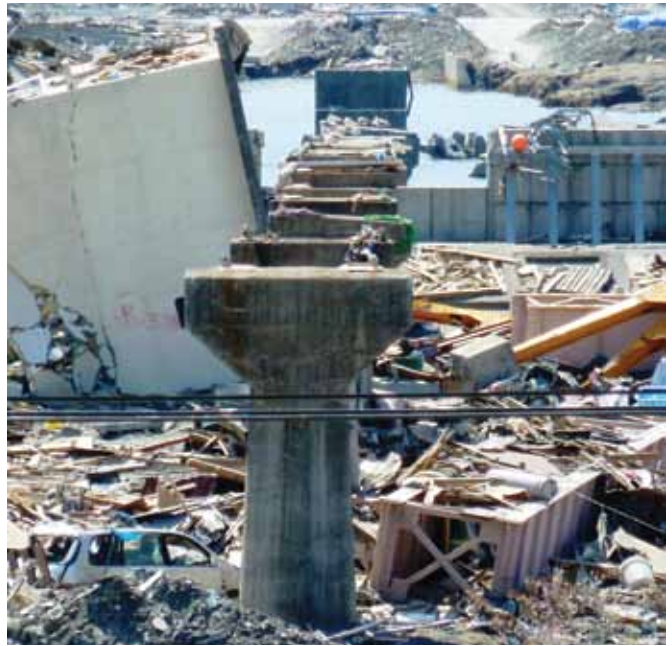
Bridge outages were numerous, including both highway and rail bridges and overpasses. Whereas roadway bridges can be replaced by temporary or by-pass structures, the failure of a railway bridge generally results in a much longer outage of the rail line. In the case of railways, these failures were a result of large sustained lateral forces on the bridge spans, sufficient to fail seismic anchorages or pull down the overpass piers themselves. In many other cases, seismic lateral blocking and ductile anchorage of highway bridge girders were ineffective in resisting uplift. The example of a railway overpass in Otsuchi demonstrates the severity of hydrodynamic loads (Figure 6).

Figure 6: Multiple span and pier failures of a railway overpass and river bridge in Otsuchi, having braced steel plate girders. Courtesy of Ian Robertson, ASCE.
