# Getting to the Bottom of Underpinning

By David B. Peraza, P.E.

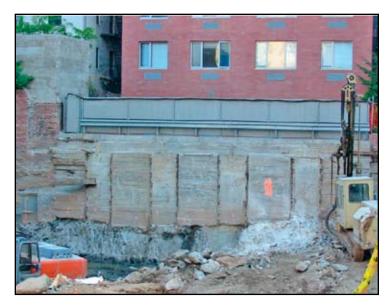
Figure 4: Completed concrete underpinning.

Figure 4 shows a photograph of a completed underpinning installation.
