The Restoration of Texas Courthouses

Case Study: The Ellis County Courthouse, Waxahachie, Texas

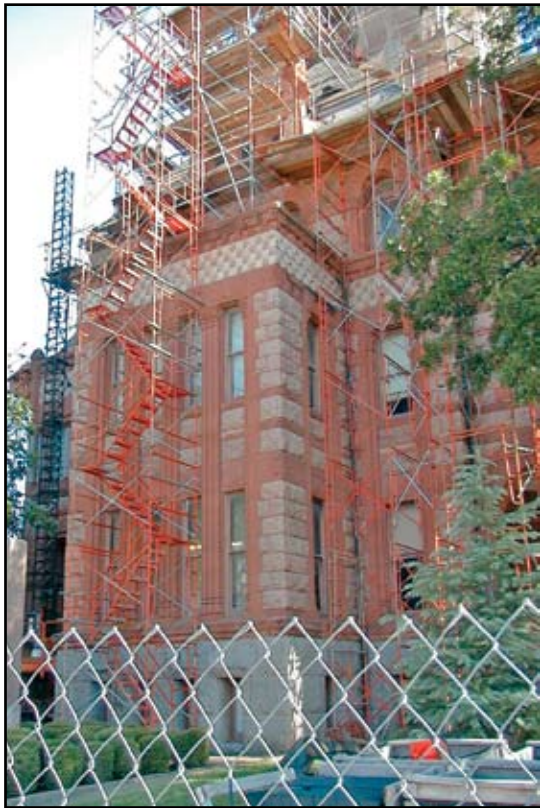
Exterior south stairs scaffolding, Ellis County Courthouse

The restoration of the central clock tower elements (i.e., stone, slate, clock-faces) of the Ellis County Courthouse was particularly

challenging. The building's design and roof finishes required that the scaffolding system for the tower not be supported from the building below. Consequently, a special scaffolding system was designed to be suspended on large steel beams inserted through the existing masonry openings in the tower.
