Building for Extreme Events

Lessons Learned from Hurricane Katrina

By William L. Coulbourn, P.E.

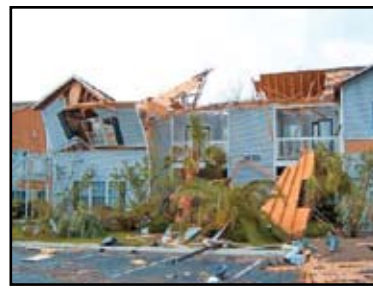
Figure 1: Roof Uplift Failure, Long Beach, MS

The roof uplift failure in *Figure 1* was caused by a lack of connections between the roof framing and the exterior wall.

Wind got under the indented porch and combined with the uplift on the roof surface to lift the roof trusses. The lack of continuity in the wall construction on the left side of the building caused the wall to peel out at the corner and twist the window. There were numerous examples

of this common roof to wall failure mode, such as:

- A lack of any connector between the roof truss and wall
- A connector field made from sheet metal and fastened with either 16d nails or roofing nails
- A connector installed but with an insufficient number of fasteners

Stronger building codes and compliance with best practices for high wind areas would have prevented these types of failures. There was significant building envelope failures with roof shingle loss, siding damage, soffit damage, wide spread glazing damage in New Orleans (where wind speeds were between 100 to 110 mph) and brick façade failures. New buildings being erected today exhibit some of the same shortcomings; there is generally a lack of attention to detail and a lack of knowledge about the importance of continuous load paths for build-

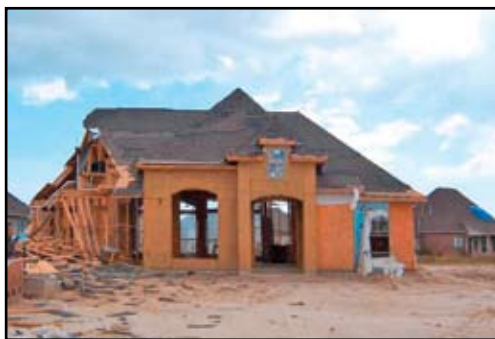
Figure 2: Shear Wall Failure, St. Tammany Parish, LA

The shear wall failure in *Figure 2* was caused by a lack of attachment. The sheathing was attached with staples that were widely spaced, and those that were present did not have both legs of the staple attached to the framing. The front wall was approximately 1 foot out of plumb from top to bottom of the wall. There were hold down brackets installed at the ends of the shear wall. The shear wall for a 120 mph (3-sec gust) wind speed should be fastened to the framing with approximately the equivalent of 8d nails spaced 4- to 6-inches on center along the edges. Exact spacing, of course, depends on shear load and the length of the shear wall useable in the wind direction being considered.

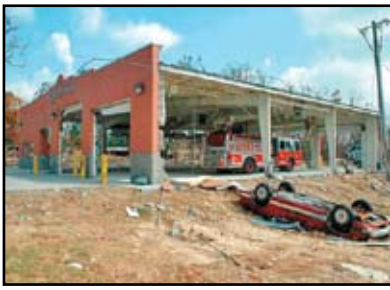
Figure 3: Storm Surge Damage, Gulfport, MS

east as Mobile Bay, AL. Water overtopped and failed the flood protection levee system around New Orleans. The lessons are numerous, and they include:

The flooding, of course, was extreme – storm surge depths of 25 to 30 feet in Mississippi and nearly 12 feet as far

- Build higher
- Robust systems can survive
- Consider flooding extremes even in back bay areas that seem very far from the primary flooding source
- Don't assume that flood protection structures will always protect
- Owners must assume some risk for living in places subject to extreme events
