Restoration of Harvard University Stadium

By Wayne R. Lawson, P.E.

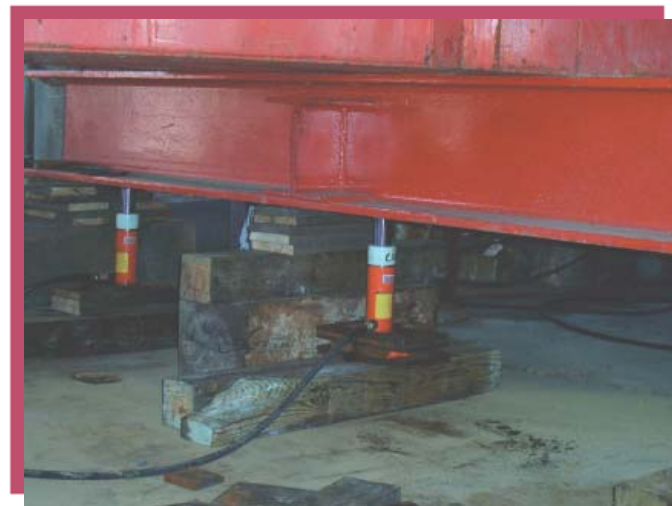
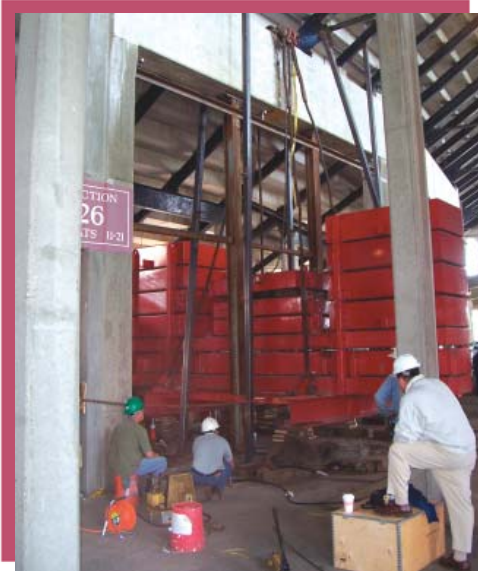
A number of top surface loading methods were reviewed including mass concrete blocks and water, however these required disruption of the stadium activities. By working with a rigging contractor, an underside loading method was devised, utilizing a crane counterweight load frame that was supported by six (6) 25-ton hydraulic jacks and suspended from the subject beam through a steel cable and harness.

The existing precast seating was disconnected from the beam and temporarily supported with additional shoring, provided to allow four inch settlement of the beam in the event that a catastrophic failure occurred during the load test.

Dial gauges were installed at each end and midspan to measure deflections during the load test. During the test, the load was applied in four increments: 90 kips, 160 kips, 190 kips and 214 kips. Initially, the entire test load was supported by the six (6) hydraulic jacks. At each test load increment, the jacks were lowered to enable a transfer of the appropriate load to the beam. Deflection measurements were taken by CBI at midspan and adjacent to the supporting columns after each load increment. The deflections were then measured after the final load had been in place for a twenty-four hour period. The test load was subsequently removed after completion of the twenty-four hour load period, and the structure recovered more than ninety percent of the maximum deflection.

The load test results successfully demonstrated that the existing beams could safely support the required dead and live loads. These results eliminated the need for installation of permanent supplemental framing, allowing more expenditures for other necessary stadium repairs and improvements.
