# Collapse of Sloping Masonry Veneer

By Richard L. Hess, S.E., SECB

Collapse of a forty foot long section of a twelve foot high sloping granite veneer required a structural evaluation to determine the cause of the failure. Built in the 1970s, the collapsed wall is at the base of a mid-rise government office building located in southern California.

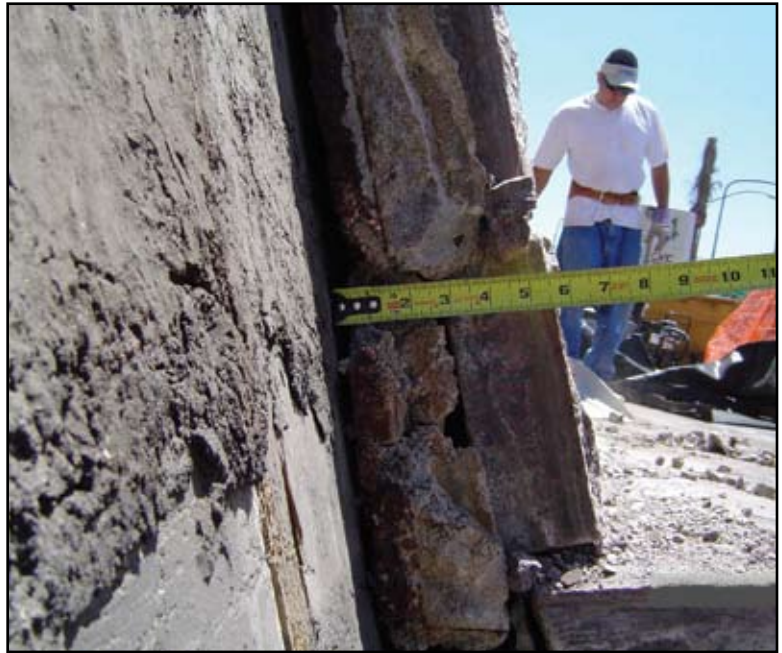
Edge of failed wall where adjacent granite has fallen off

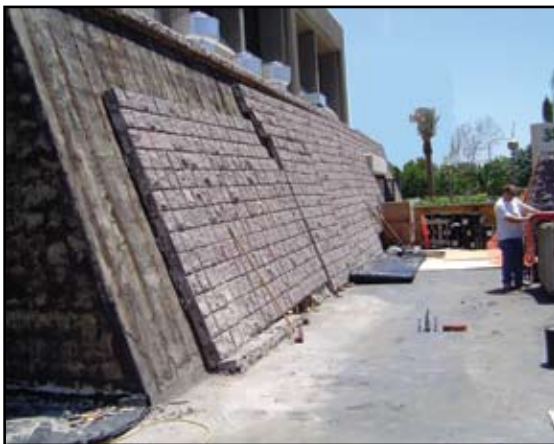
The slope of the wall is three vertical units to one horizontal unit. In order for friction to be a significant factor to resist movement due to gravity, the slope would have to be reduced to approximately one vertical unit to four or five horizontal units, a much flatter slope.

Southwest corner of failed granite wall; south face is sloped 1 horizontal to 3 vertical, while west face is vertical
