Hyperbolic Cooling Tower Column and Lintel Beam Protection

By Kraig Tarou and Stan Boshart

Such was the case for the Unit No. 2 Hyperbolic cooling tower located at St. John's River Power Plant in Jacksonville, Fla. This particular cast-in-place tower, in operation since 1987, is 450 feet tall and 360 feet in diameter. It was constructed using traditional formwork for the columns and lintel beams, and slip-form construction for the veil (shell).

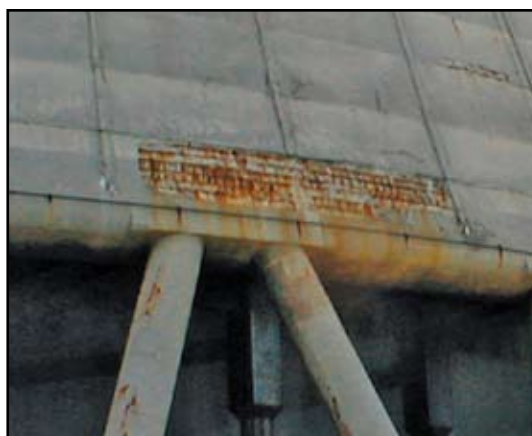
During operation, practically all surfaces in the basin are subject to "immersion" conditions. Columns and lintels are in a "splash zone" environment.

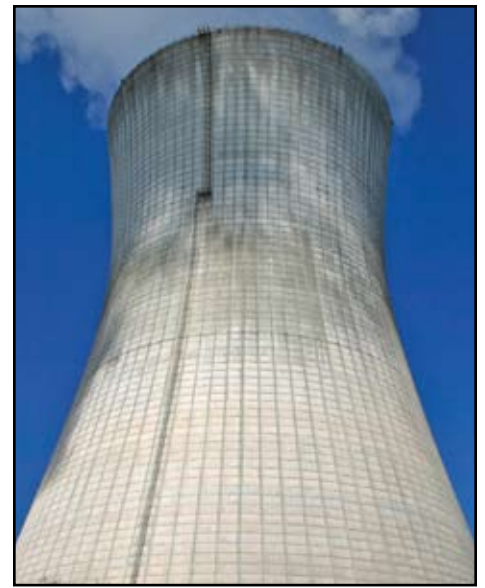
Located at St. John's River Power Plant in Jacksonville, Florida, the Unit No. 2 hyperbolic cooling tower is 450 feet tall and 360 feet in diameter.

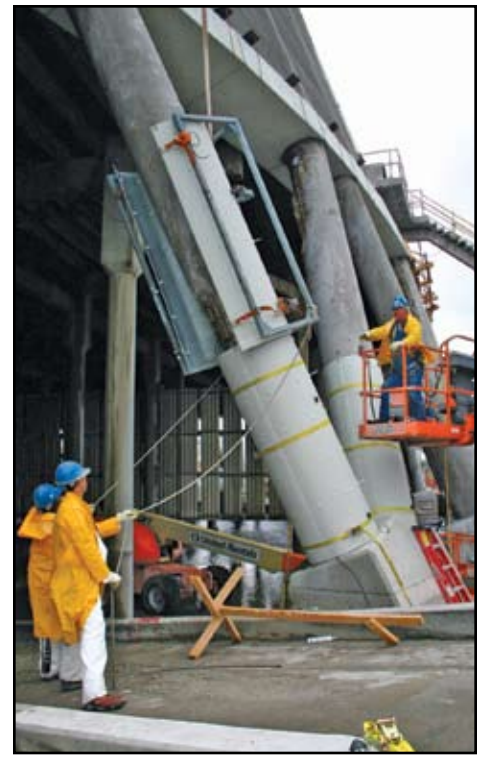
For each column, the jacket was divided into six pieces – two pieces each for the bottom, middle and top.

Jacket installation on the columns was challenging because of the compound angle of the columns. To address this concern, the specialty contractor designed and fabricated a lifting bracket that, once lifted off the ground, was at the correct angle to slide the jacket into place. For each column, the jacket was divided into six pieces – two pieces each for the bottom, middle and top. Placement started at the bottom with the two pieces resting on the foundation and subsequent pieces supported by the ones below. Each section of the jacket was lap-spliced and held in place with stainless steel fasteners. Brackets held up the jackets through the grout port-holes, and the jackets were held open with straps attached to the lifting bracket. Once the jacket

was around the column, the strap was released and the jacket closed around the column. Next, ratchet straps were wrapped around each section of jacket to increase hoop strength and to keep the jackets from warping during grouting. Grouting was performed through ports built into the jacket at 2.5-foot vertical intervals, alternately placed on either face of the column.

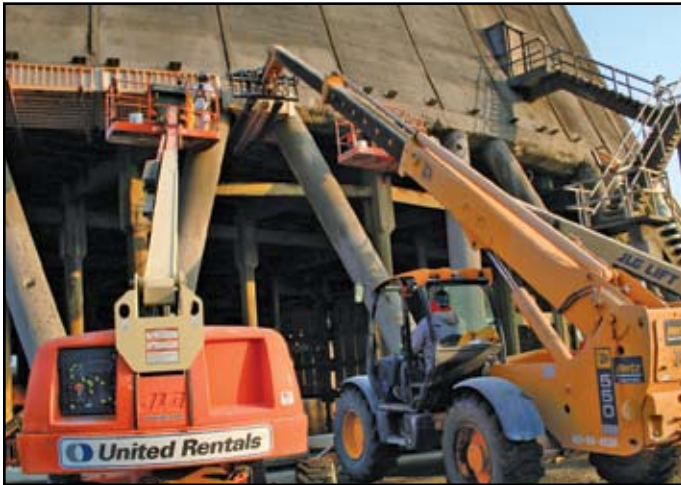
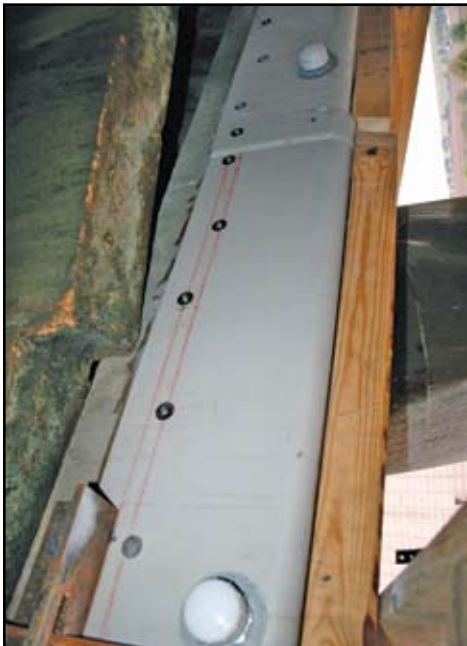
Using an aerial lift (above), the jackets were attached to the lintel beam and 4,000 psi cementitious grout was pumped through ports on the back face of the jackets (left).

Since the lintel jackets were an odd shape and size, the specialty contractor had to determine how to lift them into place and support them while grouting. Several methods were considered, and all but one were determined to be too cumbersome and time-consuming for the project. The method chosen involved building a grillage in which the jacket would be placed prior to mounting, keeping it in place and fastened to the structure until the grout cured. For this method, structural steel brackets were first mounted to the interior and exterior of the tower and were utilized, along with steel rods, to suspend the grillage formwork and jacket. First, however, the grillage had to accommodate the locations for installing the permanent stainless steel fas-

teners that hold the jackets in place. Because the final placement of the fastener was important for aesthetic reasons, the grillage had to allow space for them to be installed at precise locations. Using an aerial lift, the jackets were attached to the lintel beam and 4,000 psi cementitious grout was pumped through ports on the back face of the jackets.

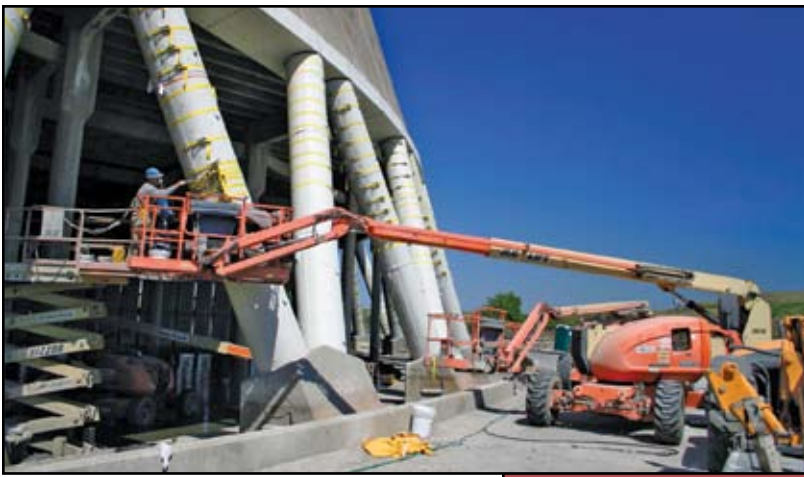
Once the jacket was around the column, the strap was released and the jacket closed around the column. Next, ratchet straps were wrapped around each section of jacket.

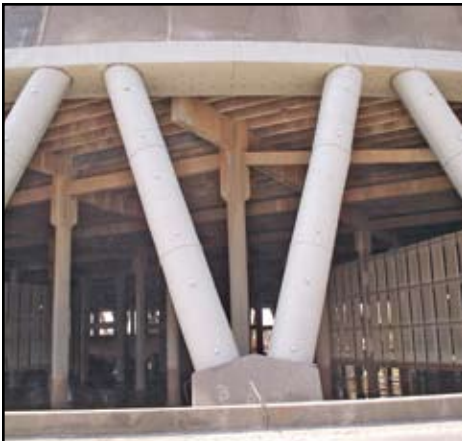
View of installed lintel beam and column jackets.
