# Beyond Failure...

A Look at the "How" and the "Why" When Structures Fail

By Jeffrey R Needham, P.E. and Malcolm "Andy" Carter, P.E.

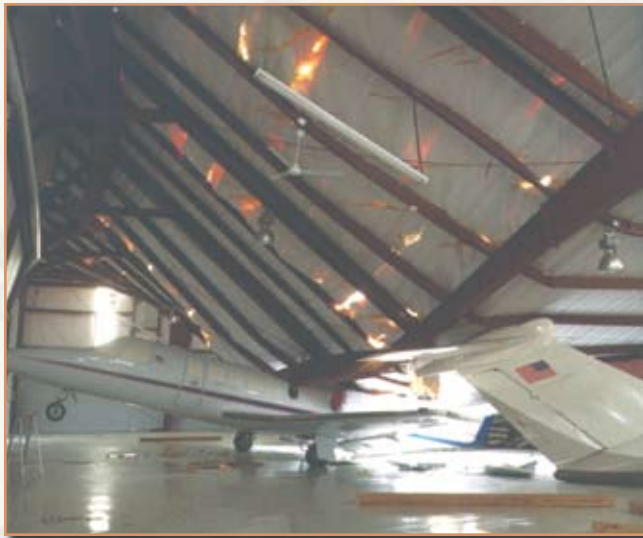
Failed corporate jet hanger

This small PEMB corporate aircraft hangar failed due to the widespread omission of compression flange bracing by the erector. This resulted in over \$12 million of damages.

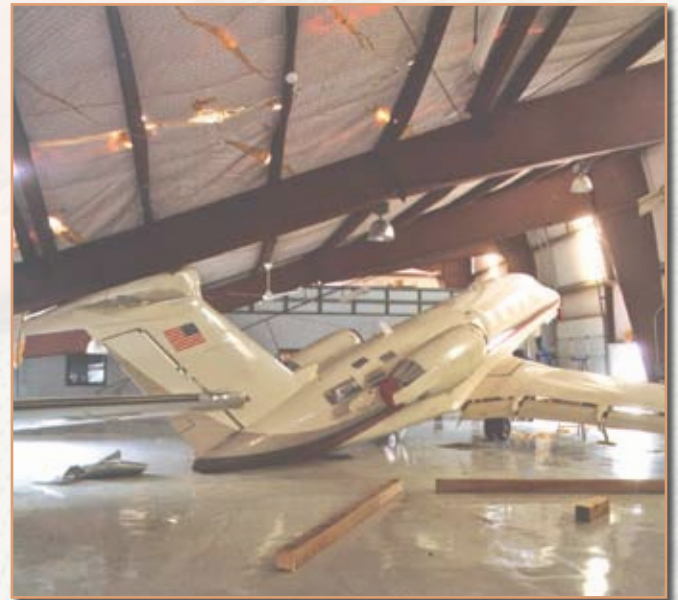
Rigid frames in failed corporate jet hanger

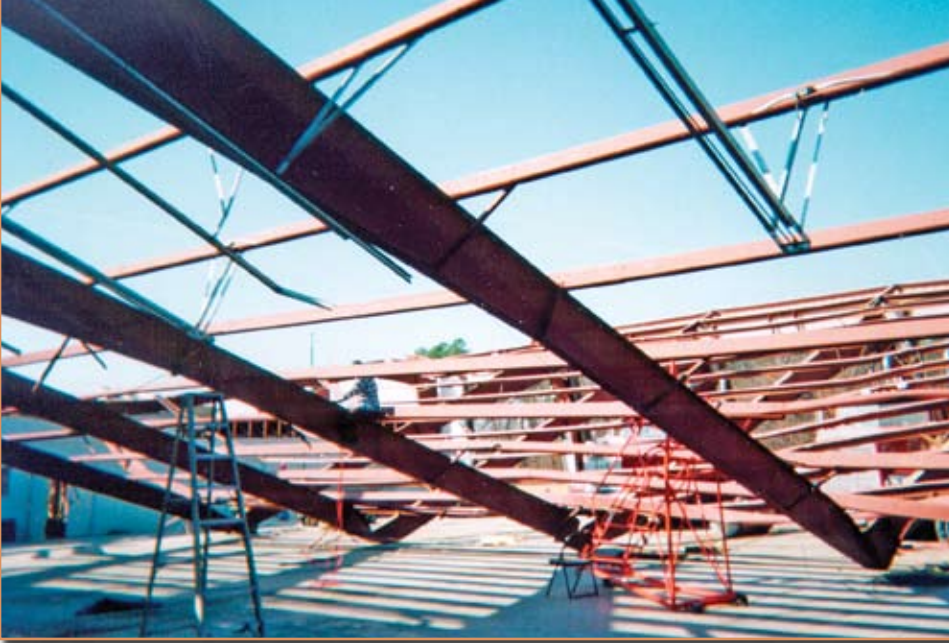
Truck garage during demolition

This small PEMB truck garage failed catastrophically due to incorrect assumptions regarding the stiffness of the column lateral brace. This resulted in \$3.5 million of damage.
