Combating Landslides in Southern California

By Gregory Axten, P.E.

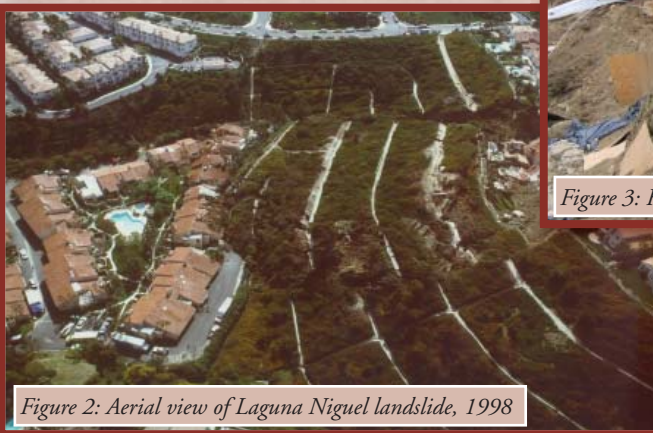
Figure 2: Aerial view of Laguna Niguel landslide, 1998

Figures 1, 2, and 3 depict just a few significant landslides.

landscaping. Sometimes the use of boundary structural restraint systems allows for the complete removal and re-compaction of landslide debris. In large-scale landslides, as might be expected, combinations of techniques are utilized. In 1998, in Laguna Niguel, a massive landslide occurred which ultimately resulted in a loss of nine moderate to upscale single-family detached homes and 52 townhome-style condominium residences below. The approximately 16 million dollar repair effort included 64, heavily-reinforced, large-diameter caissons extending to depths of an excess of 100 feet. This system, which included a buried conventional retaining wall at the top of the grade beam, initially included a single row of high capacity tiebacks to serve as an emergency repair in order to save a road alignment and to protect property further upslope.

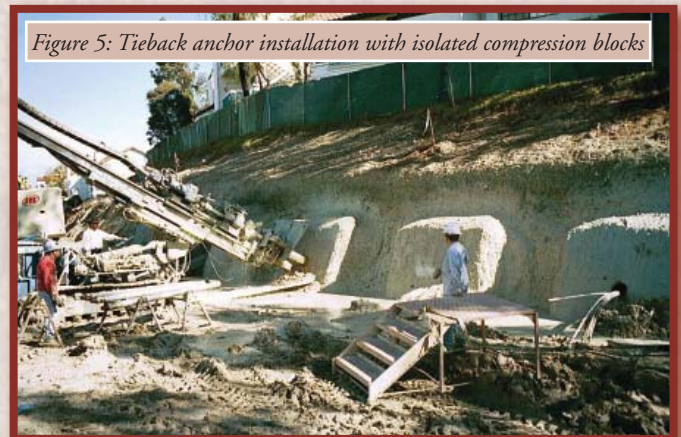
Figure 5: Tieback anchor installation with isolated compression blocks

Tieback systems are commonly installed in a subhorizontal fashion, usually at about 20 degrees from horizontal. *Figure 5* depicts a typical tieback drilling operation. Since the installation is subhorizontal, it should be intuitively obvious that such systems are considerably more efficient lateral-resisting elements than classic, cantilevered caisson or soldier pile walls. A tieback anchor is a pressure grouted bar or bundle of high-strength cables (note bundle of cables at right side of *Figure 5*) bonded within the firm underlying materials by high-strength concrete grouting. The free end of the tieback system is typically post-tensioned against an exposed or a concealed compression wall. In some cases, caissons and grade beams or soldier piles are utilized in conjunction with the tieback system. In essence, the tieback system provides the head restraint to limit the otherwise intolerable movement. Keys to properly designing tieback systems include identifying appropriate bond strengths within the firm underlying stable material and identifying the appropriate bearing capacities in the comparatively soft near surface, over-burden materials. Identifying the appropriate bond strengths is commonly supported by testing, as well as the experience and judgment of the geotechnical engineer. Appropriate bond strengths can vary widely among the tremendously variable soil and bedrock conditions which exist throughout Southern California. Unconfined compressive strengths can vary from a relatively few psi in soft soil materials to on the order of 20,000 psi in hard crystalline bedrock.

Compression blocks to which the anchors are tensioned are sometimes designed as isolated anchor blocks (Figure 5). In Southern California applications, where sedimentary formations and soft clayey overburden soil is common, continuous structural compression walls are common. With available bearing pressures on the order of 5,000 pounds per square foot, strip-style compression walls of 8 to 10 feet in height and 18 inches to 2 feet thick frequently occur. Shotcrete techniques are commonly employed in the construction of the compression walls. The structural engineer should take special care in the designing and detailing reinforcing for the shotcrete style of construction.

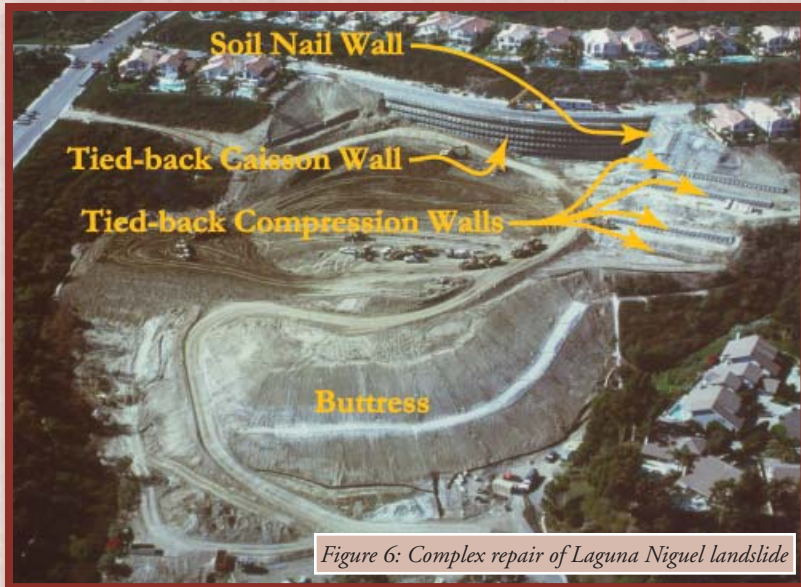
Figure 6: Complex repair of Laguna Niguel landslide

As the next phase of repair proceeded, four additional rows of high-capacity tiebacks were anchored to supplemental compression walls, constructed as excavating landslide debris proceeded to depths of over 70 feet below the salvaged roadbed. In the immediate flanks of the caisson wall and tieback area, soil nails and light structural sheets were added. Other areas of the hillside employed high-capacity tiebacks and compression walls

without caissons. With the head area stabilized, large-scale grading clean-outs of landslide debris proceeded with installation of multiple subdrainage systems below the compacted fill and the construction of a large-scale gravity buttress. An overview of the in-progress Laguna Niguel landslide repair is presented in Figure 6. To accomplish the successful completion of the stabilization, careful coordination was necessary among the offices of the geotechnical consultant, structural engineer, and contractor. In conjunction with the construction and the post-construction monitoring, high sensitivity, electronic tiltmeter-style instrumentation was utilized as well as conventional inclinometer installations. Assessing the instrument data in succeeding years has confirmed the successful stabilization.
