Repair or Replace?

That is the Question

By Scott R. Witthoft, P.E. and Randall W. Poston, Ph.D., P.E., FASCE, F.ACI

To illustrate some of the major issues confronting engineers in a concrete repair project, a case study of a 25 year-old concrete foundation showing signs of deterioration is presented. The decision to repair, as opposed to replace, is discussed in the context of the required extension of service life.

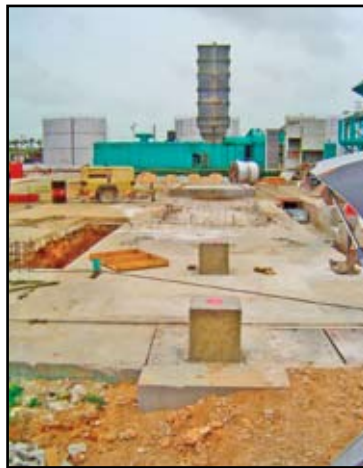
During site preparation for new power-generation equipment, staining believed to be associated with petroleum by-products was observed on the concrete surface. Exploratory demolition revealed stain penetration to approximately 20 inches (51 cm) from the top surface. During this exploratory chipping, as well as additional chipping for installation of the equipment, facility personnel reported "weak" and "crumbling" concrete. Several sections of reinforcing steel revealed at the top portion of the foundation exhibited corrosion damage, including extensive section loss. These instances raised concerns of sustained structural performance.

Figure 1: Foundation Site. Note staining and chipped areas to the right of the generator

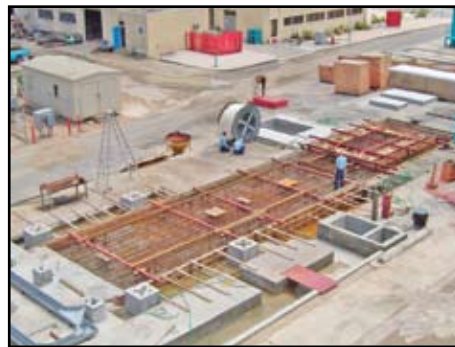
Design repairs included removing the top surface of the foundation beneath critical machinery. In total, this included approximately 60 feet (18 m) of the 90 foot (27 m) structure. Concrete was removed to 3 inches (7.6 cm) beneath the depth of the existing reinforcing steel, with a minimum depth of 12 inches (30.5 cm). Based on the assumption that the design of the original foundation was adequate for in-service structural performance, the repair design included replacement of an equivalent area of steel for the removed reinforcing steel at the top of the foundation. Three-inches (7.6 cm) of concrete cover was specified due to the marine environment and previously observed distress. Figure 3 shows the final configuration of the replaced reinforcing steel.

Figure 3: Replacement reinforcing bars in place

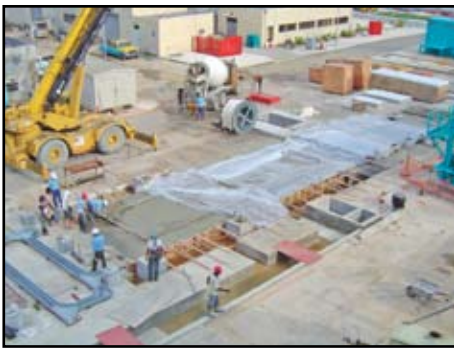
Quality control of the repair operations consisted of testing of the repair surface after removal of the old concrete, inspection of the site before placing the new concrete, observation during repair operations, and strength testing of the new concrete. The repair surface was evaluated using pull-bond testing (ASTM C1583-04). The average pull-bond strength from test locations throughout the repair area was 173 psi (1.19 MPa), greater than the 150 psi (1.03 MPa) value specified by design. This step helped to ensure good bond and minimize the effects of “bruising” from chipping operations. New concrete was delivered to the site by truck and was placed by crane (Figure 5). The concrete was installed successfully, with operations concluding immediately before an afternoon rainstorm. Subsequent testing of the sample cylinders indicated an average 28-day compressive strength of 6,400 psi (44 MPa), well in excess of the 4,000 psi (28 MPa) design specification.

Figure 5: Final stages of repair construction
