Restoration of Egyptian Monuments

By David T. Biggs, P.E., Hon. M. ASCE

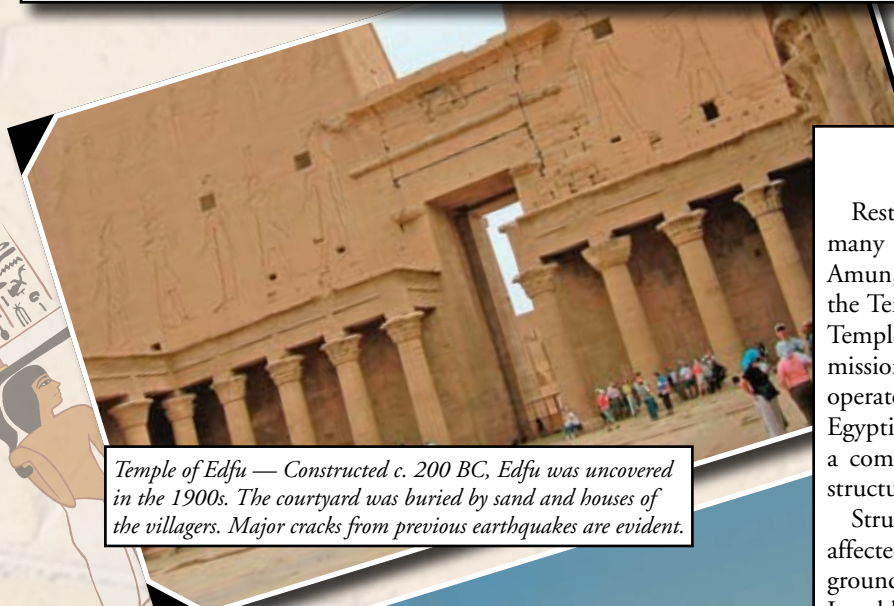
Temple of Edfu — Constructed c. 200 BC, Edfu was uncovered in the 1900s. The courtyard was buried by sand and houses of the villagers. Major cracks from previous earthquakes are evident.

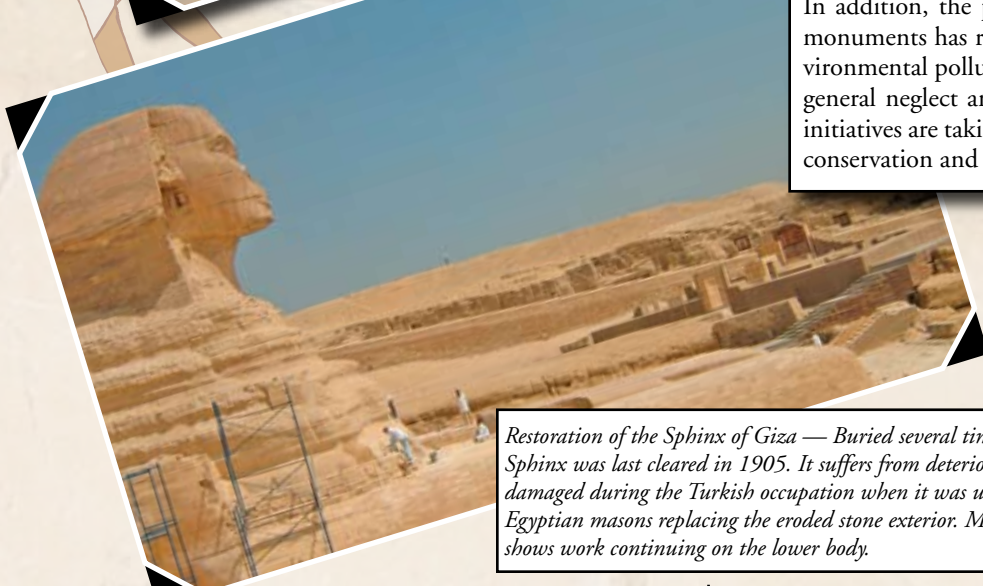
Restoration of the Sphinx of Giza — Buried several times since its construction (c. 2550 B.C.), the Sphinx was last cleared in 1905. It suffers from deterioration due to erosion. In addition, the nose was damaged during the Turkish occupation when it was used for target practice. Current restoration has Egyptian masons replacing the eroded stone exterior. Most of the paws have been completed. The figure shows work continuing on the lower body.

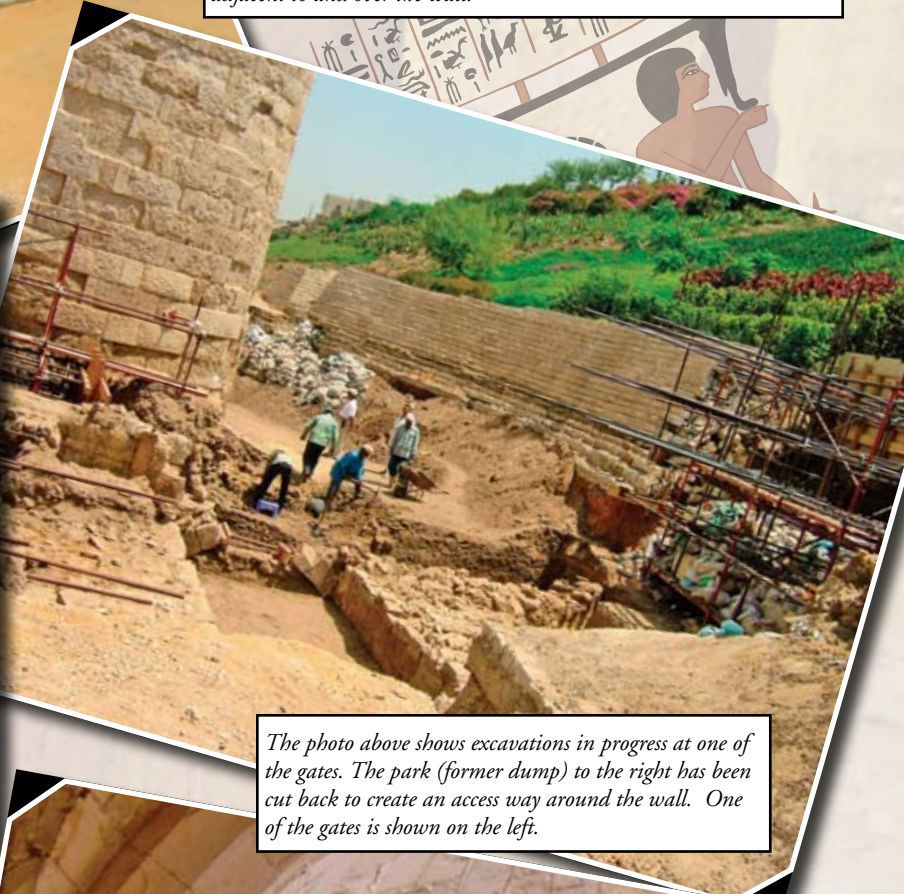
The photo above shows excavations in progress at one of the gates. The park (former dump) to the right has been cut back to create an access way around the wall. One of the gates is shown on the left.

Historic Cairo was fortified in 1176. Over the centuries, the city expanded and the fortified walls became obsolete. The wall shown to the left represents approximately 1500 meters of the eastern side of Cairo. City expansion did not occur because a massive dump was created that ultimately buried the outside of the wall. The green in the right of the figure is where the dump was converted to a park, the wall was uncovered and is now undergoing restoration. Exterior stone damage occurred due to the chemicals and salts in the soil that covered the walls as well as water damage from the buildings that were built adjacent to and over the wall.

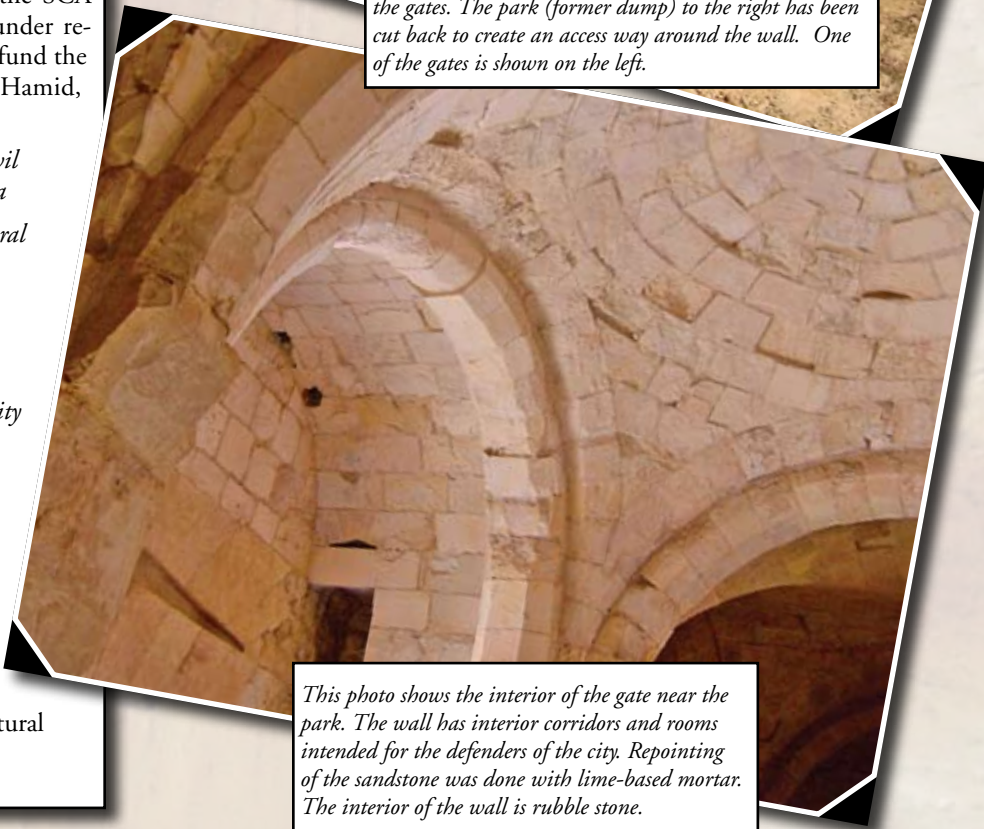
This photo shows the interior of the gate near the park. The wall has interior corridors and rooms intended for the defenders of the city. Repointing of the sandstone was done with lime-based mortar. The interior of the wall is rubble stone.

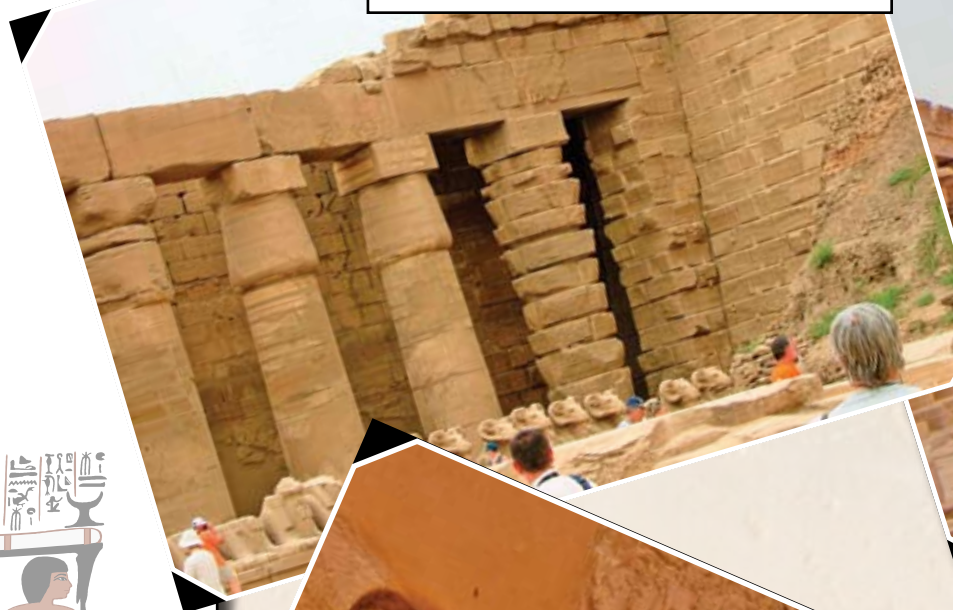
The Temple Complex of Karnak in Thebes (below) — There are three temples on 247 acres in modern Luxor; the largest temple complex in Egypt. Built over 1700 years, the site is now a French mission for restoration. 1700 years ago the two unfinished columns on the right of the figure (c.1300 BC) are part of the Great Hypostyle Hall; the builders erected sandstone slabs of stone and then ground them smooth as seen to the left.

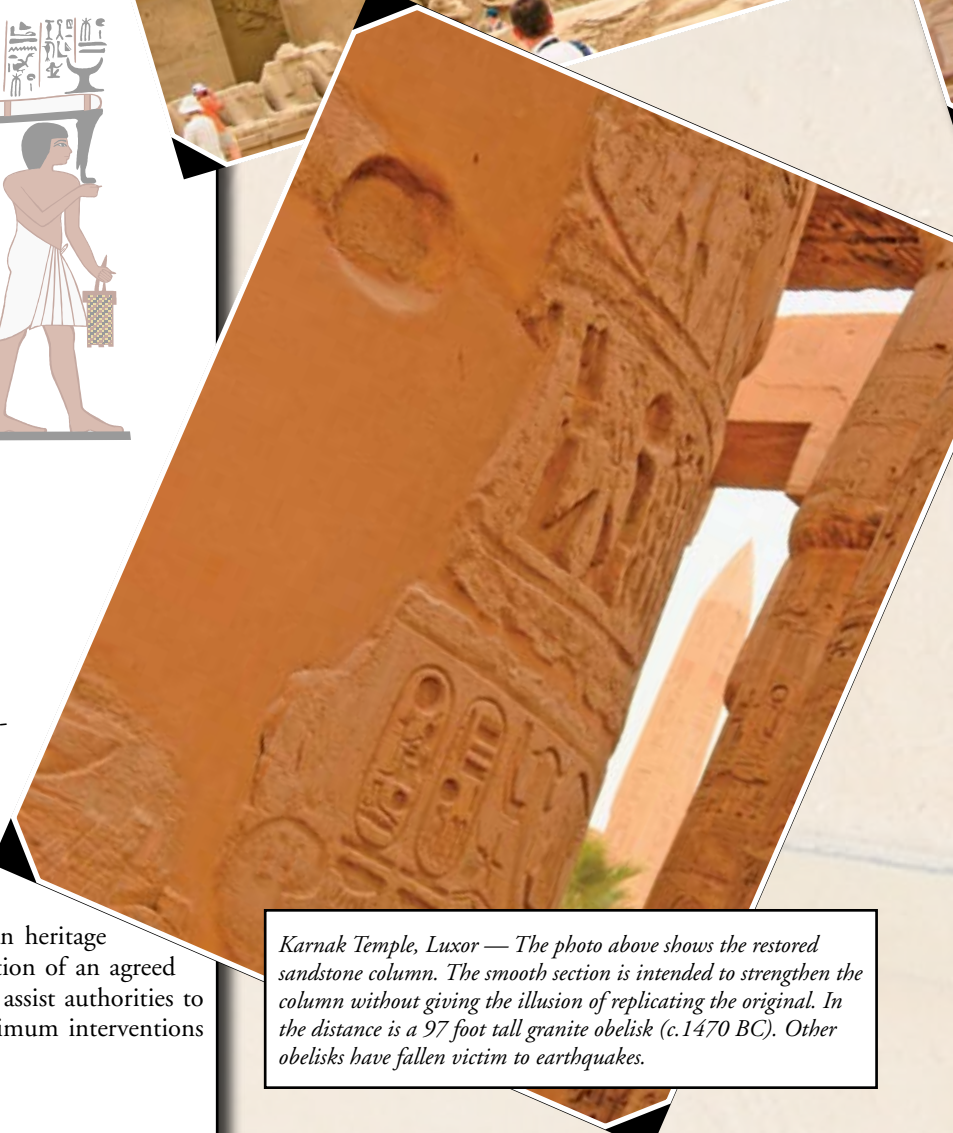
Karnak Temple, Luxor — The photo above shows the restored sandstone column. The smooth section is intended to strengthen the column without giving the illusion of replicating the original. In the distance is a 97 foot tall granite obelisk (c.1470 BC). Other obelisks have fallen victim to earthquakes.
