In the Eye of Ivan

By Kurt Gustafson, S.E., P.E.

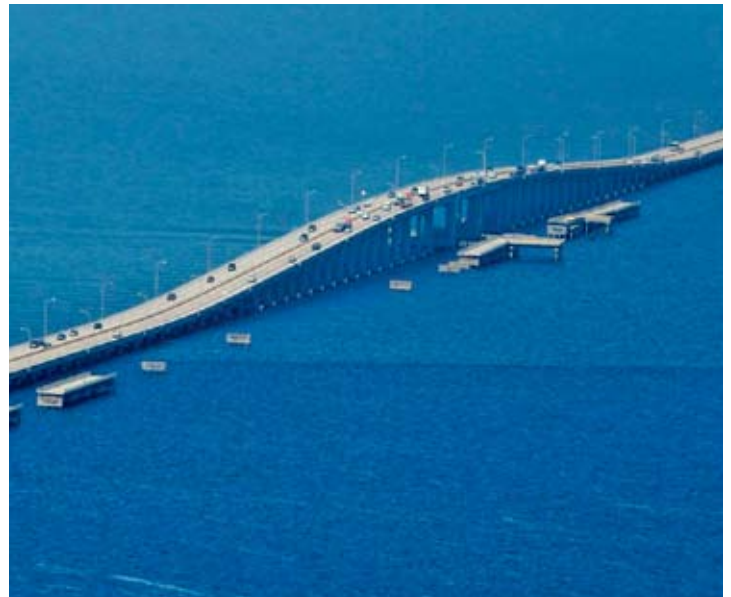
Section of Bridge Destroyed by 'Ivan'.

Many surrounding structures, including the major bridges leading to the barrier island, had not fared as well. The Interstate 10 Bridge across Escambia Bay was shut down as it incurred heavy damage; a stretch of ¼ mile of the bridge was entirely destroyed. Numerous boats were sunk or stacked at the Bayou Grand Marina at NAS Pensacola. In the immediate area surrounding the Mullet Residence, all of the timber houses sustained various structural failures.

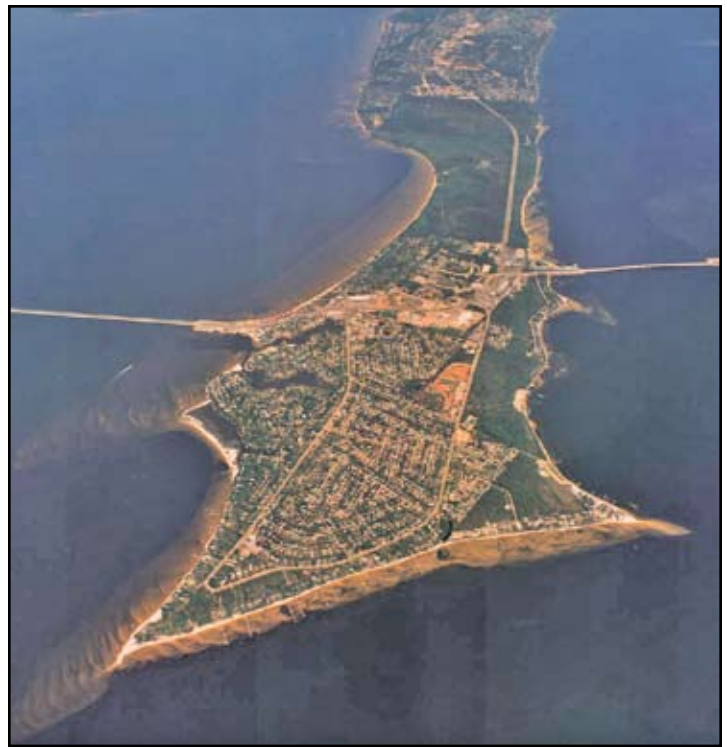
Barrier Island in Florida Panhandle / Sea Breeze

The Mullet Residence, situated on the Florida Gulf Coast, was just nearing completion when Hurricane Ivan was bearing down toward the prominent point of the barrier island where it stood. This had been a rather unique project for the design team, since they had exceptional support from the Owner. This gave the team opportunity to investigate alternatives of construction types not typical to residential structures along the Florida coast.

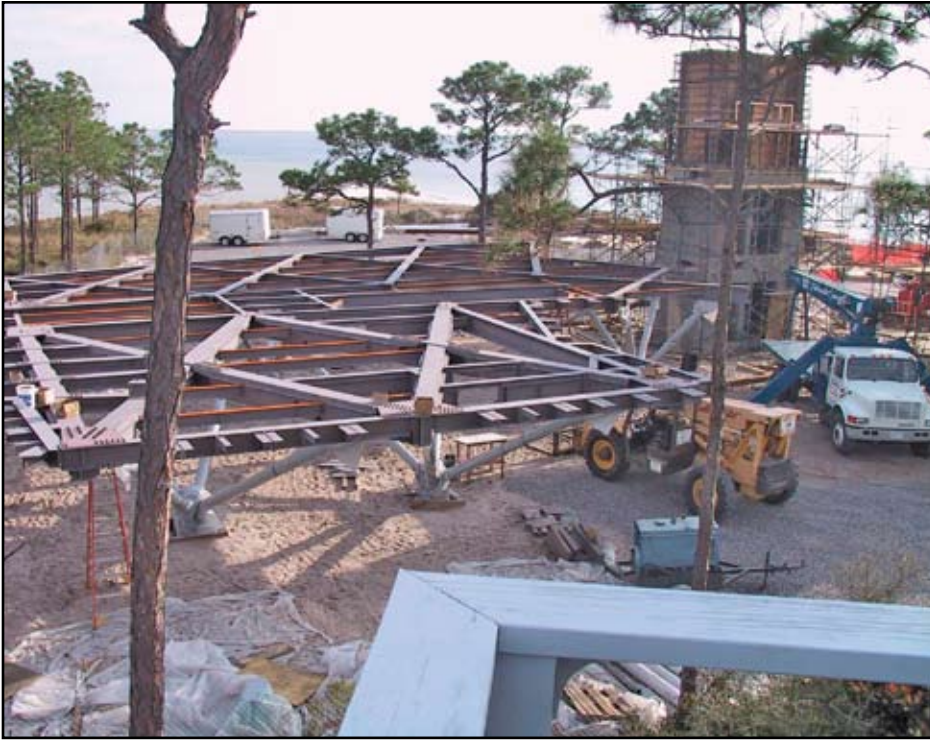
Structural Steel 1st Floor Diaphragm Supported on Sprouts.

produced a building that visually appeared to float above the ground. The sprouts are constructed of 8-inch diameter stainless steel tubes and support W18 girders at the first floor level. A total of 11 sprouts consisting of (42) 8-inch diameter columns were used to support the main house superstructure. The sprouts are supported by hubs composed of 1 1/2- to 2-inch thick stainless steel plates.

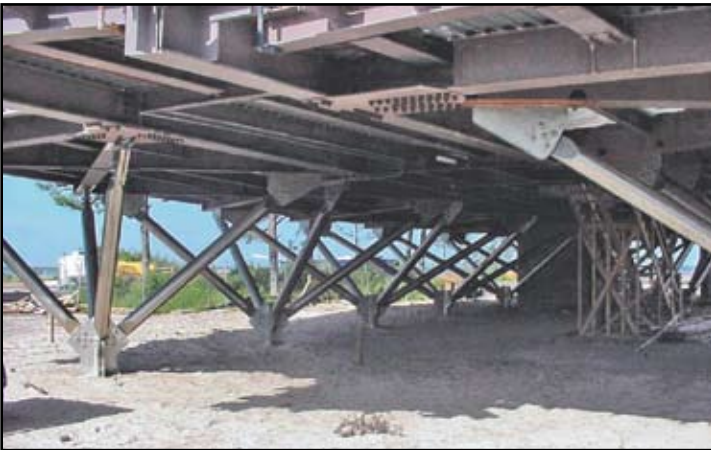
Steel Sprouts Supporting Mullet Residence.

Usual coastal construction utilizes driven wooden piles cantilevering above the ground elevation to support the main living levels. Conceptually, the Mullet Residence differs in that the architect desired to slope the columns and to connect four columns to a single foundation connection point. The creation of the "sprout" element

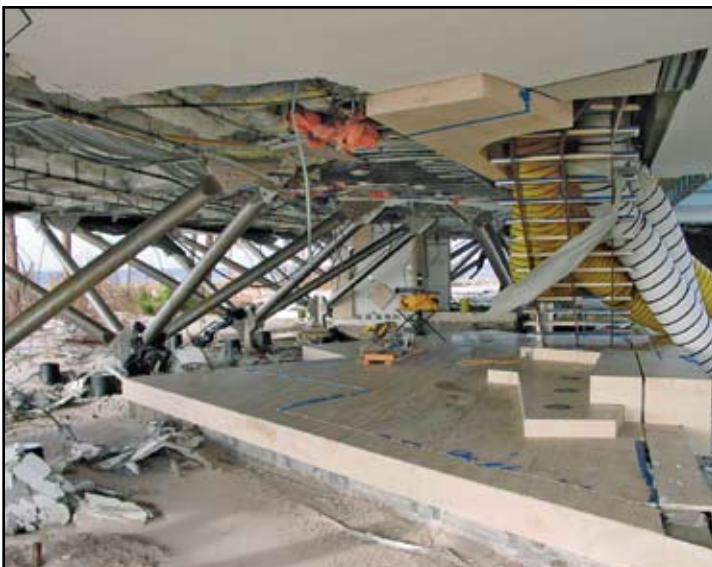
Non-Structural Damage caused by Ivan to 1st Floor Soffit.

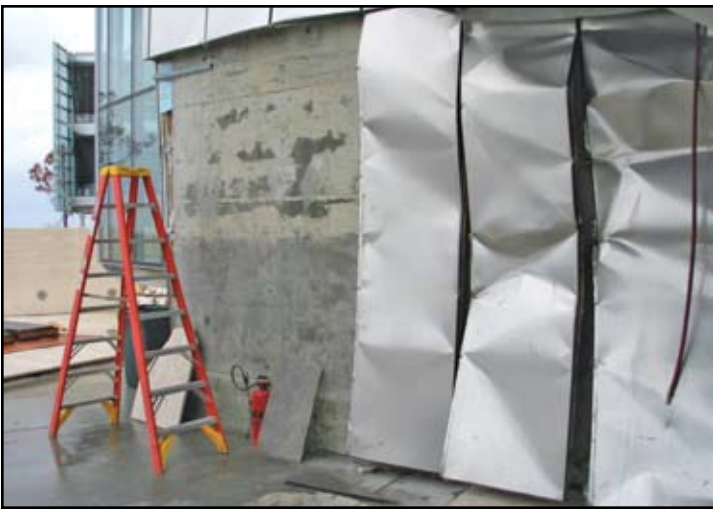
Non-Structural Cladding Damage on Core Walls.

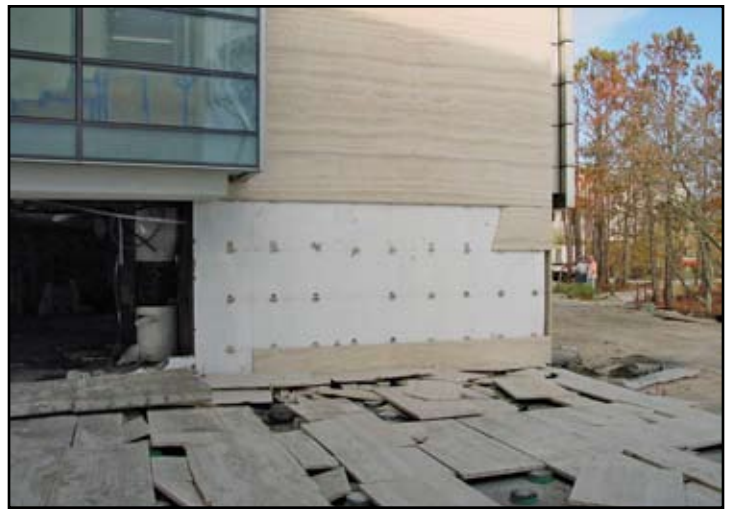
Break-Away Wall Collapse (as anticipated).

2:00 am on September 16th, 2004, Ivan made land-fall directly over the house. At that time, Ivan's strength had dissipated to a category 3 hurricane, with maximum sustained wind speeds of 130 mph. Under the forces exerted by Hurricane Ivan, the project did not suffer any structural damage. The 'breakaway' walls that had been provided in the interstitial space between the grade and raised living level had given way as expected, minimizing the effect of the rushing water flow on the structure.
