Unique Renovation at Kreis Dam

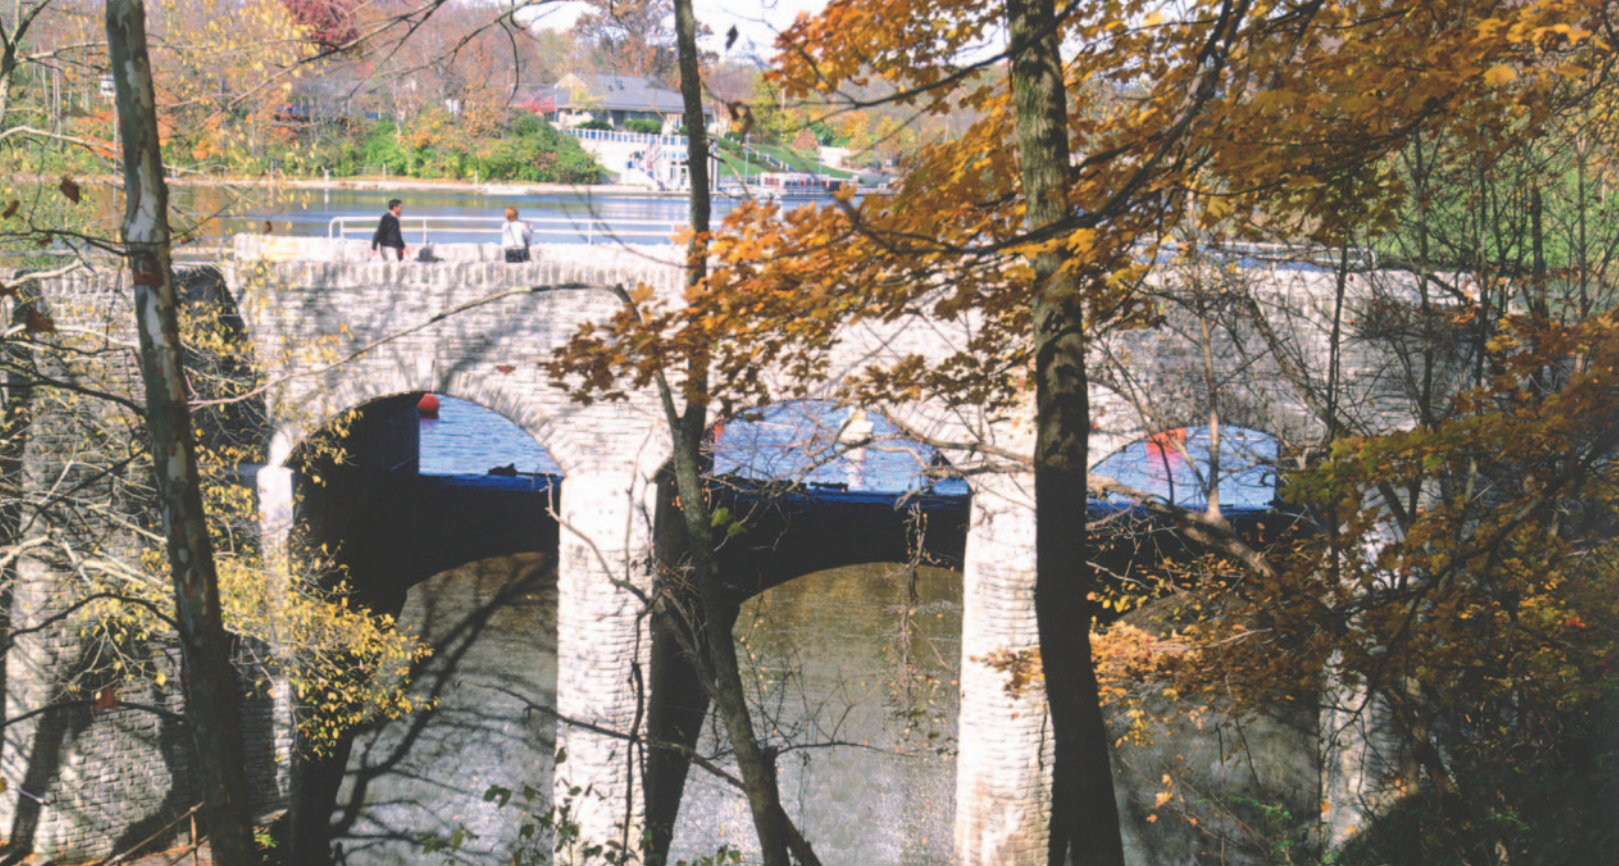
The structure of the bridge over the dam is composed of three galvanized corrugated metal arches that span approximately 16 feet each between stone-faced concrete piers and abutments. The upstream and downstream walls are constructed of stone. The dam, with a steeply sloped spillway below the bridge arches, creates a lake to the north. Concrete piers that extend up through the spillway support the arches which were covered with earth backfill and a paved roadway.

were removed, along with all deteriorated concrete, dowel bars were epoxy grouted into sound concrete and additional reinforcing was placed in the piers before replacing the concrete. If rusting of the remaining metal arches ever becomes unsightly, the scaffolding system can be re-installed to remove the now non-structural metal arches.

A number of repair methods were considered. Steven Schaefer Associates' solution was to remove the pavement and back-filled earth from above the corrugated metal arches, and replace the earth with reinforced concrete, converting the arches to a reinforced concrete structure. By doing this now before the base of the arches rusted any further, the arches could serve as forms for the new concrete arches. The stone walls and railings on the sides of the bridge would remain in place and contain the concrete over the arches. Once the structure was changed to reinforced concrete, it would be self-supporting and the metal arches would no longer be necessary. The rusted base of the metal arches could then be cut out, without worrying about supporting the weight of the bridge above. After the rusted bottom portion of the metal arches

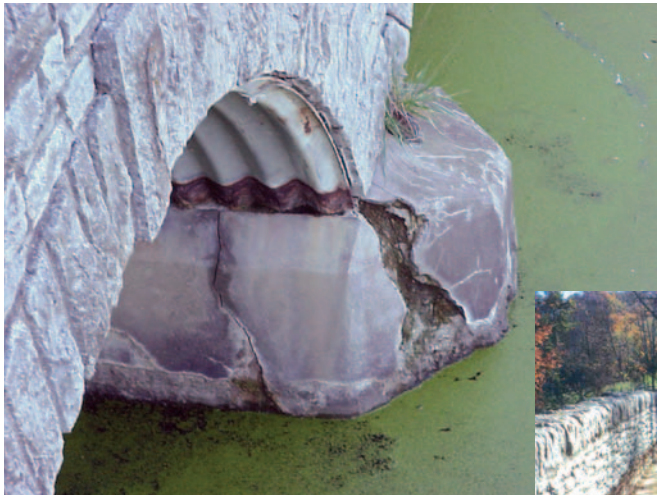
caused the cracks to enlarge. Left unattended, the problem compounded over time. Repairing the concrete piers alone would not solve the problem. With continued rusting of the base of the arches, and re-occurring cracking of the pier, the arches' ability to support the backfill and roadway would be in jeopardy.

The bridge was constructed with the bases of the three corrugated arches set into steel channels that were embedded into the tops of the concrete piers. Over the years, the lower portion of the arches, and the base that was embedded in the concrete piers, had rusted. The resulting expansion of the embedded portions caused the concrete at the top of the piers to crack. Water freezing in the cracks

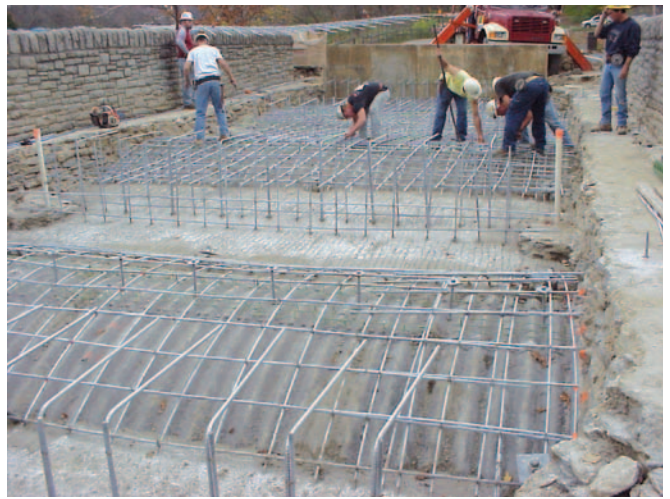
To evaluate the present stability, we needed to know the remaining thickness of the rusted steel arches. We tried ultrasonic testing; however, the results were extremely erratic. The solution was to remove samples for measuring by core drilling. We found that the rust was isolated to the base of the arches. However, even in the worst areas, 75 percent of the thickness remained.

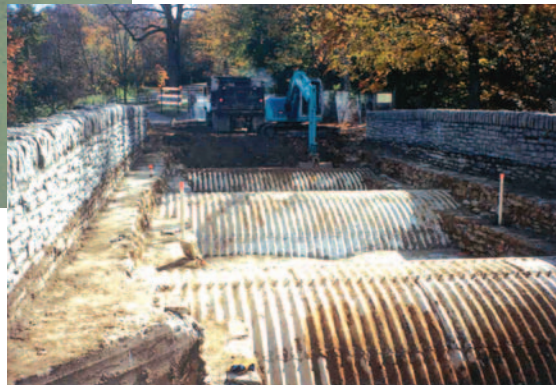
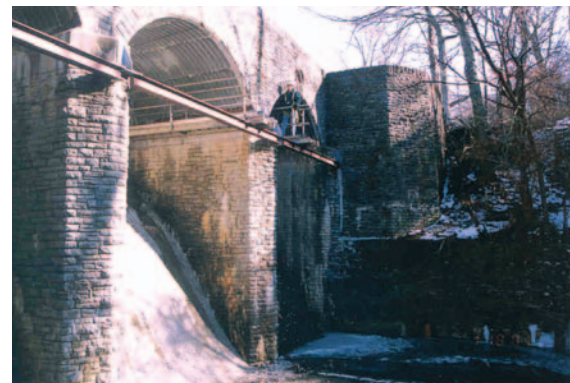
We knew that one of our first challenges would be accessing the bridge to evaluate it. The underside of the metal arches were directly over the steeply sloped spillway, and not accessible. Our proposal included designing a temporary scaffolding system supported from the concrete at the top of the spillway and steel beams bolted to the downstream side of the piers. This scaffolding was also designed to be used as a work platform during the restoration. We believed this would result in significantly lower bids, as the bidders would not need to make a conservative allowance for constructing the work platform.

The repairs by Steven Schaefer Associates, including the tuck pointing and repairs to the stone retaining walls, came in under the original estimated cost and far below the cost of replacing the structure. The scaffold system used to do the repairs can be reinstalled when future maintenance is required. The restoration added an estimated 75 years to the life of the bridge, while maintaining its historic look. The repairs were completed in less than five months while the golf course was closed for the winter.■
