# Portland Cement Cast Stone Veneers

## An Overview of Practical Detailing Issues

By Dave MacGregor, P.E. and Edward Schwieter, P.E.

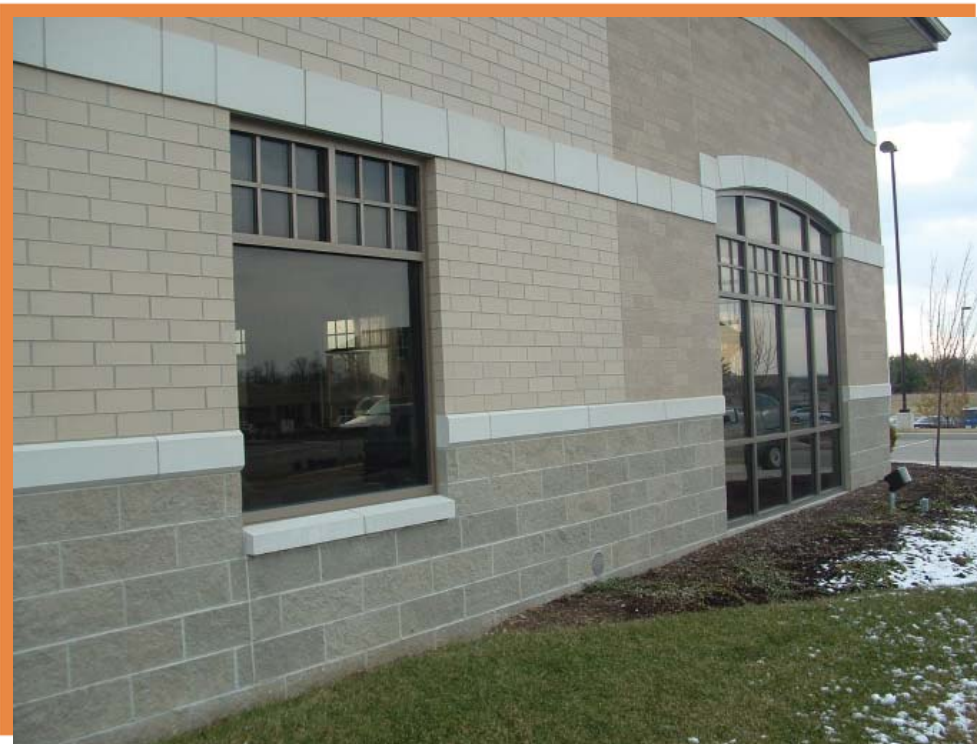
*This building has a wainscot of six courses of 8 x 24-inch cast stone, 8-inch high accent bands at the top of the wainscot and near the top of the wall, and a 12-inch high accent band above the windows. A control joint was installed below the window after cracks appeared at a number of windows. It should be noted that nearly all of the head joints in the accent band over the window have hairline cracks, but they were not noticed by the Owner.*

It is important to space vertical control joints in cast stone wainscots at distances no greater than 1.5 times the wainscot height (not the combined wainscot and brick veneer height), at window corners projecting into the wainscot, and at changes in the wainscot height. We have found that cracks in wainscots are noticeable because they tend to be fairly wide due to stress accumulation and because they are at the base of the building where they are easily seen. It is not necessary to extend closely spaced wainscot control joints into brick veneer, but all brick veneer control joints should be extended into the cast stone.

Accent bands within brick veneer are prone to cracking because they have expansive brick both above and below, creating significant tension forces in the cast stone. Fairly narrow cracks tend to occur in nearly all mortar head joints due to the uniform application of tension from brick expansion and the relatively low tension capacity of the head joint. We have noticed that when the accent band consists of more than one course, a crack in a head joint will frequently continue through the body of the unit above or below. We generally recommend a single course accent band or stack bond if more than one course is desired. It is interesting to note that where the cast stone band is a story or more above the adjacent ground, clients typically have not noticed head joint cracking and have only occasionally complained about through-unit cracking. Cast stone accent bands at parapets and head, sill and jamb accents at isolated openings have similar issues. Shrinkage and thermal cracks tend to form in head joints because of low mortar tension capacity. Since the shear capacity of the bed joint is greater than the tension capacity of the cast stone unit, the crack will tend to extend through the cast stone unit above and below unless the horizontal distance between the head joints is small relative to the height of the cast stone course. We typically recommend raking and caulking accent band bed joints to encourage cracks in the mortar joints rather than through the cast stone units.
