By Steven E. Schaefer, P.E.

Restoring the Sharon Woods Stone Arch Bridge

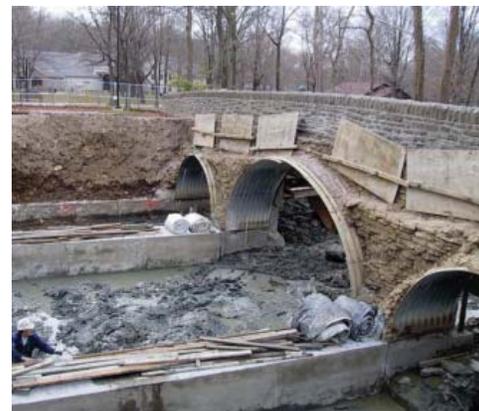
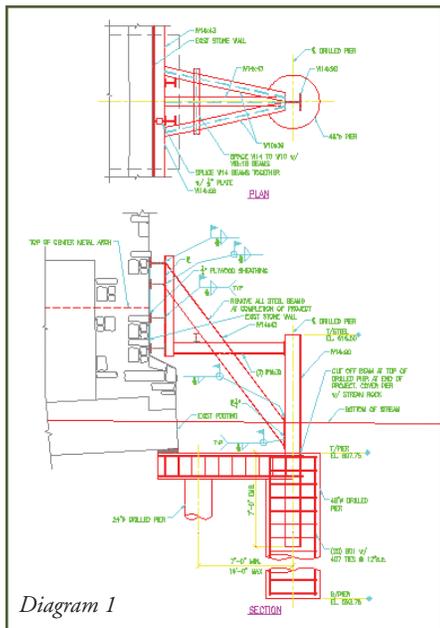
The final plans called for demolishing all of the existing bridge except the downstream spandrel wall and the two abutments. A series of steel buttresses anchored to drilled concrete piers acted as temporary bracing for the down-

stream wall during construction. In addition, SSA required that all arch stones salvaged from the upstream wall be marked and stored to allow for reconstruction of the arches in the same configuration and location as the original. The remaining face stones were stored for reuse to keep the original patina on the exterior face of the bridge.
