construction issues

Grouting of Post-Tensioning Tendons Overview of Recent Developments

Thomas A. DeHaven, P.E.

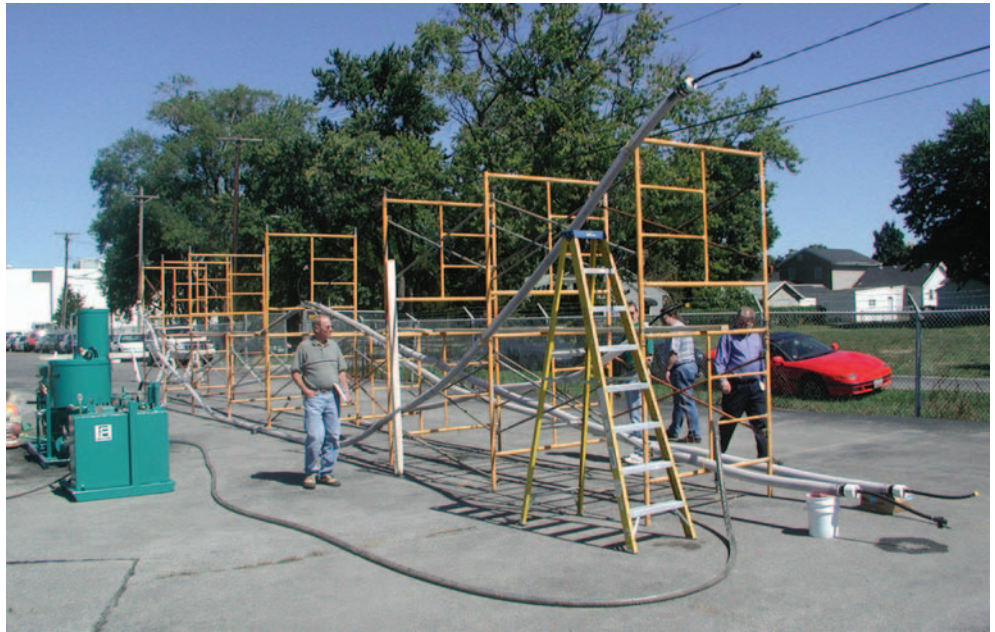
Setup for the Full Scale Grouting Mock-Up for the Maumee River Bridge.

- Full Scale Mock-Up of grouting operations prior to start of grouting so that the Contractor can demonstrate that his Grouting Plan, grouting materials, grouting equipment and certified personnel can properly grout a tendon.
