The Deception of WYSIWYG in Façade Inspections

What Structural Engineers Need to Know About Masonry Façade Inspections

By Pamela Jergenson, CCS, CCCA

Case Study

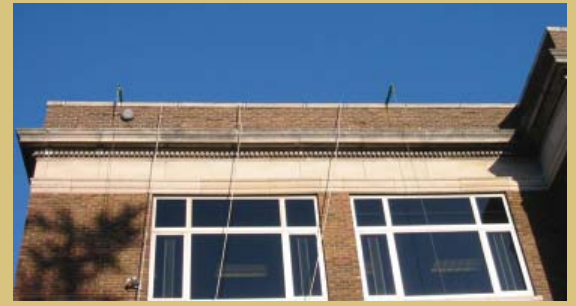
From grade the parapet of this masonry building appeared to be satisfactory (Figure 1). However, upon close visual inspection mortar was found to be missing in spot locations (Figure 2). Based on this early information, the quick remedy of tuck pointing seemed fitting and any life safety issues readily dismissed.

Figure 1: View from grade of the three-story building parapet

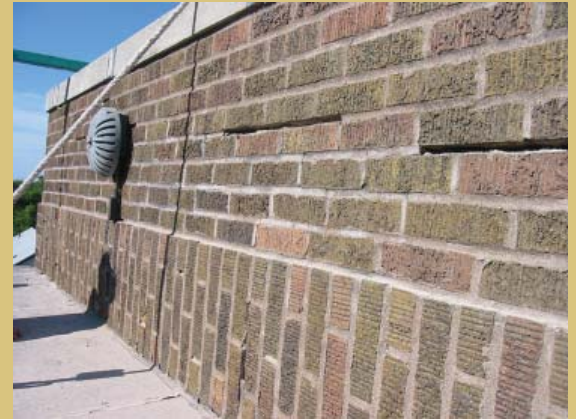
Figure 2: Close visual inspection of the same parapet shown in Figure No. 1

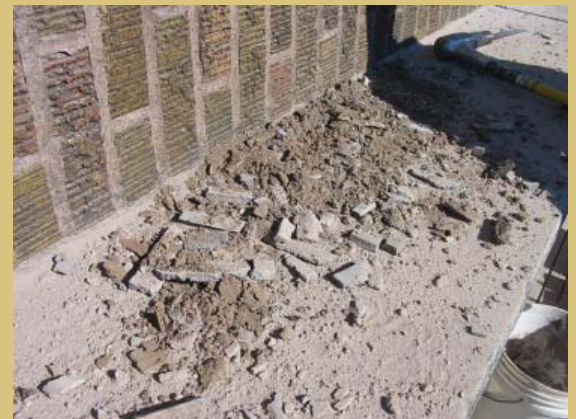
Later in the masonry façade investigation, an exploratory opening at the parapet revealed the inner masonry

Figure 3: Damp inner wythe mortar material from test opening at same location

wythe was damp (Figure 3). If heavy wind-driven rains had occurred the night before, damp masonry could be expected. A continually damp inner masonry wythe is an excellent host for corrosion of any metal, specifically masonry veneer ties.

However, the recent weather patterns were consistent drought conditions, so the wythe should have been dry. As the masonry façade investigation continued, the evidence of serious façade issues was mounting. Corroded, perforated, and failed metal strap ties were found at several parapet exploratory openings (Figure 4). The parapet was now suspect for life safety concerns.

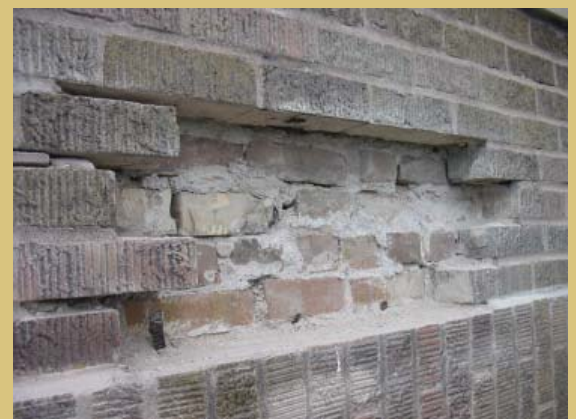
Figure 4: Corroded, perforated and failed metal strap ties in test opening

By combining the background information and the results of the close-up visual inspection and exploratory openings, the parapet of the masonry building was determined to be a life safety concern. A three-tiered set of recommendations was presented to the building owner.

- The first-tier recommendation addressed the life safety issues immediately by rebuilding the highest deteriorated parapet near building entrances.

- The second-tier recommendation addressed the potential property damage issues above lower roof areas.
- The third-tier recommendation addressed the lesser-deteriorated parapet areas.
