# Shoring Up the Past

## NEW YORK CITY Style

By Alan M. Rosa, P.E. and Stephen Lehigh

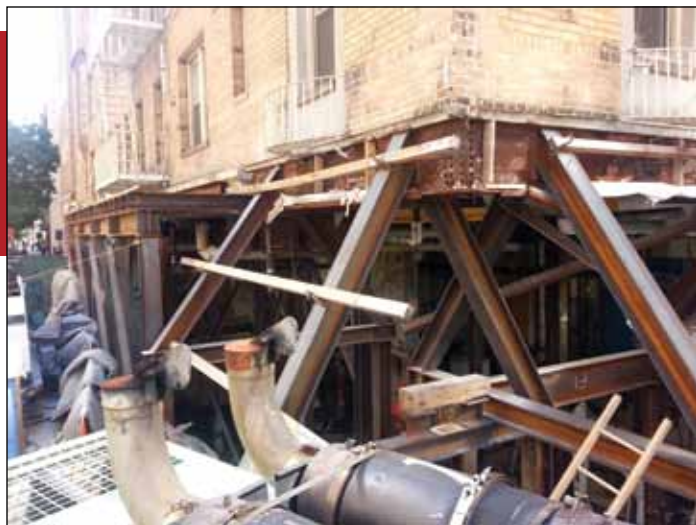
Figure 1. Elevation of temporary shoring system at north storefront and bearing wall.

Of the variety of temporary shoring designs required on this project, including one for removal of a six story steel interior column, the two main systems discussed in this article will be one for the support of the existing perimeter beams over the storefront and another for the support of the existing brick bearing walls.

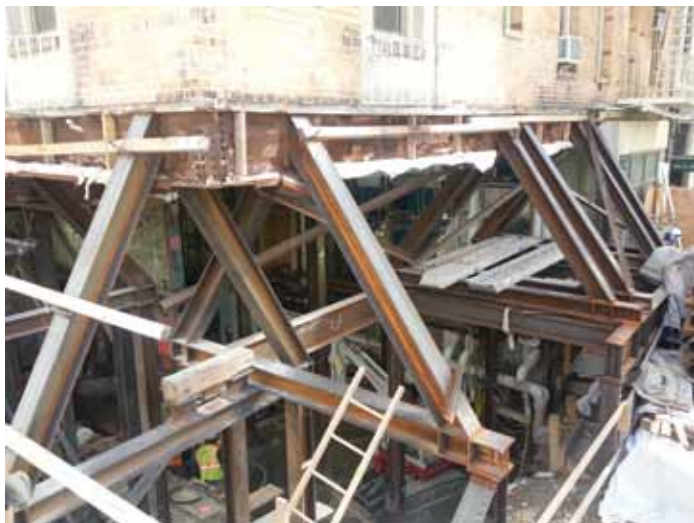
Figure 2. Typical A-Frame shoring at storefronts.

the masonry above and span the storefronts. Thus, any temporary shoring system must leave clearance for the installation of new perimeter beams and columns installed directly below the existing second floor perimeter steel framing. In addition, a system was required to allow the installation of a new concrete foundation wall to replace the existing rubble foundation wall. An A-Frame system consisting of compression struts and tension ties was developed (Figure 2). The exterior ends of the frames were supported on the post-tensioned concrete piers, and the interior ends of the frame were supported on a steel frame system which in turn was supported on 3-foot by 4-foot concrete piers to a depth of approximately thirty feet below

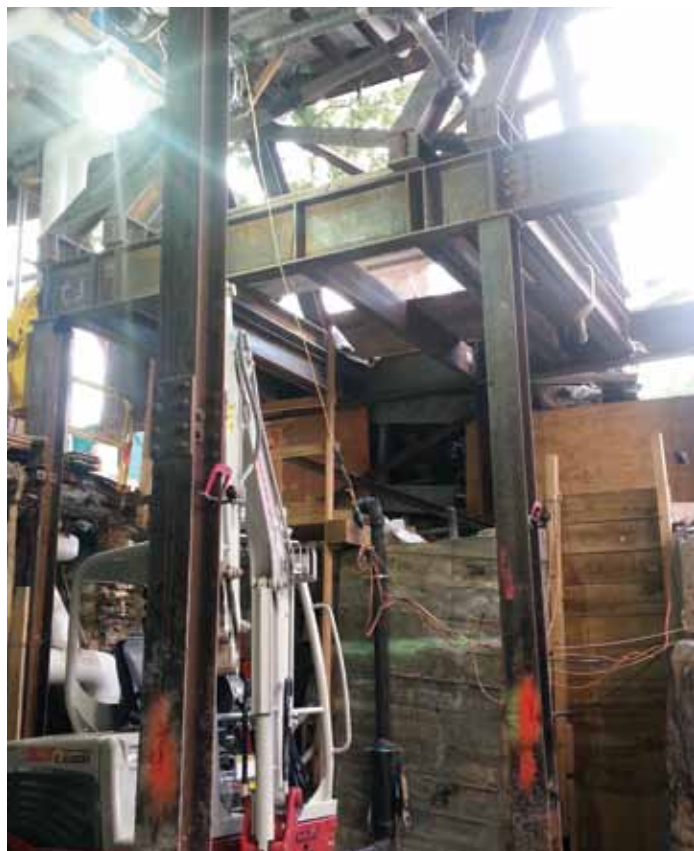
Figure 3. Elevation of northwest corner with post-tensioned pier supporting the A-Frames.

the street level (*Figure 3*). The tops of the A-Frames were attached directly to the existing steel beams by welding the compression struts to the existing girder (*Figure 4, page 28*). The frames straddled the existing beam ends above the existing columns that were being removed so as to not change the existing support conditions of the beams; that is, one A-Frame at each beam end. The A-Frames were preloaded using hydraulic jacks at each side on the frame. The jacks were supported by channels connected to the main temporary girders just below the tension members of the frames. At other locations, it was possible to jack only from one side of the A-Frame. In these cases, the lateral movement of the frames at the apex due to the one-sided jacking was determined to be negligible. Jacking loads were limited to ninety percent of the calculated dead load plus a small allowance for live load throughout the building. Since each frame was jacked independently, the expectation was that little to no vertical movement would occur due to the restraint provided by the existing brick walls. Thus, it was important that the jacking loads be determined as precisely as possible, and that the A-Frames and supporting system would have a significant amount of extra strength available to confidently remove the existing steel columns supporting the perimeter storefront steel. Monitoring systems were installed to register any movements. As a result, all original building columns were removed successfully without any appreciable movement measured or cracking observed.

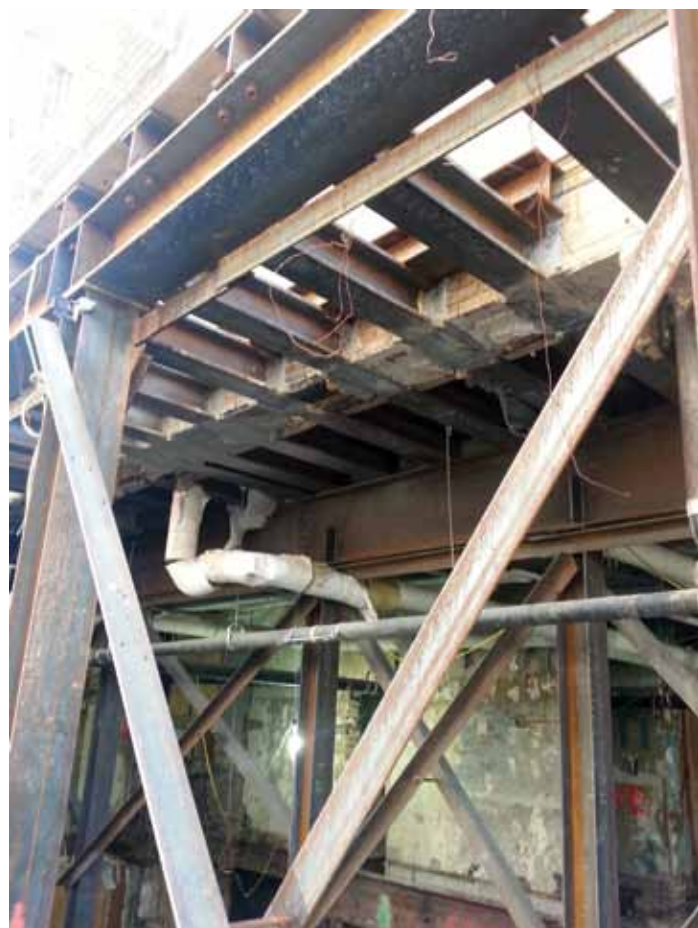
Figure 6. Needle beam support at existing masonry bearing wall with window distribution beam.

Along East 63<sup>rd</sup> Street, a thirty-eight foot long section of an existing 16-inch thick brick masonry bearing wall was required to be removed to the same elevation as the adjacent storefront (*Figure 5, page 28*). Needle beams spaced at two feet on centers, on average, were utilized. As in the case of the A-Frames, the interior ends of the beams were supported on the steel frames, which in turn were supported on the 3-foot by 4-foot concrete piers. The exterior frames were supported on the post-tensioned concrete piers (*Figure 4*). At the second floor, there were four existing steel beams supported by the existing bearing wall that needed to be shored prior to wall removal. Hung beams adjacent to the wall being removed provided the support of the existing beams and were attached to the bottom flanges of the needle beams. Distribution beams adjacent and parallel to the exterior wall were required at the larger window openings, and at the existing fire escapes, to evenly distribute the wall load to all needle beams (*Figure 6, page 28*). In order to uniformly load the existing wall, jacking methods were

not practical given the various frame deflections required to preload the system. It was therefore determined that the best approach was to wedge-shim each needle beam at each end to the required vertical displacement and then to pack it with flat shims to provide uniform bearing support. The required displacement was determined from an estimate of the uniform wall load and the tributary width of an individual needle beam. In order to account for deformations in the piers and the steel columns, and the deflections of the supporting frames, a comprehensive structural analysis was performed on both the interior and exterior frames to determine the exact level of shims required for each needle beam. Shimming could not commence until the entire web space and the top flange was packed with grout so that the masonry bearing area was increased and the masonry

was not overstressed (Figure 6). Concrete piers were monitored for settlement during shimming operations, with the understanding that the required design shim thicknesses may need to be adjusted if settlement occurred. The heaviest loaded needle beams were shimmed to an estimated mid-span concentrated load of 24 kips. Once completed, the masonry wall was removed in sections starting directly under the bottom flanges of the needle beams. Removal was completed within two days with no movement or cracking registered.
