STRUCTURAL FORENSICS

Condition Assessment of Old Stone Retaining Walls

By Dan Eschenasy, P.E., FSEI

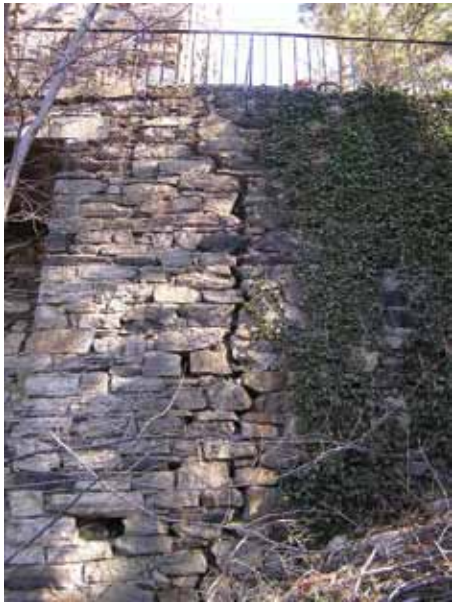
Figure 1. Crack in rubble wall.

Any aging stone facade may show signs of deterioration, i.e. delamination, peeling, erosion, loss of mortar, unit cracking, etc. A visual assessment of a stone retaining wall needs to differentiate between such symptoms of aging and those that indicate the possibility of a more severe failure or accident. For instance, some cracks, commonly found in the vicinity of corners, are just the result of deformations due to thermal movement. Such expansion cracks, even when they completely separate the wall into two segments, might not affect the wall's stability, as each segment may remain capable of resisting the out of plane forces acting upon it (Figure 1).

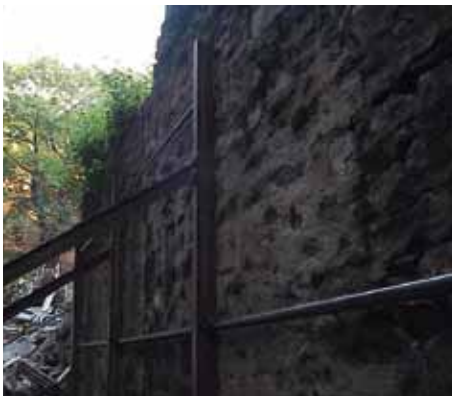
Figure 2. Retaining wall stabilized with rakers after collapse. Note lean of wall.

issues related to the assessment of old stone retaining walls existing in New York City. Most of the symptoms of deterioration discussed were observed during the New York City Building Department's inspections and filtered through the experience of several forensic collapse investigations (See Figures 2, 5 and 6, see page 12).

Outward lean of a wall is a significant symptom presaging collapse (Figure 2). It may be caused by insufficient or deteriorating strength or by the failure of the soil underlying the toe. In the absence of original drawings, it is difficult to ascertain whether the present orientation of the wall face matches the original intended geometry. (e.g., did the wall move from an original batter?). Over a long period of time and as a result of intermittent load increases (e.g., high rainy seasons and icing pressures at the top) and simultaneous reduction of friction, the wall might have slowly moved from the original vertical or battered position, thus reducing the original factor of safety. It is conceivable that the outward displacement of a wall might decrease the pressure of the retained soil (i.e. from at rest pressure to active pressure). A new equilibrium is then

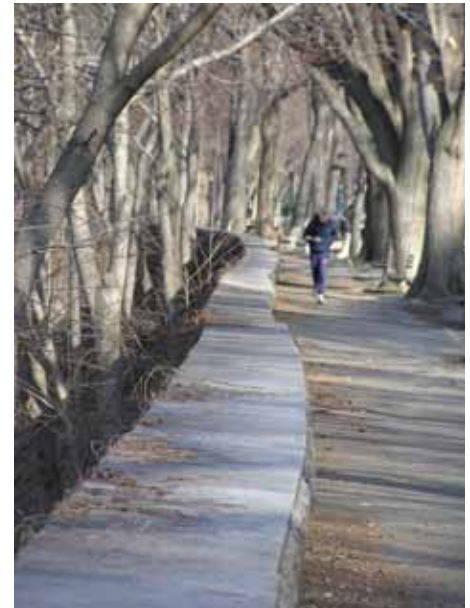
Figure 3. Irregular alignment at top of wall.

Outward rotation or movement of a wall has associated signs of distress that include sink holes and tension cracks at or around the top of the wall. Sometimes sink holes may only indicate erosion of the retained soil. At the bottom of the wall, one might observe soil swelling and sloping towards the wall. For long stretching walls, observation of the alignment at the top of the wall can indicate differential movement of wall segments. It might also help distinguish walls built with batter from wall segments that moved (Figure 3).

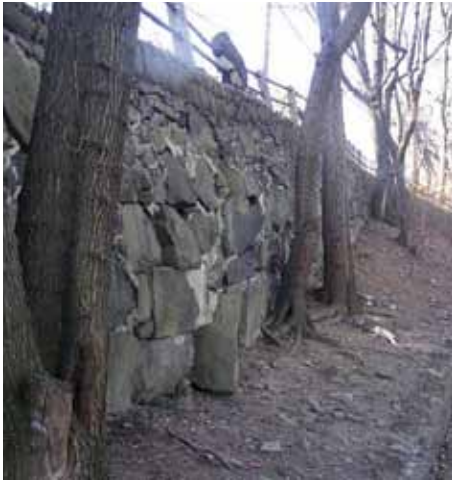
Figure 4. Bulging wall.

Incipient sliding failure at the base may be preceded by swelling of soil at the bottom of the wall. In some cases, there is a separation of soil at the top of the wall. Sliding of portions of the wall along intermediate planes can lead to outward deformation of the top of the wall or bulging at the lower parts of the wall. Sliding of the top of the wall may lead to collapse of this top portion (Figure 4).

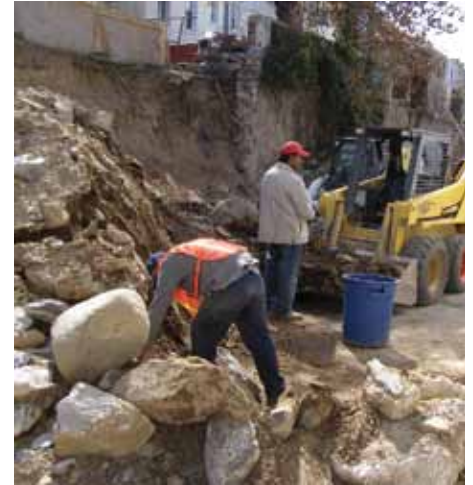
Figure 5. A visual inspection prior to collapse might not have detected that the wall was only 2 feet deep.

Even when the aspect of the outside face is satisfactory, there remains significant uncertainty as to the method of construction used for each particular wall (Figure 5).

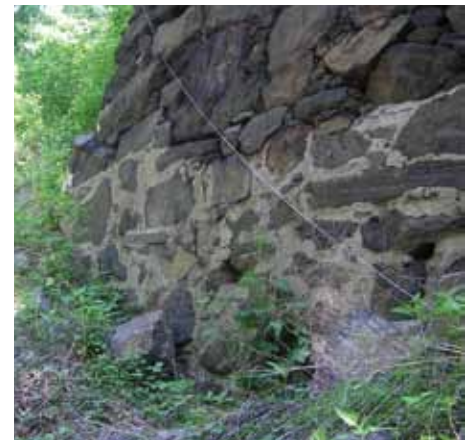
Figure 6. Collapsed dry wall. Repair pointing at the base, intended to keep pins in place, might have contributed to collapse.

Dry stone walls generally allow water to circulate, except for cases when subsequent repairs added mortar to the face of the wall (Figure 6). Ice formation or tree roots might create "wedges" that could lead to some local wall deterioration.
