HISTORIC STRUCTURES

Gustav Lindenthal's Little Hell Gate Rail Bridge

New York City

By Alice Oviatt-Lawrence

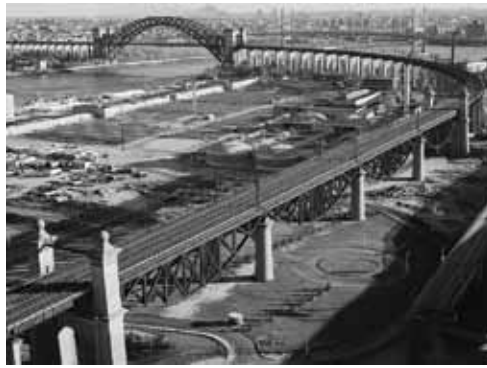
Figure 1. Flanked by viaduct spans, the century-old, still in service, distinctive Little Hell Gate Bridge reverse bowstring arch-spans suspend; with the Hell Gate and Triborough Bridges beyond. HAER NY 121-16, Weinstein, Photographer, 1996.

Near the flagship Hell Gate Bridge (STRUCTURE, October 2013), and crossing a former inlet between Wards and Randalls Islands, stands Gustav Lindenthal's still-in-service 1915 Little Hell Gate Bridge; four unique skewed-deck truss spans of reverse parabolic bowstring arches. They are visually striking, sited as they are above flat land and below miles of high plate-girder viaducts. The total length between centers of the abutments is 1153.5 feet. Four-rail tracks operate on the 60-foot wide deck (Figure 1).

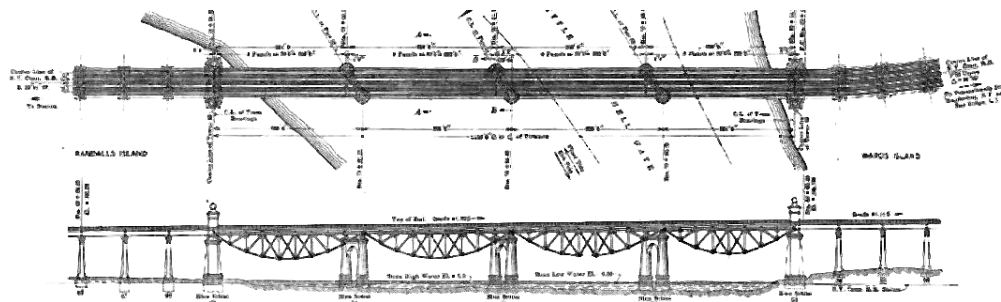
Figure 2. Lindenthal office drawing, Little Hell Gate Bridge, plan and elevation. The center skewed piers originally aligned with the inlet current. Two tracks load each truss. Transactions of ASCE, v. 82: 1918.

The lightweight, simple, riveted web trusses are of lightweight Class A open-hearth structural steel. The reverse bow-string (under) deck trusses are constructed of 50-foot high parabolic and parallel arches, set 52 feet apart. The bottom tension chord is comprised of between ten to thirteen pinned eye-bars – the largest size forged to date, each at 38 feet long, 16 inches wide by about two inches thick, and connected by 16 inch-diameter pins tightly covered with cast-iron caps. Twenty-one of the 1,900 tons of annealed structural steel full-size eye-bars were tested before construction, with results of an average elastic limit of 36,500 pounds per square inch (psi) and an ultimate tensile strength of 61,800 psi. The truss structural steel is slightly higher at 66,000 psi, and has a yield point of 35,000 psi (Figures 2, page 34 and 3).

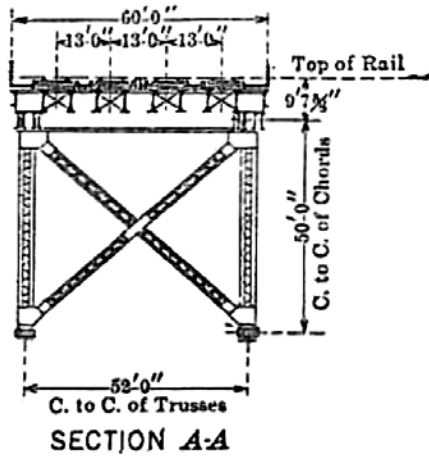
Figure 3. Lindenthal office detail, transverse section drawing. Sway-frames transfer lateral loads from the bottom chord via stiff diagonals to a heavy & rigid lateral system in plane with the top chord truss. *Transactions of ASCE, v. 82: 1918.*

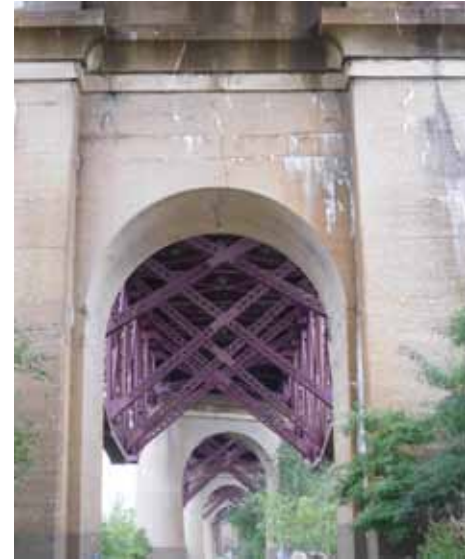
Figure 4. The Buttressed Barrel-Vault Arch at end pier 53, view to the north. The round river-piers and reverse arch spans stand and suspend beyond. Stiff steel sway frame diagonals provide lateral bracing. Concrete cracks, and white alkali-aggregate reaction deposits are active. Many tree roots stress shallow foundations.

There are no transverse supports at the bottom chords. Instead, stiff diagonal sway frames connected to each vertical web member angle up from the bottom chord, transferring wind loads up to a rigid and extra-heavy wind and vibration truss in plane with the top chord (Figure 4). The angles and joints connecting the uniform-sized truss members of the reverse bowstring arches are geometrically aligned, so as to equalize and distribute the dead loads.

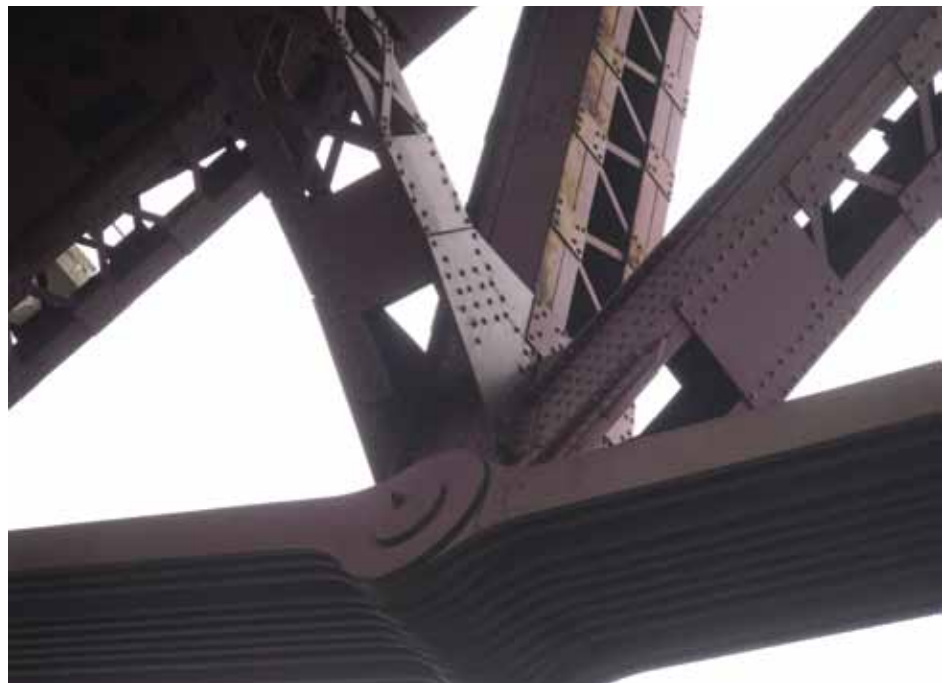
Figure 5. Detail, Little Hell Gate Reverse Bowstring Truss Bridge, 1915. Lower tension chord of eye-bars, with a view up to the deck, illustrating an array of structural steel truss members. Except for the eye-bars' 16-inch diameter pins, the bridge is riveted to exacting specifications, at the high cost of 25 cents each.

McClintic-Marshall Construction Co. also handled the manufacturing and erection of all the steel for the trusses. Steel gantry travelers erected 11,250 tons of steel. Bents supported the material track at the top chord level, from which the truss members were lifted from below the track by the traveler. After the bottom chords were assembled and laid on adjustable camber blocking, the posts, diagonals and top chords were set in-place by gantry traveler. Total costs of the project were \$990,000 (Figure 5).

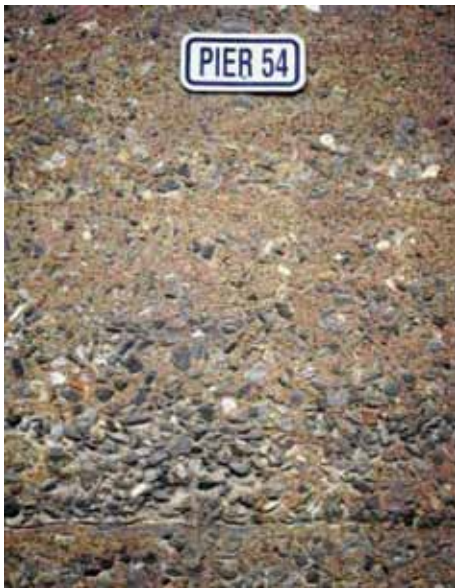
Figure 6. East face, pier 54. Permeable, century-old weathered concrete surface with exposed, large-sized aggregate which appears to have settled at the time of the pour. Note the one-part Portland cement to one-to-two parts fine-aggregate mortar slushing-edge between the horizontal pour layers. AREMA 1911 Specifications, in use at the time, stated that a uniform distribution of materials shall be obtained with the use of a straight slicing shovel after each pour.

Concrete surfaces, observed in an October 2014 site trip, exhibited weathering, spalling, cracking, and incipient rust stains, especially at the Little Hell Gate end piers. Much of the original dense concrete protective exterior surface layer (Figure 6) is eroded, exposing the interior to destructive alternating wet-dry cycles. Moisture is clearly penetrating the masonry via gravity and wind forces, surface tension, and capillary action. In addition, alkalis in the Portland cement, used in the concrete mix, are reacting with siliceous or carbonate elements in the aggregate. The chemical reaction develops new compounds as gelatinous white alkali within the masonry, which then expands through the masonry to harden on the exterior surfaces. While Portland cement was generally in use by c. 1890, its uniformity and alkali content varied considerably. The reaction phenomenon would be researched after c. 1916, when widespread reports of concrete

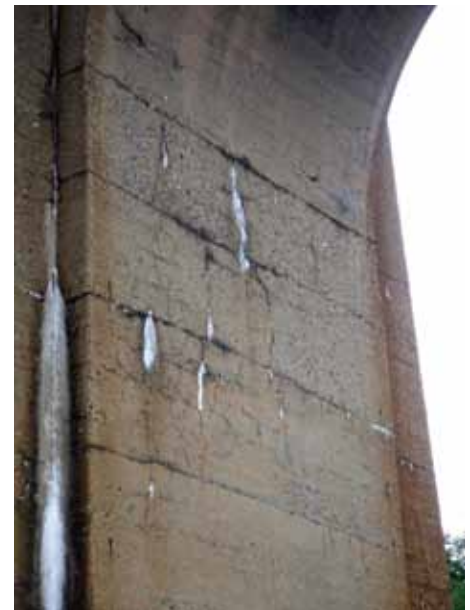
Figure 8. Cylindrical-vault abutment sidewall, end pier 53. Detail of active and desiccated white alkali deposits from reactions between inherent chemicals in the cement and aggregate, thermal effects, polluted air, and moisture. Note the resulting pattern-cracking below the arch springing. Increasing permeability of the mass and incipient oxidation of reinforcement are contributing to the cracking.

deterioration emerged. The research continued into the 1950s, at which time the exact science behind the reaction was still little understood (Figures 7 and 8).

Cracks and strength-loss result from masonry-mass volume changes. At each end pier there is a continuous vertical crack leading all the way down on both faces of the re-entrant spandrel walls and cornices, and following through the vertex (center) of the six-foot deep barrel-vaulted arch-intrados (soffit), reflecting some displacement of the heavy masonry structural elements. Through-cracks have developed near the springing points in the same manner as at the vertex. Hinges have formed where the lines of thrust converge within the arch-structure boundaries. Three hinges produce a statically determinate structure with changing equilibrium and shifting thrust moving increasingly horizontally through the hinging points. Internal and external degradations develop instability and eventual overloading of the structure.

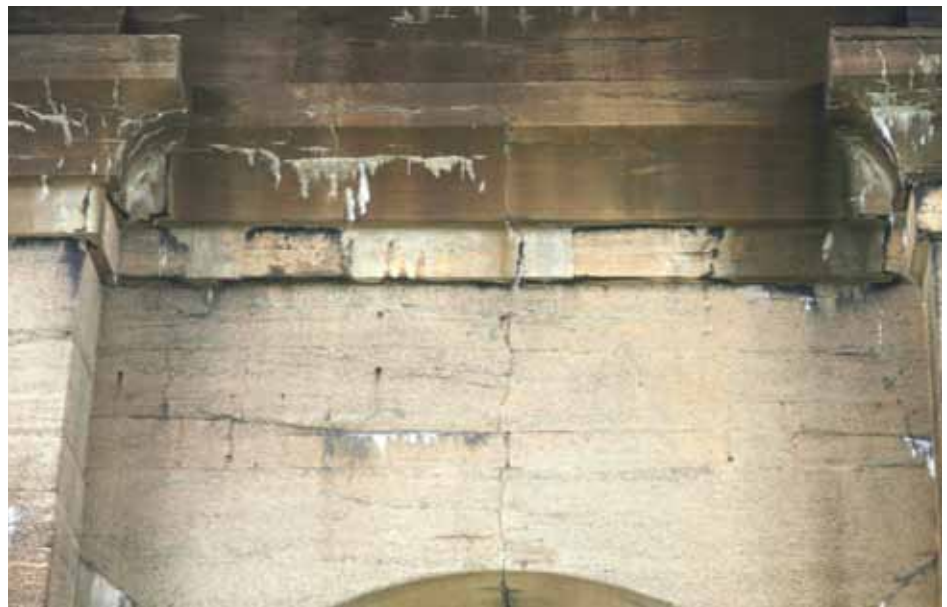
Figure 7. South face end pier 49. Vertical and horizontal popout-cracking, with ongoing severe spalling and alkali-aggregate reaction evident. New compounds from the reaction expand inside the masonry mass; the resulting localized pressure-zones result in microfracturing and spalling of the structure, here seen in the re-entrant spandrel-wall below the cornice. Cracks are oriented parallel to the bars. Volume changes and strength-loss of the masonry-mass are in progress.
