STRUCTURAL FAILURES

Reflections on the 2014 South Napa Earthquake

By John A. Dal Pino, S.E.

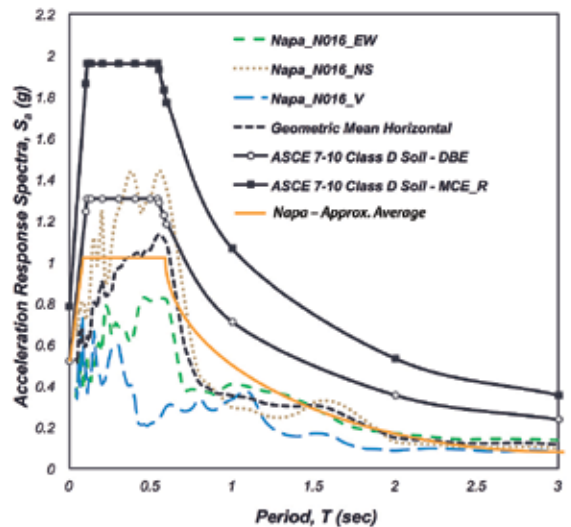
Figure 1. EQ response spectra (with assistance from PEER).

This 6.0 magnitude earthquake, at least by California standards, would be considered moderate to strong and therefore the area of strong ground shaking was somewhat smaller than one might think. The peak ground acceleration was in the 0.3g to 0.4g range, with a maximum (geometric mean) spectral acceleration of about 1g (Figure 1). A generation ago, an earthquake of this size was the standard *Uniform Building Code* (UBC) “Zone 4” event. Today, this earthquake, in terms of acceleration, is approximately 30% lower than the current design basis earthquake for Napa and much of coastal California, including the inland portions of southern California, except for areas very near active faults. So this event could be considered as a likely event throughout California and something we should be ready for almost anywhere and at any time.

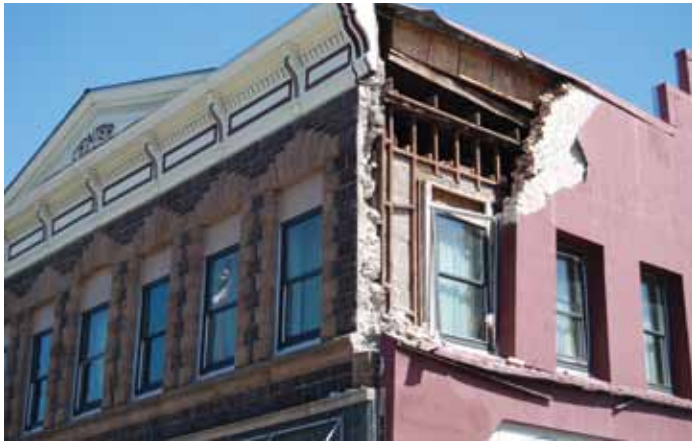
Figure 2. Damaged URM building.

The spotty performance of URM buildings in the South Napa earthquake (Figure 2), even those buildings that had been retrofitted (Figure 3), reconfirmed perceptions

about the hazards these buildings pose to the public. The earthquake damage showed that some of the un-strengthened buildings really did need to be strengthened, but it also showed that many buildings that had been strengthened sustained serious, life threatening damage.

In many communities, URM buildings showcase community history, provide a visual link to the past, and offer interesting architectural spaces for restaurants, shops, offices and the like. Since it is apparently almost impossible to fully eliminate all risks from URMs, communities need to reconsider what ought to be done with these buildings. Many are protected historical structures, so they can't exactly tear them all down in the interest of seismic safety. The Napa experience would suggest that improvements need to be made in terms of safety, but that raising the standard too much will result in the strengthening becoming overly costly and visually destroying what makes URM buildings interesting in the first place.

An alternative is to publically acknowledge that even strengthened URMs are significantly more dangerous than most other buildings and leave it at that. While that might be the right policy for the risk from infrequent earthquakes, it may be one the public finds troubling given the serious life-safety consequences.

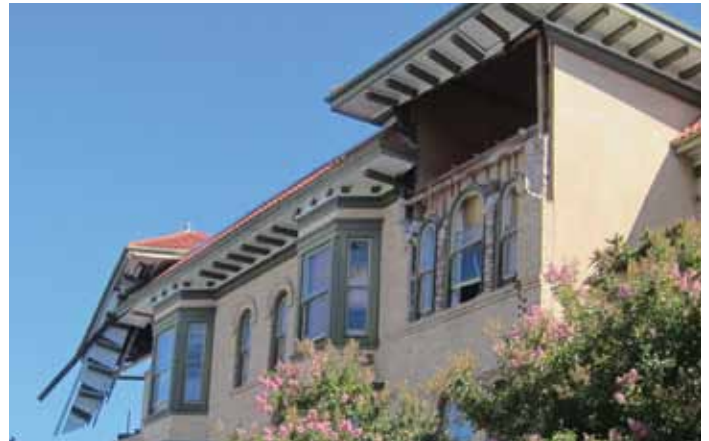
Figure 3. Damaged, retrofitted URM building.

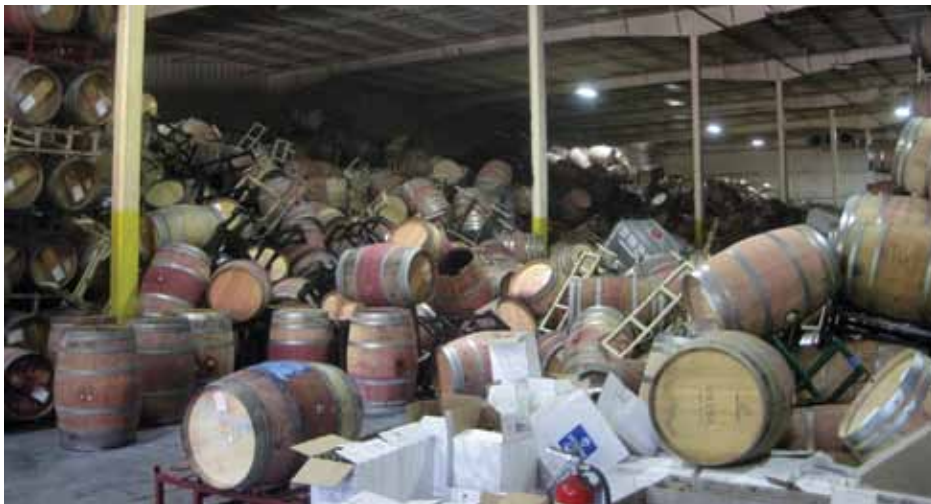
Figure 4. Toppled wine barrels.

Napa is not an industrial town in the classic sense, but it does have a significant, world class agricultural wine industry, with all of the grape processing and wine storage and bottling infrastructure that goes with it. The wineries sustained a significant amount of damage to their wine storage tanks (mainly modern thin-walled stainless

steel) and stacked wooden barrels (Figure 4). Wine industry sources place the damage at approximately \$80 million. Given the extreme weight of the stacked barrels, toppling barrels also caused significant damage to the structural framing in some light-framed buildings, and nearly created lateral and vertical instabilities that would have resulted in structural collapse.

the earthquake moments before the ground motions reached their system 50 miles to the south. Had the BART trains been running (they weren't at 3:20 am), train operators could have started to slow the trains to protect passengers. In a winery, 15 seconds warning would give the workers a chance to move to dedicated safe locations away from the greatest hazards near the barrel storage.

Another idea would be to prevent the ground shaking from getting to the stacked material in the first place. Base isolation has become an accepted, somewhat routine method for protecting high value property. In a warehouse environment, it would certainly be possible to create an isolated double slab with simple ball and cone isolators. This approach is used to protect data centers located in high seismic regions. The similarity with the wine industry is that the computers in data centers need to move around, aren't easily anchored and are susceptible to internal damage from intense shaking.

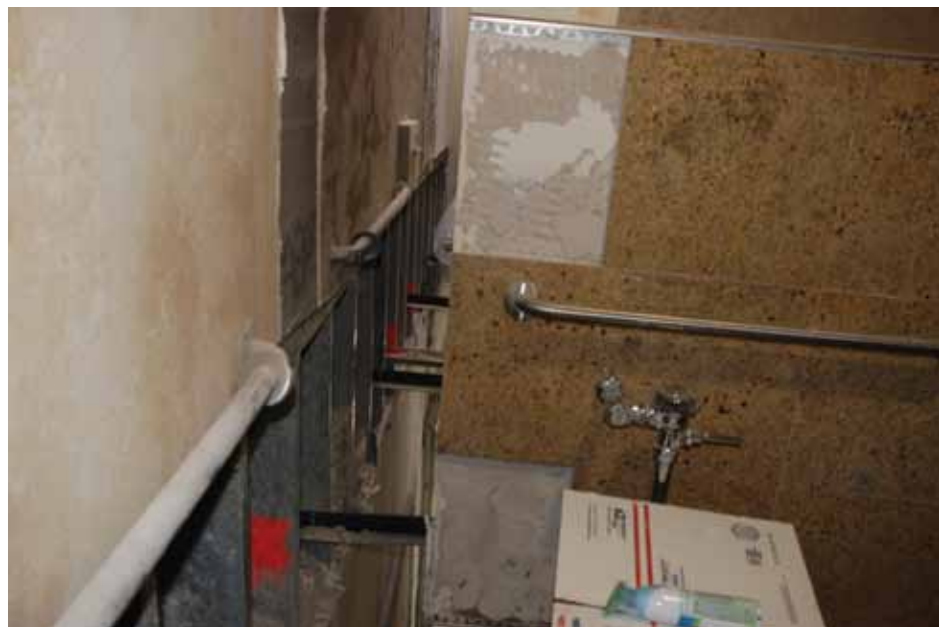
Figure 5. Exterior wall separation/gap.

One of the more interesting damage observations, from an AE industry perspective, involved the incompatibility between the lateral movement of the structure and the non-structural cladding in a modern three-story steel frame building. In this building, the cladding consisted of a balloon-framed metal stud and stucco exterior wall. The structure laterally deflected more than the stiff cladding and the cladding connections could tolerate, due to the lack of horizontal seismic jointing to accommodate inter-story

drift, resulting in damage to the connections that stabilize the wall and attach it to the steel structure (Figure 5).

Besides the damage, the more important issue is the design coordination of the architectural and structural systems, whether designed by the architect or by a third-party specialty structural engineer working for the contractor. In California, cladding receives extensive review and scrutiny by the State on hospital projects, but less so on commercial buildings, where the responsibility for proper design and construction rests almost exclusively with the design professionals. In the interest of public safety, clear and continuous communication and coordination is required between all parties, with each taking responsibility for their assigned roles and tasks. It is critical that the parties resist the temptation to limit their involvement in the process, thereby shifting design responsibility to others.

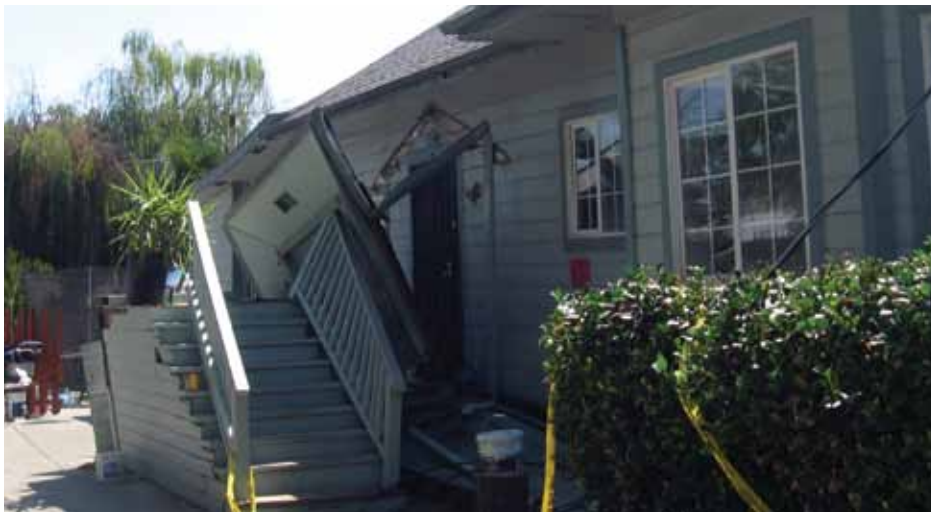
Figure 6. Residential cripple wall failure.

The observed damage was similar to that seen in past earthquakes. Older homes fall off their foundations (Figure 6), masonry chimneys fall over or suffer significant damage, and internal contents fall. For engineers, there was no mystery about what was going to happen. What engineers ought to be doing is figuring out how to prevent the damage in the first place, given the importance of a safe, dependable housing stock.

Wood frame homes, except those founded on a concrete slab-on-grade, are classic soft-story buildings with rigid superstructures above open crawl spaces. The retrofit techniques necessary are well known and widely available. The Association of Bay Area Governments (ABAG) has a wonderful collection of information for homeowners, and their engineer and contractor, to use.

The real question is why haven't more homes been retrofitted? Is it apathy, ignorance of the issue, or a lack of financing? Probably some combination of the three. What is needed is a financing program, coupled with incentives and education. The City of Berkeley has a model program that helps homeowners finance the purchase and installation of rooftop solar panels, repaid through their property taxes. In California, many homeowners are house rich and cash poor, so this approach to earthquake retrofit seems like an avenue communities ought to explore.
