RURAL PHILIPPINE SHELTER CONSTRUCTION

Structural Engineering Challenges

By Gustavo Cortes, Ph.D., P.E.

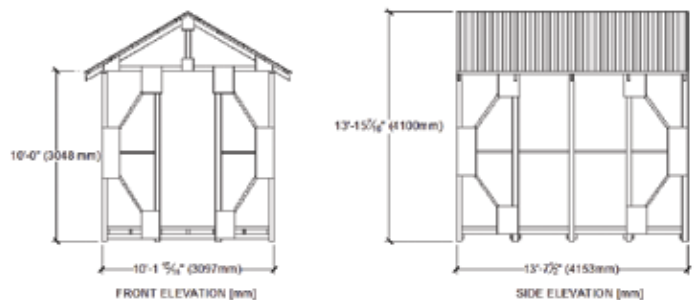
Figure 1. Shelter elevation views.

After an assessment of the needs and the living habits of the local population, architects from Medair rapidly developed a prototype shelter. *Figure 1* shows elevation views of the structure in its first phase. Initially, the unit is enclosed by means of a tarp, allowing for immediate occupation and future expansion. This initial phase provides 129 square feet (12 square meters) of living area; however, the owners could increase its size to 301 square feet (28 square meters) as their income allows. This can be accomplished by adding two rooms, one on each side of the house.

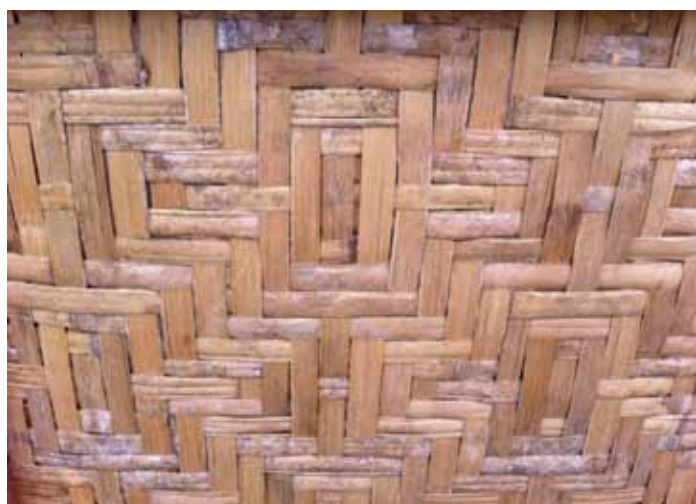
Figure 2. Amakan fabric used for siding.

Another unique aspect of the loading conditions was created by the enclosure used for exterior walls. The initial phase included the distribution of a tarp to be placed around the shelter to provide protection against wind and rain. Accordingly, the lateral-force resisting system was designed to withstand the forces generated by the wind pressures acting on the membrane. Several houses visited, however, had not used the provided membrane and were instead using a locally produced thin fabric called Amakan. This fabric is made by weaving bamboo strips at 90 degree angles (*Figure 2*). These fabrics have large gaps between the bamboo strips, which allow for wind to flow through the shelter. This membrane is also very likely to let water enter the shelter even during moderate winds. Under high wind pressures, the Amakan fabric will possibly fail, allowing wind to flow through the

shelter, reducing wind pressure on the main lateral-force resisting system but increasing the pressure at roofing elements. The solution, if all the scenarios are to be considered, is to design the lateral-force resisting system for the maximum loads coming from the full wind pressure, when the structure is enclosed, while the roof should be designed to withstand uplift from an open structure.

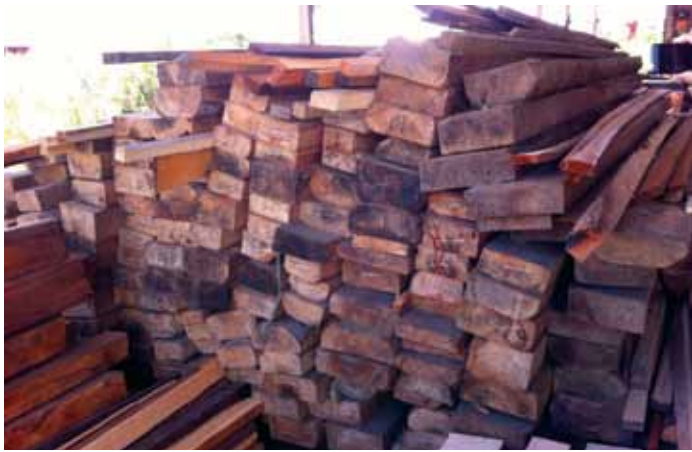
Figure 3. Local coco lumber supply.

Coco lumber is a natural resource widely available in the Philippines. It is extensively used for housing construction in rural areas because of its availability and relative low cost. An extensive amount of coco trees fell during super typhoon Haiyan, increasing the supply of this inexpensive material. Figure 3 shows a typical coco lumber supplier found by the side of a major road in Tacloban. However, coco lumber requires careful processing and strict quality control for it to serve as structural lumber. Untreated coco lumber exposed to weather is very susceptible to fungi and termites, which can destroy the hard portion of the trunk in less than 2-3 years and the soft portion in just a few months (Arancon, 2009). Although treatment would increase its life span, treated coco lumber was not readily available in the region. Furthermore, available coco lumber from local supplies varied greatly in dimensions and density. Much of it was cut using chainsaws, resulting in uneven pieces of lumber. Given the uncertainty of the quality of the coco lumber found, it was not used for structural elements. However, in order to promote the local economy, coco lumber was specified for non-structural elements that will not be directly exposed to the weather. It is important to aid the local economy as much as possible without compromising the structural integrity of the shelters.
