## A Practical Approach to ASR Mitigation in Existing Structures

By Craig E. Barnes, P.E., SECB and Sofia Zamora, EIT

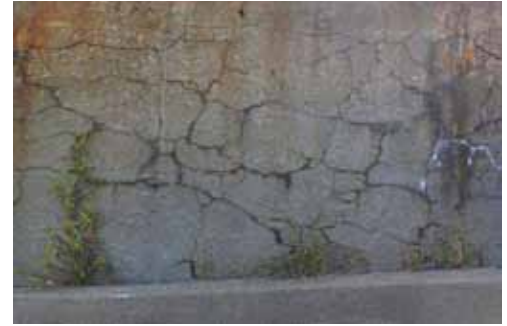
Typical look of a wall suffering from severe ASR damage. The failure is occurring due to the aggregate of the wall expanding and pushing out the outer layer.

did not have to extend further since both of these known deterioration mechanisms affect the steel reinforcement and yet no damage of this sort was observed on the wall. Concrete cores revealed a reasonable compressive strength (3500 psi) and laboratory analysis quickly ruled out reductions in concrete durability due to low air content; although, the air content was estimated at no more than 2-2.5%. At a time when petrographic analysis had not become widely accessible, the engineer had to rely on visual observation of concrete through a magnifying glass to estimate its constitution. The aggregate was large, up to an estimated 2-inch diameter and well graded. Its texture hinted that it was not river washed but taken from a pit. Finally, after what appeared as multiple aimless hunts, the first solid pattern of failure was established: the larger aggregate appeared quite fragile as it split in several directions, although some looked intact. Upon removal of the concrete binder, the aggregate consistently would fall apart while being held. After comparing these observations with concrete deterioration literature, Mr. Barnes hypothesized that the aggregate was suffering from Alkali-Silica Reaction. This theory was confirmed when the results of a through-wall excavation revealed that the water dependent reaction receded upon further excavation into the center of the wall and then increased again as the excavation approached the other side of the wall. The phenomenon seemed appropriate, as the surface on both front and back of the wall was subjected to greater moisture compared to the concrete within the depth of the wall.

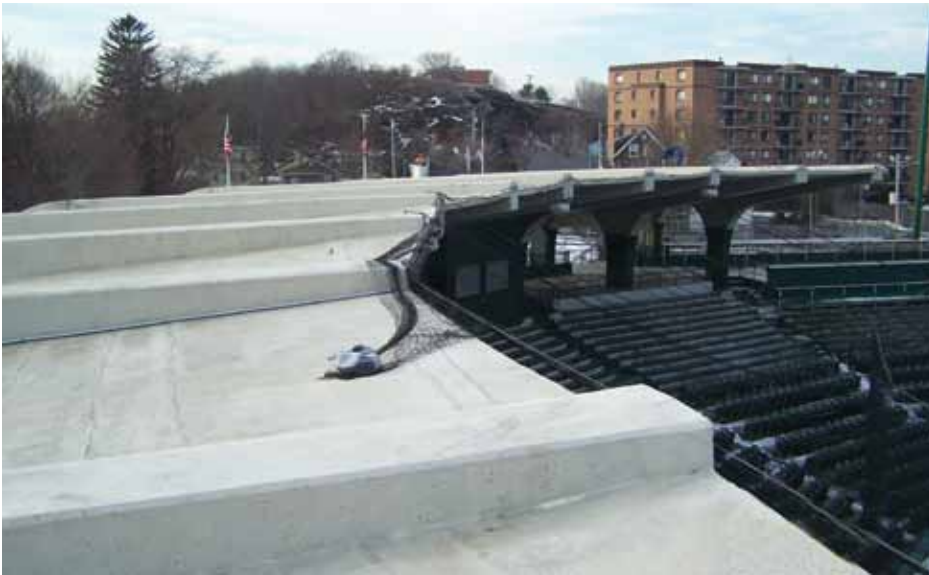
Upturned beams at a stadium.

- 1) Where appropriate, such as with upturned exposed beams, copings, parapets, buttresses, and piers, wrapping to exclude water can extend the surface life.

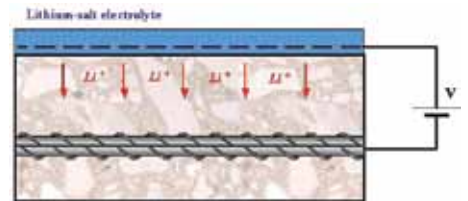
Illustration of aggregate protection through lithium electrolysis.

of topical applications on shallow and small repairs. No significant improvement results have been observed in larger specimens. This triggered a study by Whitmore and Abbot in 2000, where they used electrochemical impregnation techniques to increase the penetration of the lithium compound on large structures. The technique is very similar to that of electrochemical chloride extraction technique. An electrode anode is applied to the concrete surface. The lithium electrolyte is ponded at the surface and a D.C. voltage is applied between the anode and the embedded steel (reinforcement) to drive the electrolyte into the concrete. A current of 60 volts appears to be the most effective, achieving a significant decrease in alkali reaction 2 inches into the surface. Electrochemical applications should be considered when large areas are affected and a long term protection mechanism is feasible.

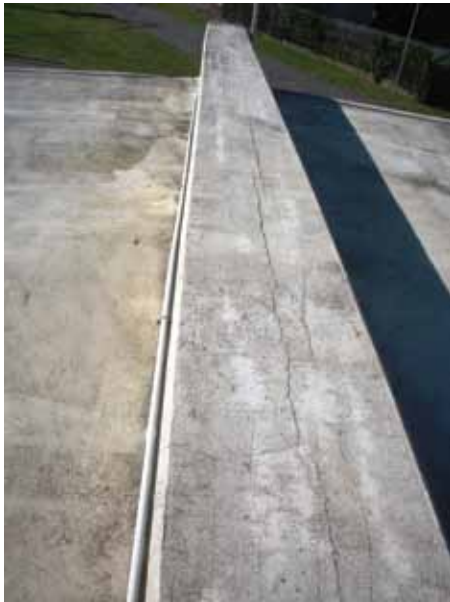
Exposed concrete deck and beams suffering from ASR. Area was patched 20 years ago and the lifetime of the patches has been reached. Waterproofing coating after replacing concrete surface would extend repair lifetime.

only one of the repairs CBI has guided over the years have been fortunate enough to have detailed post repair studies, it has been their experience that in an exposed environment, cement-based patches over ASR-prone aggregate concrete do not stop the deterioration; rather, they only slow it down.

To provide additional protection, CBI also recommends applying waterproofing

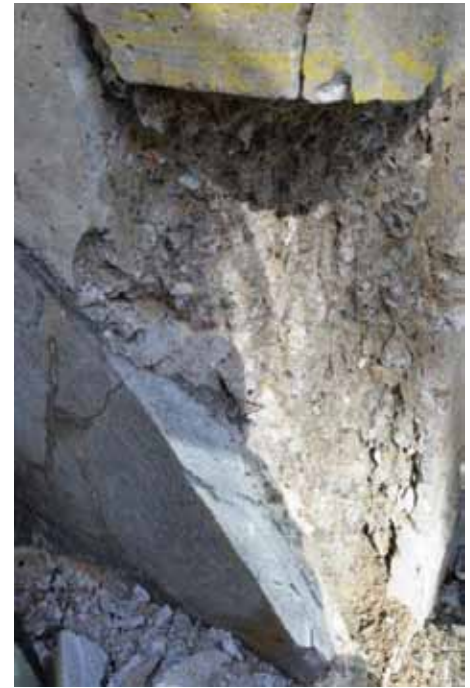
ASR deterioration.

- 4) In older structures, look for the characteristic “map cracking” on the surface of the concrete that may be an indicator of an expansive aggregate (ASR) that is increasing the volume of the concrete, which exceeds the cement paste binder aggregate’s tension capacity. This phenomenon has also been referred to as a “varicose-vein” surface.
