STRUCTURAL FORENSICS

Corrosion Diagnostics and Electrochemical Repair for Historic Steel Frame Buildings

By Gina L. Crevello and Paul A. Noyce

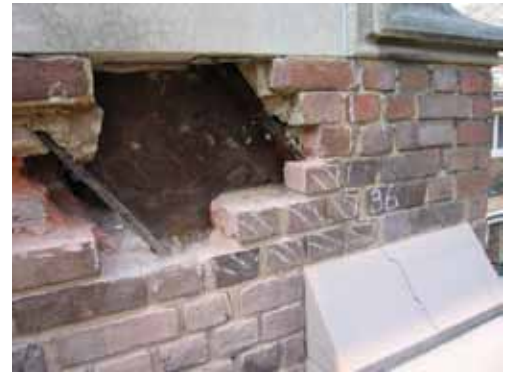
Figure 1. Cracking of masonry due to corrosion of the steel frame.

Corrosion related damages are the root cause of numerous façade failures on masonry clad steel frame buildings (Figure 1). Corrosion of the underlying steel frame or anchorage can lead to cracking, spalling, displacement, and eventually the loss of entire masonry units or severe section loss of structural components. Corrosion is a quantifiable reaction, whereby initiation, propagation, and deterioration can be projected through comprehensive assessments and durability modelling.

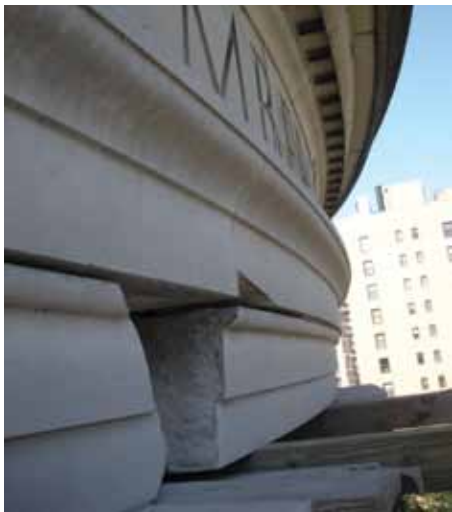
Figure 2. Electrochemical test area of masonry corresponding to Figure 3.

E_{corr} or *steel potential* is established by the taking half-cell potential of the steel with a reference electrode (Figures 2 and 3).

I_{corr} or *corrosion rates* are measured by Linear Polarization Resistance. The resulting corrosion current and loss of electrons is equated to section loss based on Faraday's Law of Metal Loss. This has a direct relationship with rust accumulation (Figures 2 and 3).

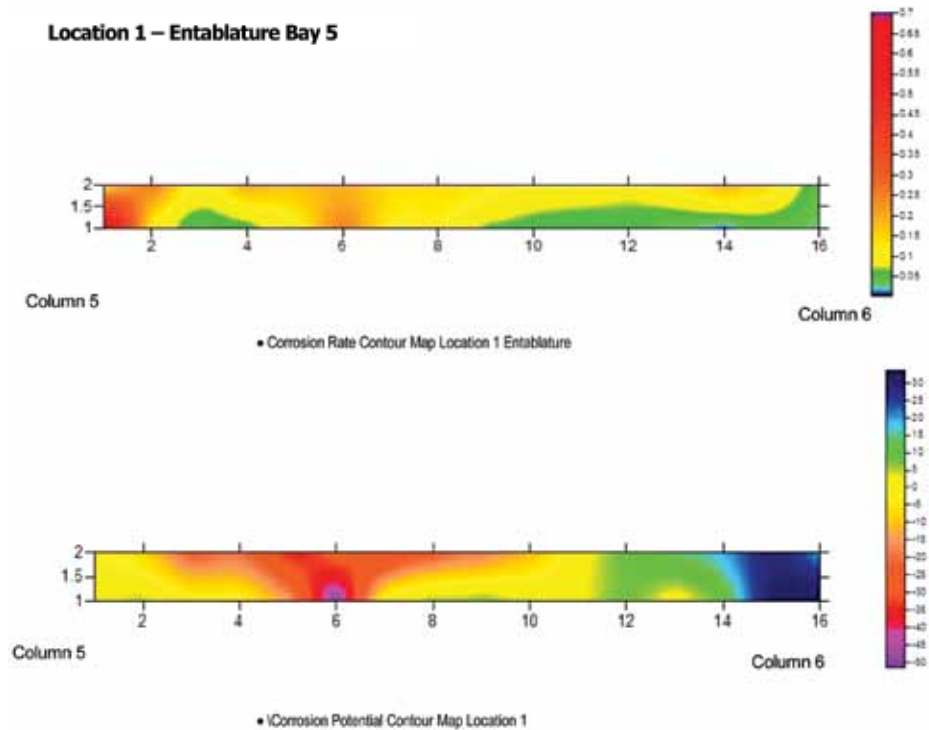
Figure 3. Contour maps of the test data of correlate probable corrosion risk (potential), high moisture, low oxygen and areas of active corrosion. Top contour corrosion rates, bottom contains half-cell potential.

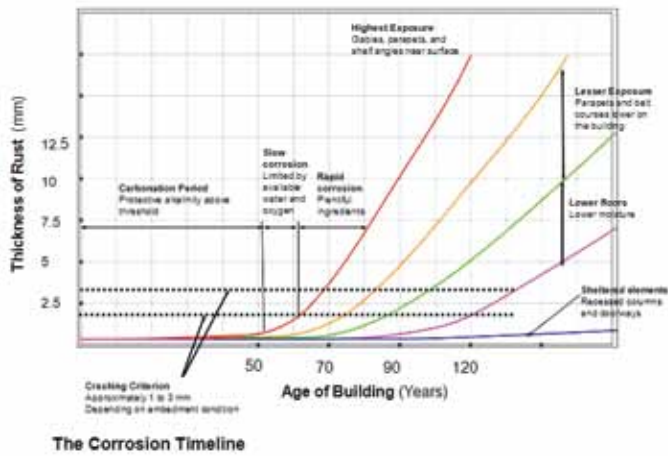
Figure 4. Corrosion timeline: These charts illustrate corrosion activity and deterioration of certain elements of the building within their service life.

As the various elements tested all possess a function in regard to the corrosion behaviour of the building, knowledge of the conditions and the interpretation of the data is required in the overall corrosion assessment (Figure 4, page 16). This information sets the basis of assessing service life of the structure and durability of the repair. Utilizing durability models, time to cracking and time to critical section loss can be determined to ensure the most appropriate repair is used.

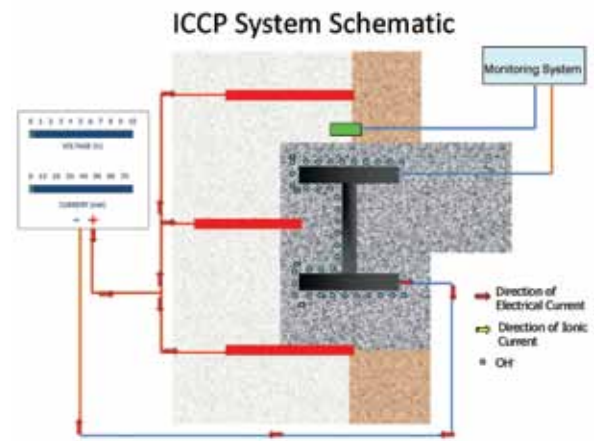
Figure 5. Cathodic protection schematic.

A schematic is provided in *Figure 5*, showing the layout of a system in a masonry-clad, steel-frame building. The rod anodes are attached to the [+] of the power supply (red), and the steel frame (cathode) is connected back to the [-] of the power supply.

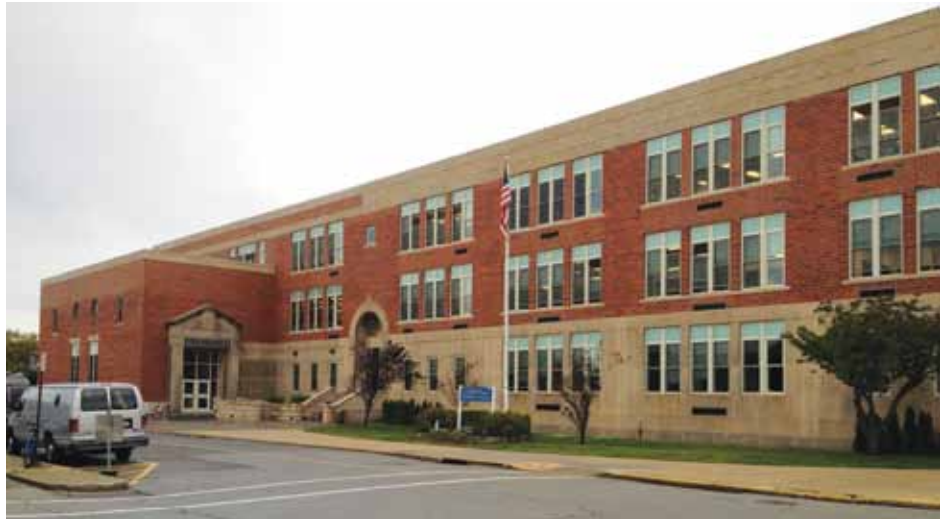
Figure 6. Completed system on steel frame buildings.

In the United States (US), the first full scale application was installed in 2004 to the façade of a prominent historic Chicago department store, which was built in multiple phases from the late 1800s to the early 1920s. Today, at least 20 of these systems exist in historic steel frame buildings in the US (*Figure 6*).
