STRUCTURAL REHABILITATION

Precast, Prestressed Thin Slabs in Parking Garage Structures

Or, When Thin is a Not a Win-Win

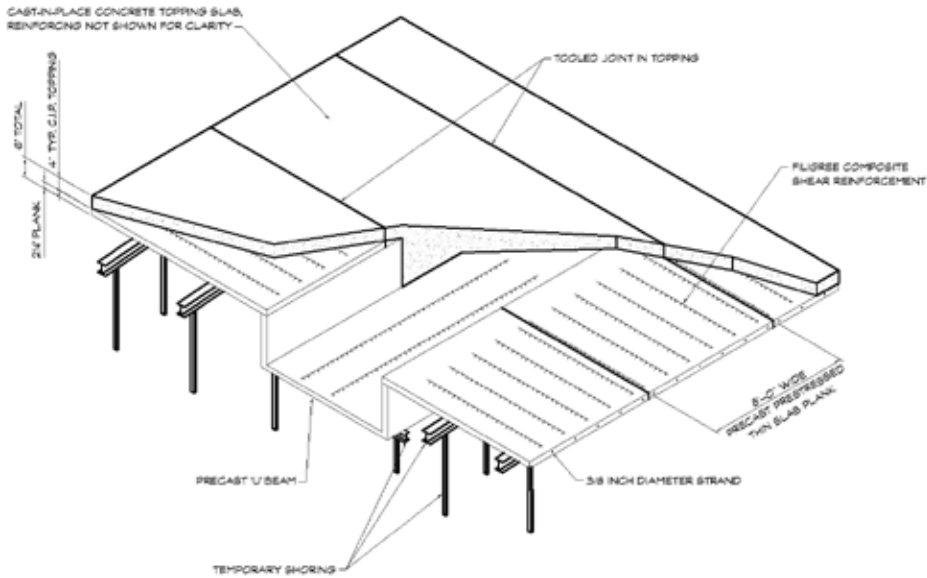
Figure 2.

Similar to an aged and failed, tooled and sealed topping joint in a typical double tee parking garage structure, joints in a thin slab garage structure will allow for moisture intrusion into the joint. The moisture, which is typically contaminated with chlorides from deicing salts either applied to the surface or brought in from the road by vehicles, tends to migrate through the

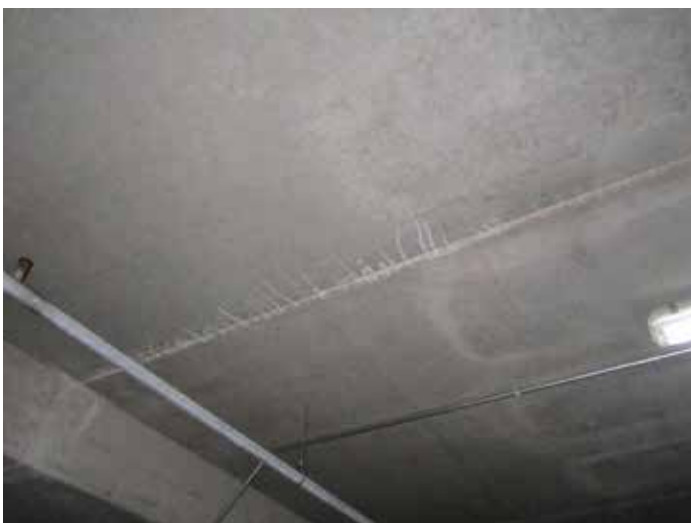
Figure 3.

joint. The moisture flows horizontally into the interface between the topping and precast via capillary action, and across the bottom surface of the soffit of the precast (Figure 3). As a result, any reinforcing steel that is adjacent to the joint will begin to corrode, causing the surrounding concrete to deteriorate.

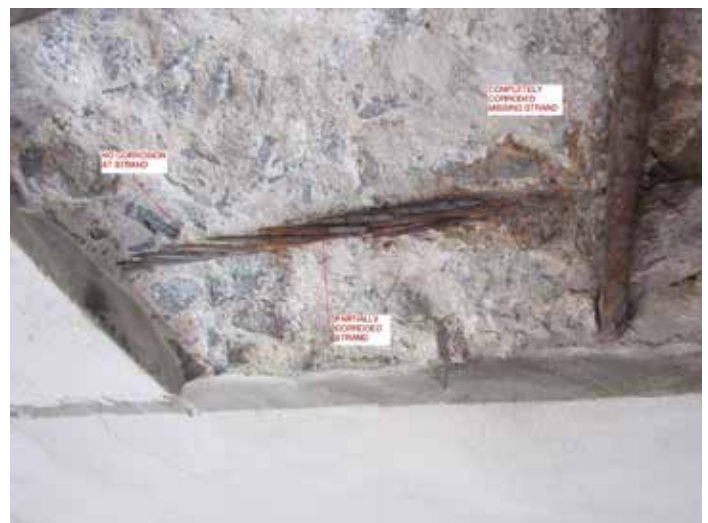
Figure 4.

In a double tee flange edge, this can result in isolated damage to the connectors and mesh reinforcing, which can often be repaired conventionally. In a thin slab plank, however, the proximity of the outside strand to the joint edge can result in the corrosion of a portion of the primary positive flexural reinforcing in the composite slab system. If the two outside strands of a typical 6-strand plank become corroded to a point at which a considerable amount of cross-sectional area is lost, or the strand is completely consumed – which is frequently the case because of the relatively

small diameter of the strand (Figure 4) – the associated 8-foot-wide section loses 33% of its positive moment capacity.

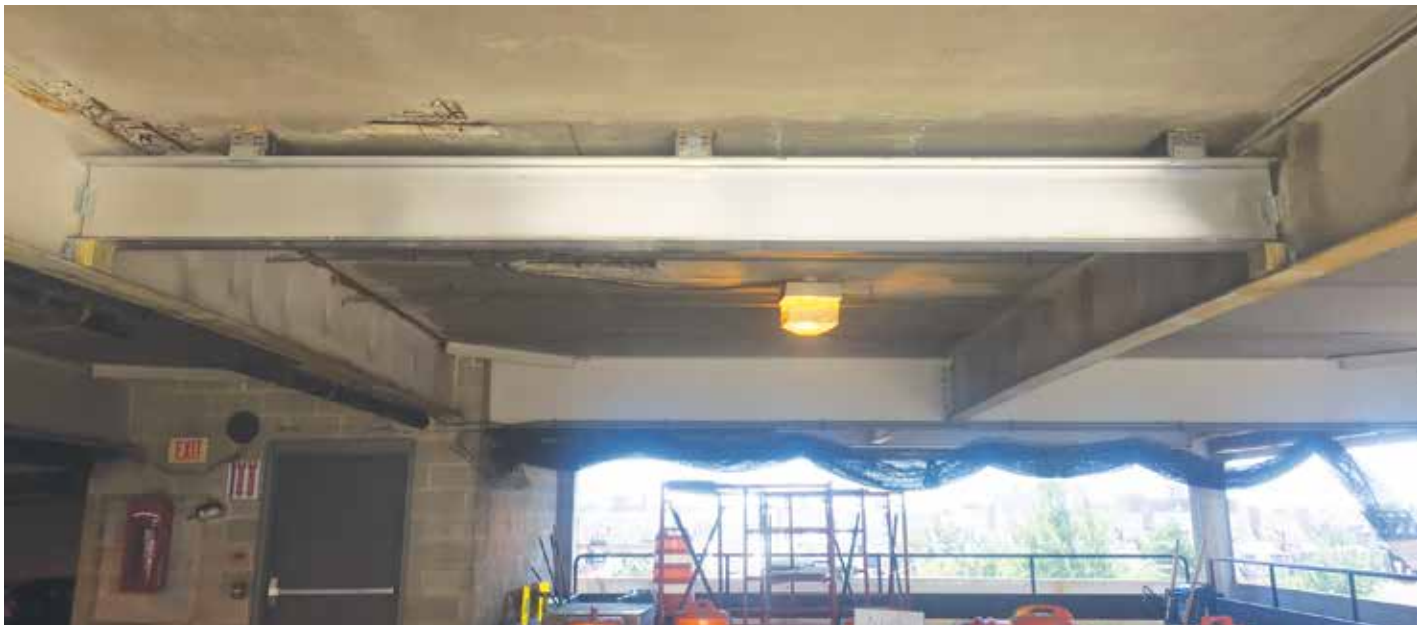
Figure 5.

The loss of two out of six strands, which was the maximum strand loss documented in any of the 30-year-old planks, equated to a strength reduction of approximately 33%, which was greater than the 20% reserve capacity. These planks required the installation of aluminum shoring beams immediately below the location of the corroded strand, which were shimmed tight to the underside of the plank soffit. The shoring beams spanned between, and were supported by, the existing steel beams that provided the original support of the planks (Figure 5).
