MARRIOTT MARQUIS RENOVATION

By Virginia Mosquera, Ph.D., P.E.

Supporting world's largest LED billboard installation at the crossroads of the world required quick coordination and immediate solutions to conflicts.

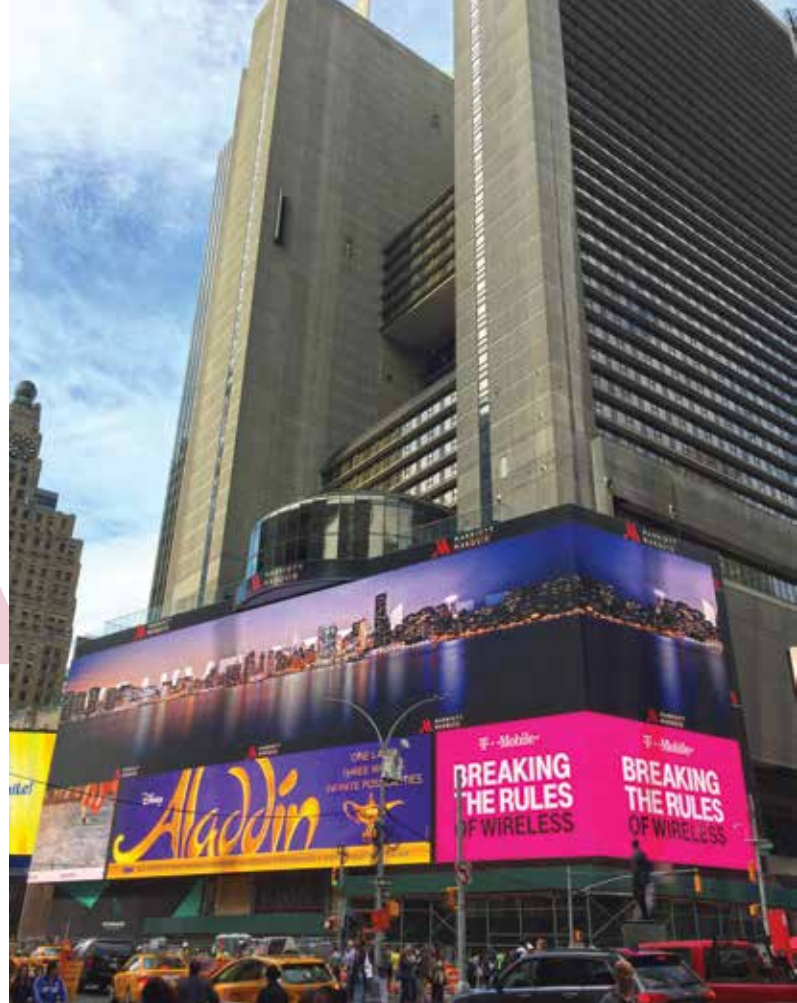
Figure 1. Marriott Marquis building featuring the world's largest high definition LED sign.

The iconic Marriott Marquis hotel, located at the center of Times Square, was recently renovated to display the world's largest high-definition LED billboard (Figure 1). At five stories tall, this gigantic screen spans the entire width of the building (a full city block, from West 45th Street to West 46th Street on Broadway), wrapping partway around its sides. The renovation also included converting the two underground parking levels and first two above grade-levels to prime double-height retail spaces, the remodeling of back-of-theater rooms, and the creation of new rooftop space offering coveted views of the New Year's Eve ball dropping.

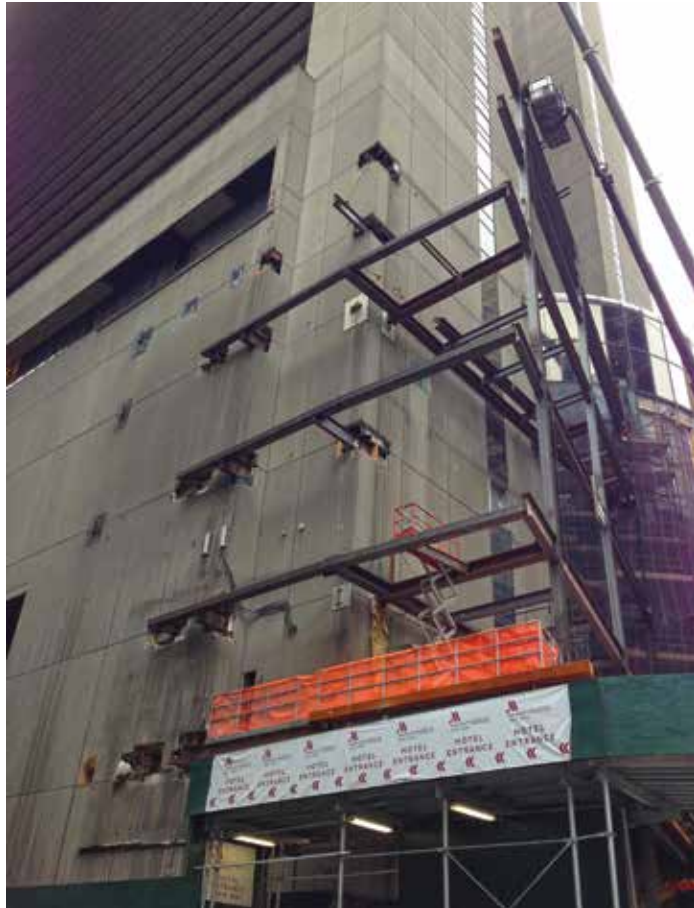
Figure 2. Broadway framing.

The LED screen is five stories tall and is located between levels 3 and 8. The supporting framing for the sign along Broadway was divided into three sections (Figure 2). On the north and south sections, the existing façade was set-back from the property line; at these two areas, the hotel requested open-terraces overlooking Times Square to be constructed on the 8th floor. On the south side, moment frames were constructed along the property line that provided support to both the LED sign and the south terrace. On the north side, a combination of new framing along the property line and framing cantilevering out of existing columns was used. For economy, existing connections and precast openings were also used on the north and south sides of the Broadway façade. In the middle section, above level 6, the existing façade protruded and had to be demolished to install and support the LED sign. The framing in the middle portion of the Broadway façade consisted of hangers suspended from the floors above, and did not have the capacity to support the new load; therefore, the existing structure in this area could not be used. To accommodate the absence of connection points on this portion of the façade and satisfy the stringent limitations on the deflections of members supporting the LED screen, a vierendeel truss was used (Figure 3). The truss spans 57 feet horizontally and has vertical supports only at the existing columns at level 3. It is connected horizontally at only a few discrete points within its 75-foot height to reduce displacement produced by wind loads. The vierendeel truss was selected

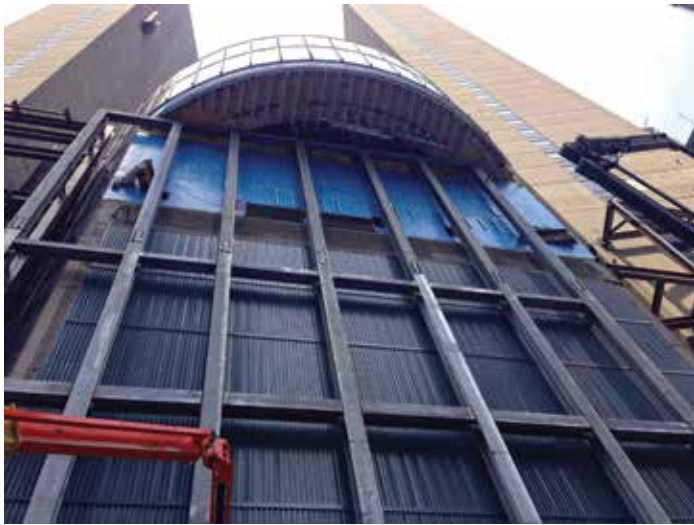
Figure 3. Vierendeel truss.

as the most efficient solution to span the distances between the supports, creating a structure that was robust for both the vertical load and the wind load.

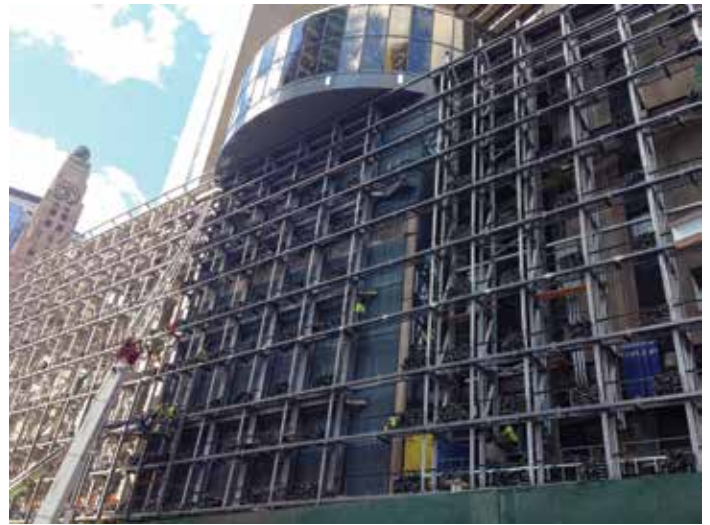
Figure 4. Installation of LED sign.

The LED screen consists of approximately 6- by 8-foot interlocking panels that connect to a secondary or back-up structure connected to the supporting structure described previously. The supporting structure had to be designed for the deflection limits required to accommodate the LED screen; however, it was also very important in the design to control the relative deflections at different support points within the width and height of the screen to avoid having issues during and after the installation of the screen panels. For this reason, sandbags with the same weight as the LED screens were stacked on the back-up structure of the LED sign, allowing for adjustments to be made before the installation of the LED screen and resulting in a successful procedure (Figure 4).

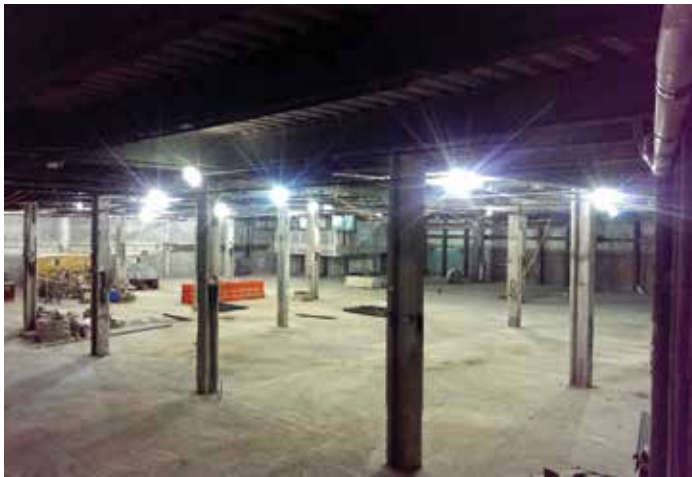
Figure 5. New double story space with reinforced columns.

An important aspect of this work was to devise a sequencing scheme for the reinforcement of the columns and foundation wall that allowed for the demolition of the floor level and also ensured the safety of the structure at all stages. Different types of reinforcing options were evaluated. The main two factors that determined the column reinforcing used were that plating would cause minimum space intrusion and guarantee the stability of structure at all construction stages. The existing columns had the strong-axis capacity to span the two levels, however the weak-axis capacity was insufficient; therefore, the demolition and reinforcing scheme chosen consisted of initially demolishing only the deck and beams bracing the column on its strong axis, then providing

the flange plate reinforcing. Once the reinforcement was installed, the increased column section would have sufficient axial capacity in the weak axis to allow for proceeding to demolish the beams that were bracing the columns on the weak axis.

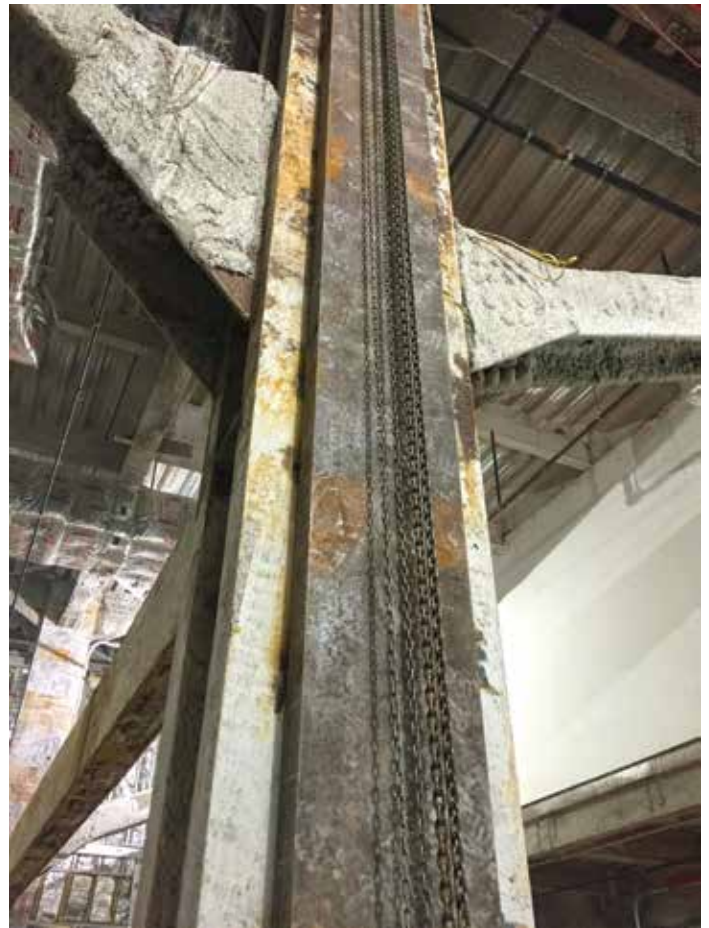
Figure 6. Column reinforcing.

That reinforcing scheme was typical at the two basement levels. Some of the columns on the first two levels above grade also had to be reinforced to allow for double height spaces. These columns were very critical to the structure as they were part of both a vierendeel truss lateral system for the building in one direction and a bracing system used for gravity in the other direction. The moment connected beam of the Vierendeel needed to be removed to allow for an open space. Since these columns were critical to the building, plating sequencing needed special care. Plates on each side of the beam were temporarily installed on the column to provide the required axial capacity. After the beam removal, a plate centered on the column flange was installed that would not protrude as much from the column as the temporary side plates (Figure 6).
