# THE CAREY BUILDING VERTICAL EXPANSION

By Joseph E. Caza III, P.E. and Michael Palmer, Ph.D., P.E.

A 22,000-square-foot vertical expansion is currently under construction at the existing Carey Building located at 314-320 East State Street, Ithaca, NY. The mixed-use building, owned by Travis/Hyde Properties of Ithaca, is being expanded to accommodate new commercial space and residential apartments while maintaining the current first floor retail space. The expansion involves the addition of five stories stacked above an existing two-story reinforced concrete structure originally constructed in 1922.

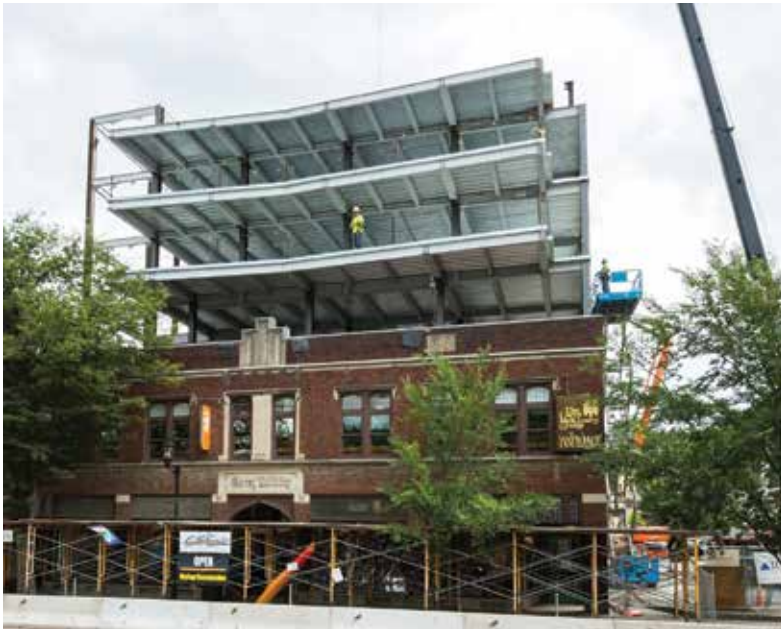
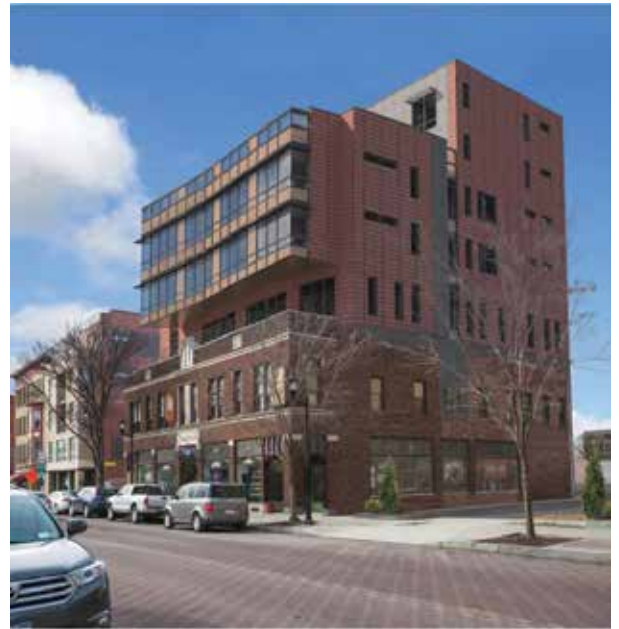
Figure 1a. Carey Building Southeast elevation during steel erection. Courtesy of Gary Hodges Photography.

Figure 1b. Carey Building REVIT rendering of Southeast elevation. Rendering courtesy of John Snyder Architects.

The expansion will increase the building height from 27 feet 2 inches to a height of 81 feet above finished grade. The unique design supports the entire addition on the existing structure by locating the five story frame directly over the existing concrete columns (Figure 1a and 1b). An important facet of the project was the need to have the retail space on the first floor remain occupied and open for business throughout the project.

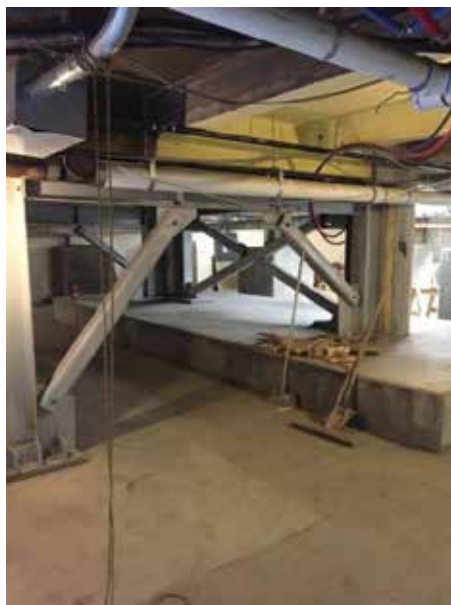
Figure 2. Center core braced frame at basement level.

forces, creating excessive building drift. To maintain the total drift level to less than  $L/500$ , the design required a series of steel braced frames to pass through the core of the existing and new building (Figure 2). The “overbuild” columns are located directly over the existing reinforced concrete columns. To ensure a successful design, the existing structure required an extensive structural analysis to locate building elements that needed to be bolstered to support the additional gravity and lateral loads.

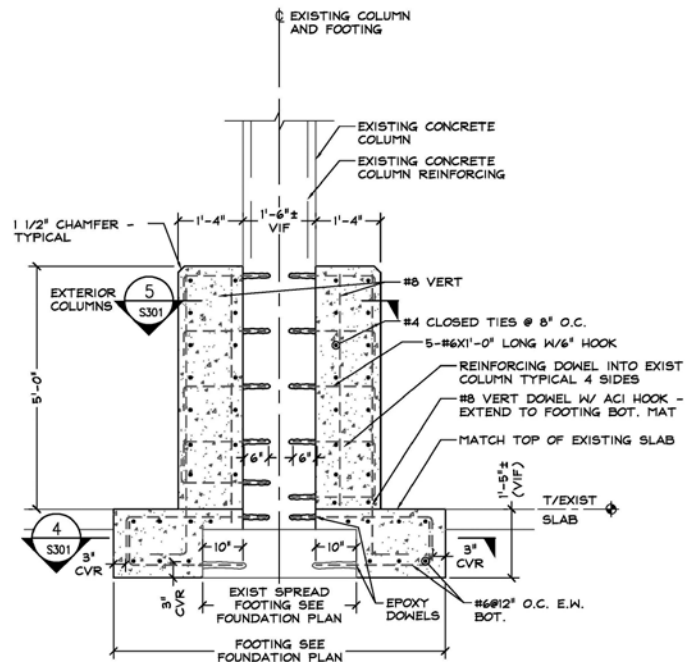
Figure 3. Footing extension reinforcing typical detail.

The first phase of the project was to analyze and reinforce the existing foundation. Based on initial field investigations, the original foundation was recognized to be composed of shallow caissons, possibly hand dug. Discovered during construction were three existing foundation types: strap footings at the West wall columns, shallow caisson foundations, and typical spread footings. The methodology used for the existing foundation redesign, to ensure sufficient bearing capacity and to mitigate unwanted settlement, was to ensure that the existing foundation did not support any additional load. The foundation loads increased from a typical load of 180 kips to a maximum total new foundation load of 360 kips. The decision was made to support this additional load on the new foundation elements. The new design requires the enlargement of the existing foundations with reinforced concrete “footing extensions” doweled into the existing foundations (Figure 3 and 4, page 44).

determining the size and location of existing footing reinforcing was by destructive testing. In lieu of extensive destructive field tests, the existing footings were treated as plain concrete when designing the footing extensions. With the assistance of a reinforced concrete collar used to supplement existing column reinforcement at the basement level, most of the footing extensions do not require an additional reinforced concrete “cap” over the existing footings. A concrete cap was required at one braced frame foundation (Figure 5). The additional concrete cap self-weight also serves to completely mitigate foundation uplift at this location.

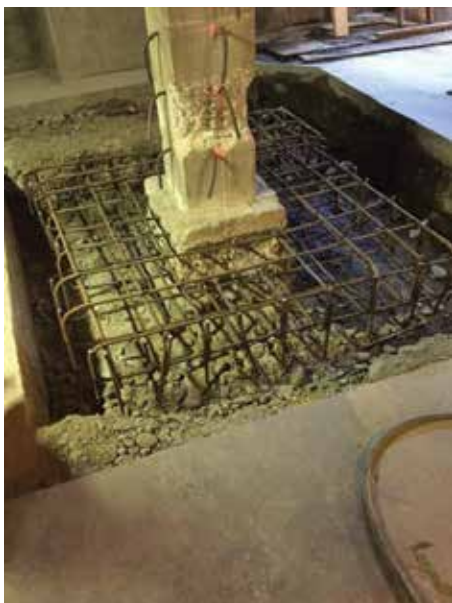
Figure 4. Footing extension reinforcing at existing caisson foundation.

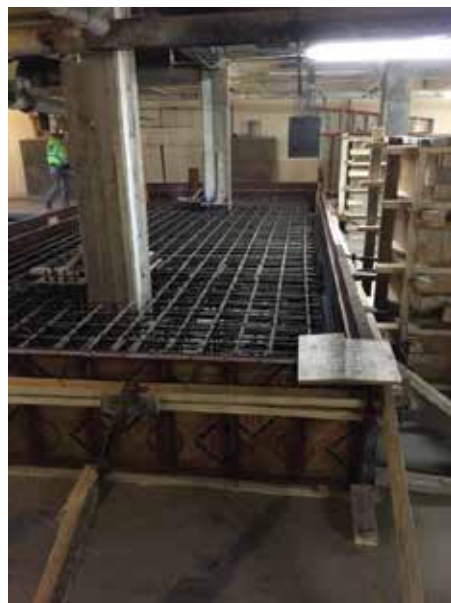
Figure 5. Braced frame uplift resisting mat footing.

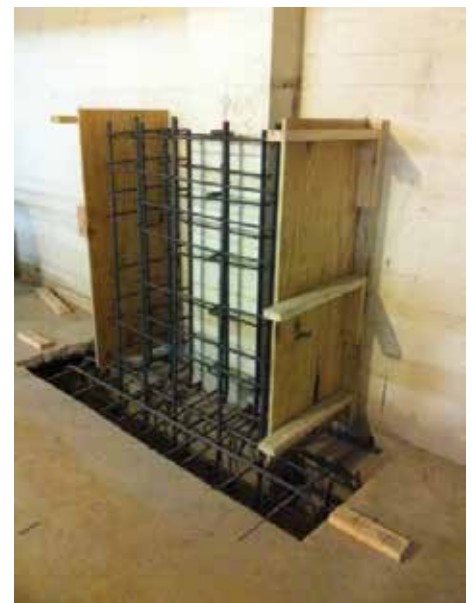
Figure 6. Existing column concrete collar reinforcing.

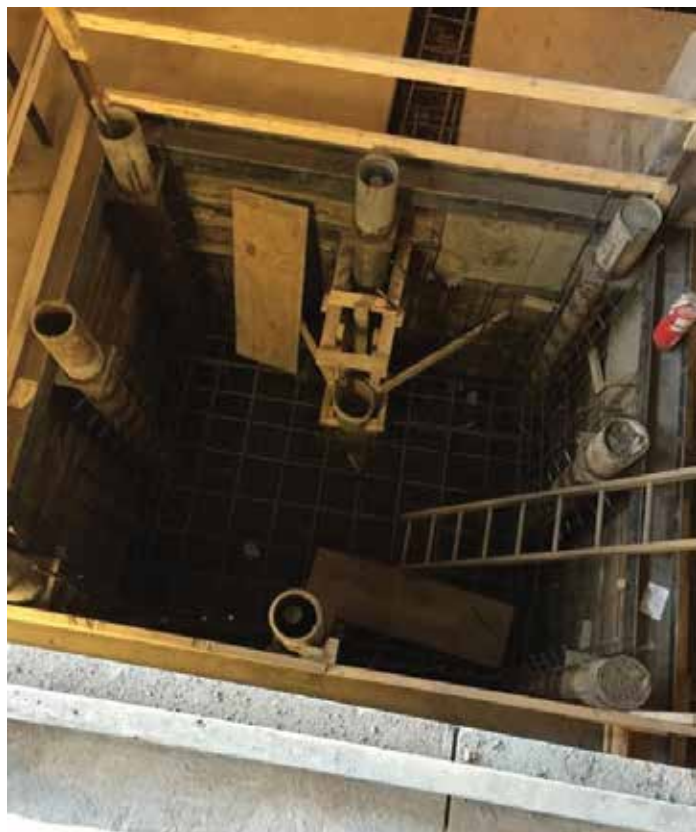
Figure 7. Aerial view of micro pile support of excavation at new elevator shaft.

The third phase of the project was the placement of the elevator shaft foundation. The foundation was designed with the assistance of underground engineering specialist Brierley Associates, headquartered in Syracuse, NY. The elevator shaft is constructed of 12-inch cast-in-place reinforced concrete up to the new third floor level and 12-inch reinforced masonry to the roof level. As a primary component of the lateral force resisting system, not only is the elevator shaft tasked with providing gravity support for the adjacent framing, but also with resisting wind and seismic event forces. With an aspect ratio of nearly 8V:1H, bending controls the shaft design. Also, the slender elevator shaft walls introduce significant uplift forces to the foundation. To resist the uplift, (8) 8-inch diameter micro-piles were uniformly spaced around the elevator shaft foundation and socketed 25 feet

into bedrock located 30 feet below grade. Problematic to the design was how to transfer the uplift forces between the elevator shaft shear walls and the micro piles. The solution was to weld a series of 1/2-inch shear studs to the micro piles and extend the pile shaft directly into the elevator foundation walls, thereby lapping the pile casing with the foundation wall vertical reinforcing. The micro-piles also served a critical function during excavation for the elevator pit and pile cap. The elevator shaft is located within 2 feet of an existing column and in close proximity to the earth retaining exterior basement wall. The 8-foot deep excavation necessary for the elevator foundation would undermine both soil bearing elements. A plan was devised to create a support of excavation (SOE) system using the micro pile casings that would extend up to the basement floor elevation and become cast into the foundation wall (Figure 7). The SOE utilizes a typical soldier pile and lagging scheme, with the micro piles serving as the soldier piles. Six-inch WT standoffs were welded to the outside of

the soldier piles to create a void space between the lagging and the micro pile casing. The void space permitted concrete to flow between the lagging and the casing, completely casting the micro pile into the elevator shaft foundation wall.
