Fastener Corrosion

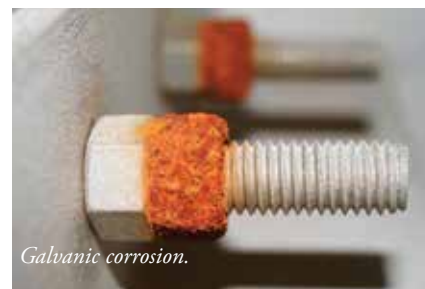
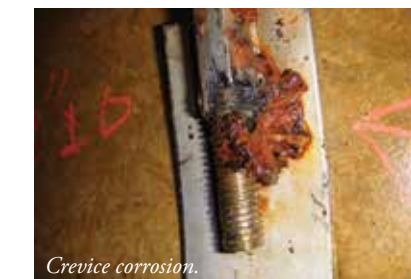
Crevice corrosion is a form of localized attack that most often occurs in narrow fissures where oxygen access is poor and a stagnant electrolyte solution is present.

Crevice corrosion is insidious and can rapidly progress, resulting in the attack of metal within the crevice areas (e.g., beneath bolts and cracks already initiated due to stress related corrosion). Possible mitigation methods are: avoiding formation of a crevice, sealing crevices with caulking compounds or elastic joint seals and painting surrounding cathodic surfaces, inspecting regularly for signs of crevices, and applying cathodic protection.
