# THE MODERN TEMPLE

## MAKING A HISTORIC MONUMENT SHINE

By *Brendan Ramos, S.E. and David W. Cocke, S.E., F.SEI, F.ASCE*

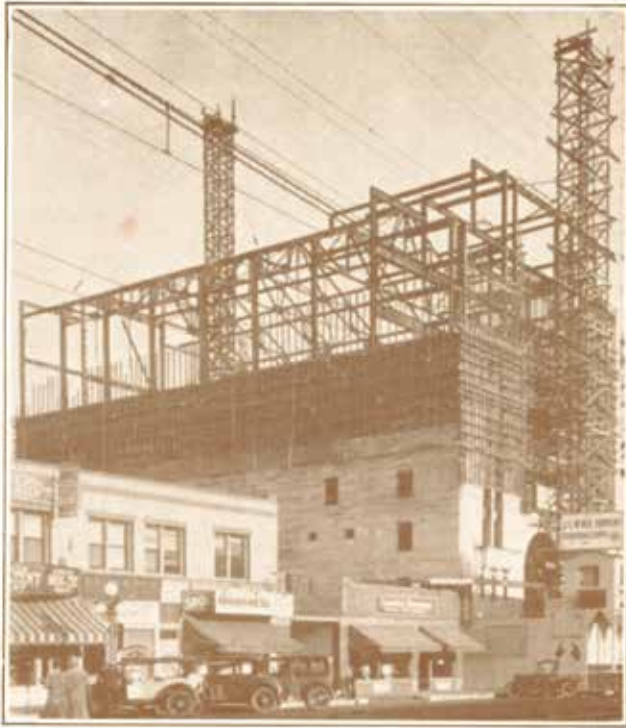
Figure 3. October 1928, exposed steel frame before completion. Source: *Masonry in Glendale: A Brief History*.

At first glance, The Masonic Temple appears to be a purely concrete building. Its exterior concrete walls mask the true skeleton of the structure: a steel-framed building, as seen in Figure 3. The main girders, beams, and columns of the building are made of structural steel and typically encased in concrete fireproofing. The building is essentially a “concrete-dipped” steel structure. As with many other existing buildings, full documentation of the original construction was limited. Structural properties and reinforcing were determined or verified through testing, scanning and, in some cases, exploratory demolition.

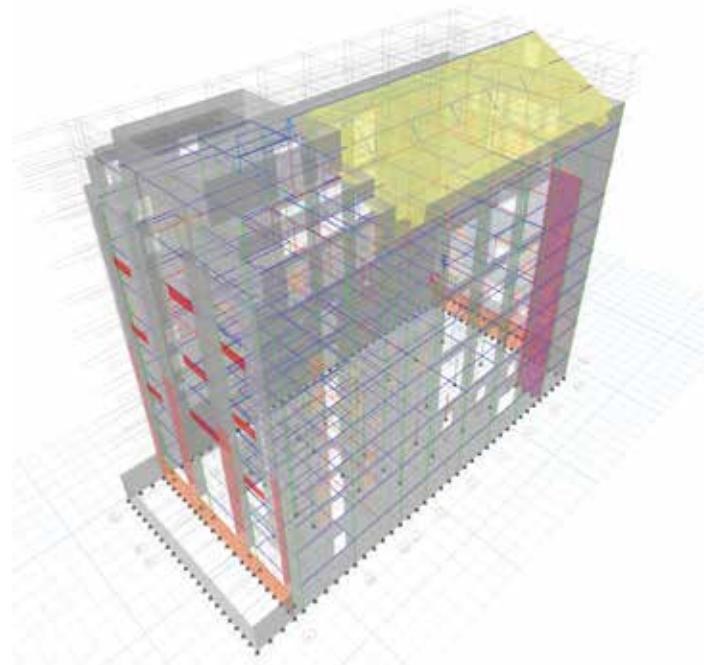
Figure 4. The Masonic Temple ETABS MT model.

The voluntary seismic retrofit of The Masonic Temple began with a structural assessment, identifying all the building deficiencies, utilizing the *Seismic Evaluation and Retrofit of Existing Buildings* standard sponsored and published by the Structural Engineering Institute (SEI) of the American Society of Civil Engineers (ASCE), also known as ASCE 41-13. This document is a tool that outlines a systematic procedure to evaluate building deficiencies and provides retrofit guidelines for the designer to follow for the building to meet the desired building seismic performance objective. For this building, the desired building seismic performance objective was Collapse Prevention. A structural model was built in ETABS to aid in understanding the behavior of the building (Figure 4). The major deficiencies identified included

vertical discontinuities (perimeter lateral force resisting elements did not continue through the basement), torsional irregularity (the west elevation’s lateral force resisting element was considerably “softer” than that of the east elevation), and unbraced mezzanines (several interior mezzanines were not adequately braced for lateral resistance).

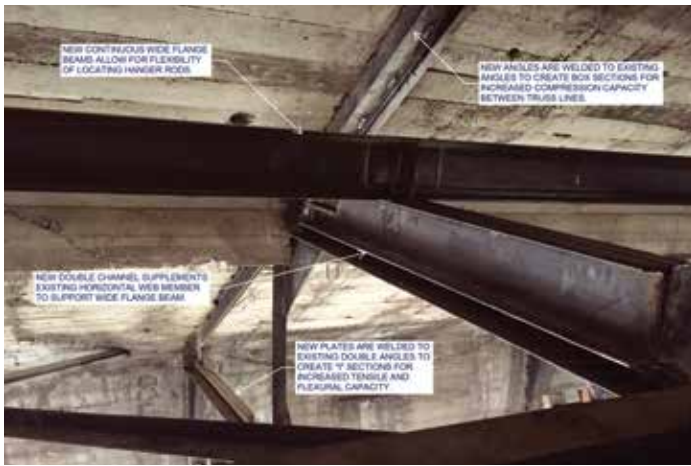
Figure 6. Construction photograph showing the modifications to the steel trusses needed to hang the rods.

“Floating” mezzanines with thin profiles and conference rooms on the uppermost floor were key to implementing the open office, which translated to a desire for no interior columns. Rather, large hanger rods supported by steel roof trusses above achieved the column-free space. To accomplish this, the roof trusses above were analyzed using a two-dimensional RAM Elements model for the additional loads imposed by the hanging mezzanine floor below. Supplementing existing angle truss members with new angles to create box sections strengthened compression elements. New steel plates increased the area of steel, increasing the tension capacity of tensile elements. Transforming double angles into “I” sections using steel plates increased the flexural capacity of truss members. Existing riveted connections were supplemented with welds to increase the connection capacity. As a result, the strengthened roof trusses, supporting exposed hanger rods and fireproofed with intumescent paint, provide the open concept aesthetic that columns could not offer (Figure 6).
