# STRUCTURAL DESIGN

## A Structural Engineer's Survival Guide for Waterproofed Appendages

By P. Travis Sanders, P.E., S.E.,  
Geoff A. Laurin, GC, NACHI  
and Achim A. Gross

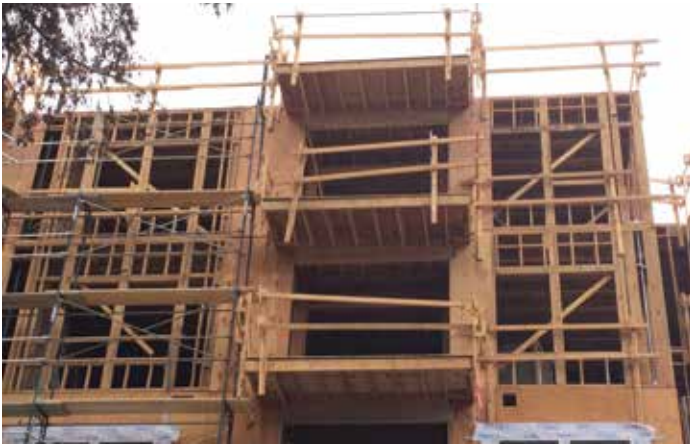
Figure 1. Common wood balcony configuration under construction.

A typical California wood balcony, under construction, is shown in *Figure 1*. Non-treated Douglas-fir lumber joists are designed to cantilever outward from the interior of the building (as extensions of the floor framing), passing through the exterior wall. Ideally, all of the wood is protected by waterproofing and any water on the surface of the deck drains away. In a perfect world, the structural engineer designs the framing, the envelope designer (usually the architect) designs the waterproofing and the contractor builds it so there is never a leak.

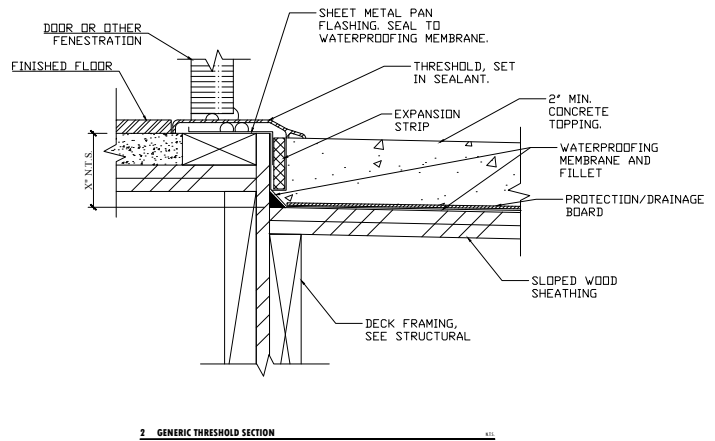
Figure 2. Generic detail.

Figure 2 (page 23) depicts a typical exterior deck-to-wall detail. The membrane is located on the top of the wood sheathing, beneath the concrete topping and turned up the vertical surface to lap beneath the metal pan flashing.

The detail graphically depicts sloped structural wood framing, the wood sheathing, and the concrete topping. The detail also refers the contractor to the structural drawings for the deck framing. These notes could be interpreted as transferring the reader’s attention to those portions of the drawings prepared by the responsible party (which is would be incorrect in almost all instances) or transferring responsibility for computing framing slopes/elevations/clearances on the exterior deck to the structural engineer (which the structural engineer would object to). For many modern light-frame apartment complexes, the drainage design can be a complex exercise which cannot be addressed with simple notes on

Note also how the concrete topping is specified as “2-inch min”; the implication being that the topping can be thicker as needed. But the fixed dimension from the threshold to the top of the structural elements limits the ability to slope the topping by thickening the topping. Inadequate slope of the concrete topping fails to provide Deflection, the first ‘D’. The dimension on the left is “not to scale”, resulting in a detail that makes it look much easier to achieve the minimum thickness and slope than it really is.

This detail also specifies a protection/drainage board over the membrane to protect the membrane from damage during the placement of the concrete topping and other construction activities, as well as to provide a drainage plane. Providing the slope for drainage, the second ‘D’, at the membrane is important as water will work its way beneath the concrete topping.

This detail could easily be constructed with level structural framing if the structural drawings don’t show the required slope and a flat or nearly flat concrete topping due to dimensional restrictions. This detail does not show the configuration of the cantilevered wood joists. However, cantilevering a level floor joist out past the exterior of the building requires specific structural detailing to produce a sloped structure on the cantilever. A cantilevered joist system also results in no elevation change of the structure across the threshold, requiring a different solution for matching finished elevation. The bottom line is that elevations, clearances and surface slopes must all be coordinated by the building envelope (and waterproofing) designer, which is typically not the structural engineer.

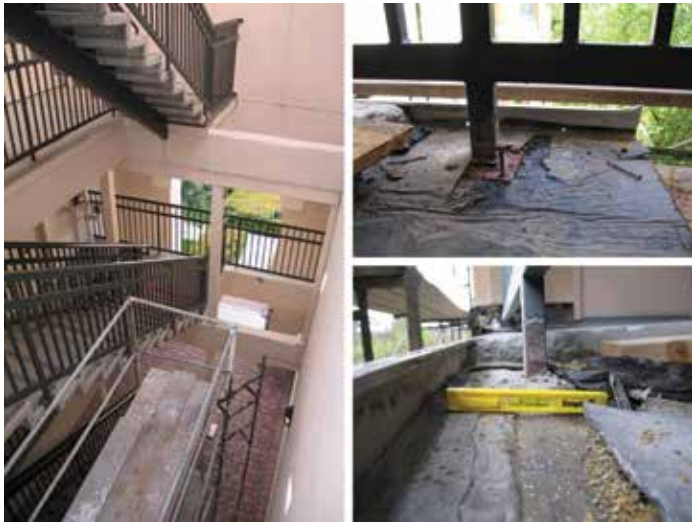
Figure 3. Detail creates a reverse slope.

Figure 3 (page 24) shows a condition where the details at the edge of the concrete topping created a reverse slope in the membrane interrupting the second ‘D’, the drainage path to the weep holes. This stairwell is exterior of the building envelope and exposed to rain, similar to a covered balcony. The buildup of layers of materials, notably the closure plate for the concrete topping, cause the membrane to change slope at the edge of the stairwell. This situation is perhaps a little more difficult for the structural engineer to anticipate and influence in design, but it is certainly something to look for during design coordination phase and during structural observation site visits.

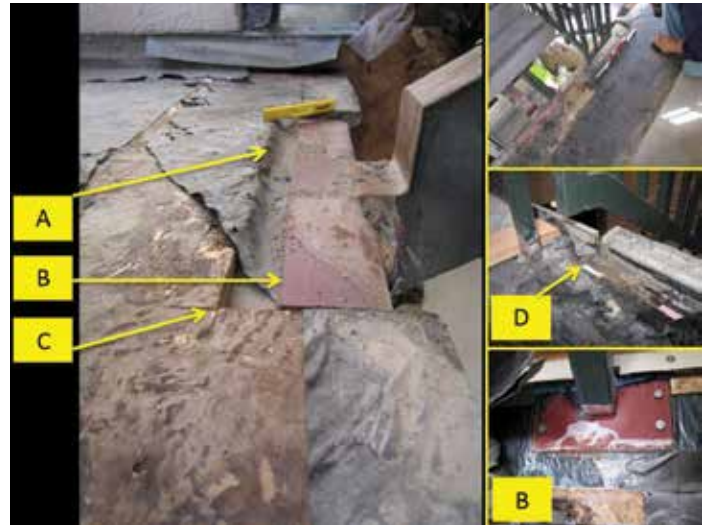
Figure 4. Failed waterproofing at elevated stairway.

Figure 4 (page 24) depicts an elevated stairway exposed as part of an investigation associated with litigation. The stairs were comprised of steel stringers and pre-cast concrete treads. The guardrails were comprised of steel pickets lag-screwed into the supporting wood framing. The waterproofing membrane and concrete topping system was conceptually intended to emulate a “bird-bath” with perimeter weep-holes intended to drain water reaching the membrane level. It was discovered that the waterproofing design and installation fell well below the performance standard of providing positive drainage to prevent ponding and preventing moisture from penetrating the building envelope.

Issues observed within Figure 4 include:

- A) Inadequate slope to drain, the second ‘D’. Areas of “reverse-slope”.
- B) Waterproofing traverses rough/ sharp edges.
- C) Horizontal OSB notched for steel plate. Water directed *behind* cladding.
- D) Waterproofing spans dissimilar materials.

Without adequate waterproofing, the supporting structural element was exposed to excessive amounts of moisture. The

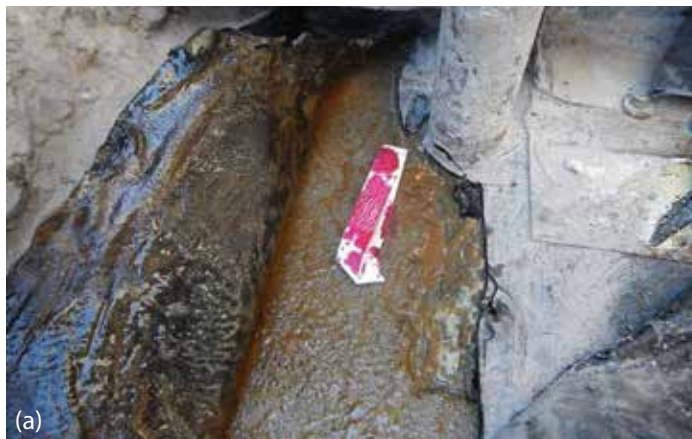
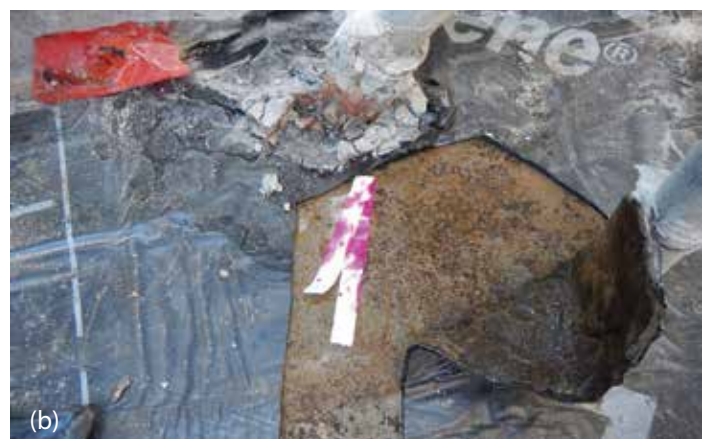
Figures 5a and 5b. Penetrations.

Appendages are the intersection of the interior and exterior, and as such require some elements to cross the moisture barrier. Penetrations such as those shown in *Figures 5a* and *5b* (page 24) occur in both the vertical barrier on the wall and horizontal barrier on the surface of the appendage. Penetrations may be unavoidable, but they can be reduced and located and designed strategically to better integrate with the waterproofing system. Providing Deflection and Drainage (the first and second Ds) to direct water away from penetrations is the first line of defense at penetrations. Providing Drying and Durability (the third and fourth Ds) can go a long way toward mitigating minor, intermittent water intrusions and prolong the life of the structure.

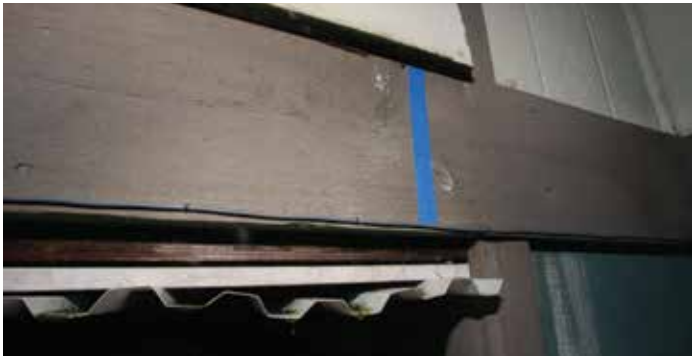
Figure 6. Fascia board over edge-beam.

*Figure 6* show a fascia board over the face of a multi-ply edge beam at the edge of a deck and *Figure 7* shows the structural framing once the fascia has been removed. Further investigation revealed similar concealed deterioration

between the plies of the beam. This deck was not waterproofed, but it illustrates how multi-ply elements can trap moisture and conceal damage. Using a single, solid structural member is a more durable solution that eliminates the faying surface that traps moisture between the plies. Adding vertically oriented spacers that provide a drainage space between the fascia and the beam could have significantly improved the performance of this deck.

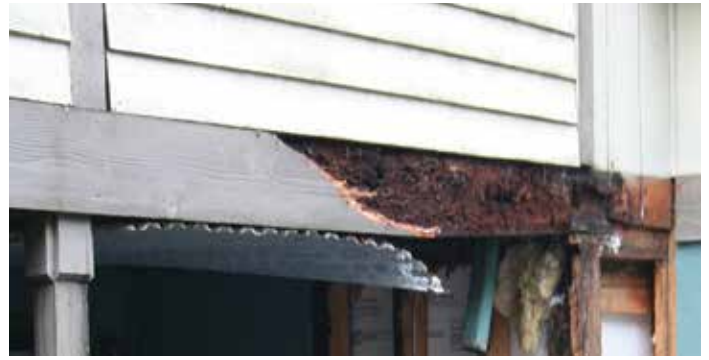
Figure 7. Structural framing (fascia removed from assembly shown in Figure 6).

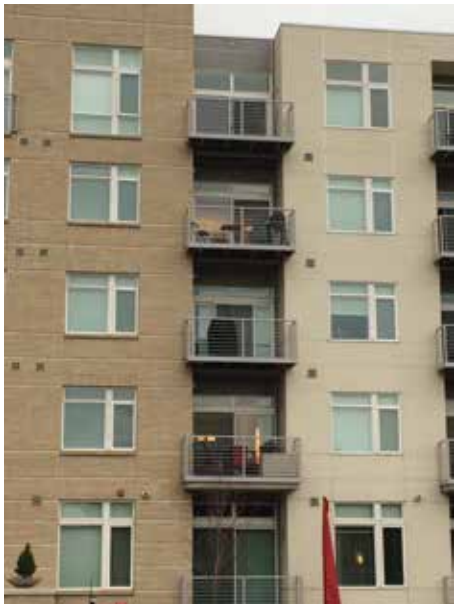
Figure 8. Steel balconies.

Why not just use steel? *Figure 8* shows steel balconies in Colorado. The setback of the exterior walls allows for a structural framing system alternate to cantilevering of the interior floor joists. The choice of material is the fourth ‘D’, durability.

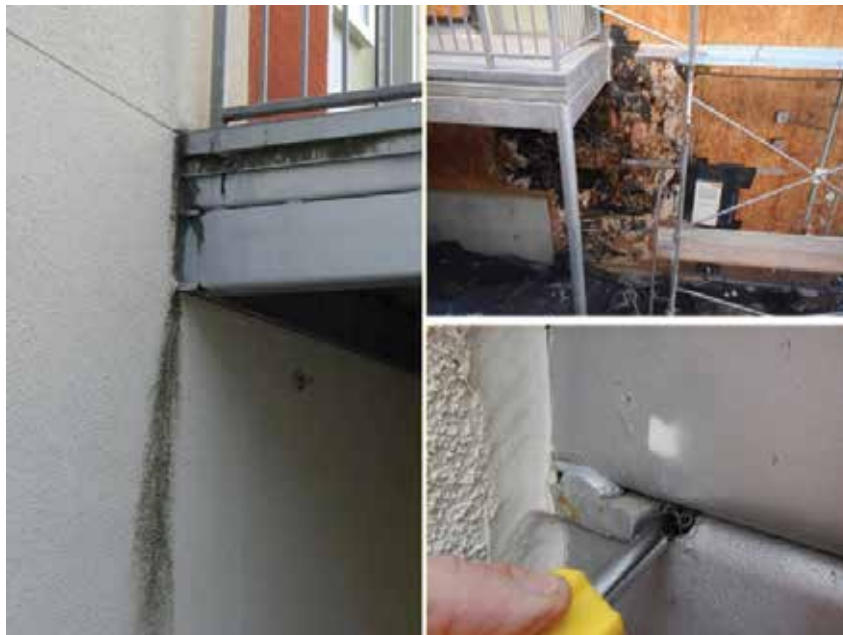
Figure 9. Steel stair landing. Images are actually taken from multiple examples of this landing type.

However, to highlight that steel is not a panacea and the difficulty of integrating structural appendages, *Figure 9* depicts a pre-fabricated steel stair tower bolted to a wood-frame building. The project requirements featured mock-ups, quality-control inspections, coordinated design and a specialty waterproofing consultant, yet this element failed to perform. The openings created by coped structural connections provided a path for water to access the interiors of the elements. The structural engineer can’t blame that on the architect.
