# STRUCTURAL REHABILITATION

## Thinking Outside the Wooden Box

Creative Problem Solving for Repairing Wood Structures

By Kimberlee McKitish, P.E.,  
LEED Green Associate

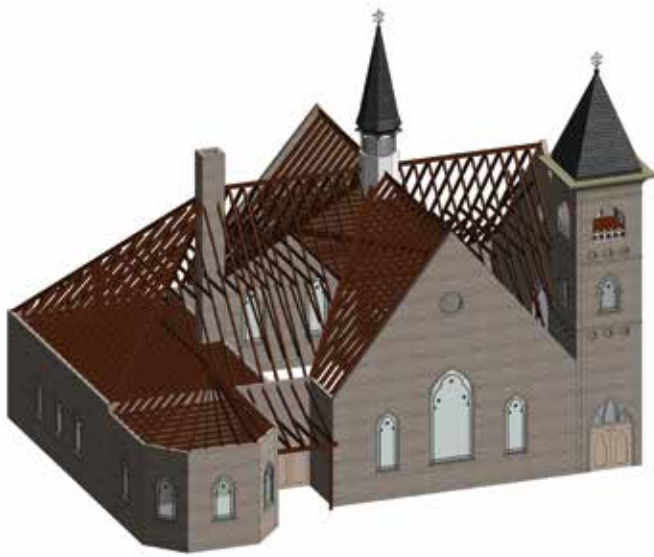
Figure 2. Ceiling and roof framing from the church in Case Study one.

The overall construction is a multi-wythe masonry bearing wall with wood roof construction. Valley and ridge beams bear on the walls and support stick built trusses to create a vaulted

ceiling space, attic floor, and roof rafters. The front auxiliary space and the front porch are framed independently. *Figure 2* presents a 3D visual of the roof and ceiling framing.

During NuTec’s survey, several typical defects were observed throughout the structure. Cracks were noted in all of the ridge and valley beams and many of the rafters and vertical bracing members. These cracks reduced the expected load-carrying capacity of the members. Bowing vertical bracing members, indicating significant load-demand in main members, were common across the structure and appeared to be due to the additional load from the slate roof.

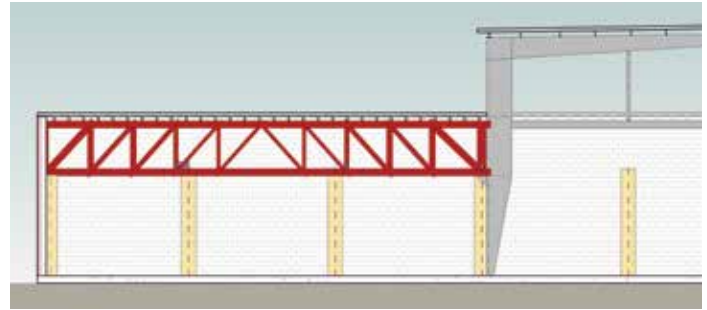
Figure 3. Section of the pre-engineered metal bay and wood truss bay in the building from Case Study two.

The overall construction of the building is a multi-wythe masonry bearing wall with integral piers. A raised center bay of 60-foot long pre-engineered steel frames was installed after the original building was constructed. Wood trusses supported by the steel frames span approximately 60 feet and wood purlins, 20 feet long, span between them. There are a few interior walls built next to, or around the existing trusses. Refer to *Figure 3* for a section displaying the truss construction and raised center bay.

During the survey, typical defects were noted throughout the structure. The defects noticed most frequently were checks in the top and bottom of many members through the member connections. These connections were comprised of 4-inch diameter split-rings. The checks at the member ends reduced the capacity of the connections. Some members had cracks against the wood grain, and most of the members had cracks through a portion of

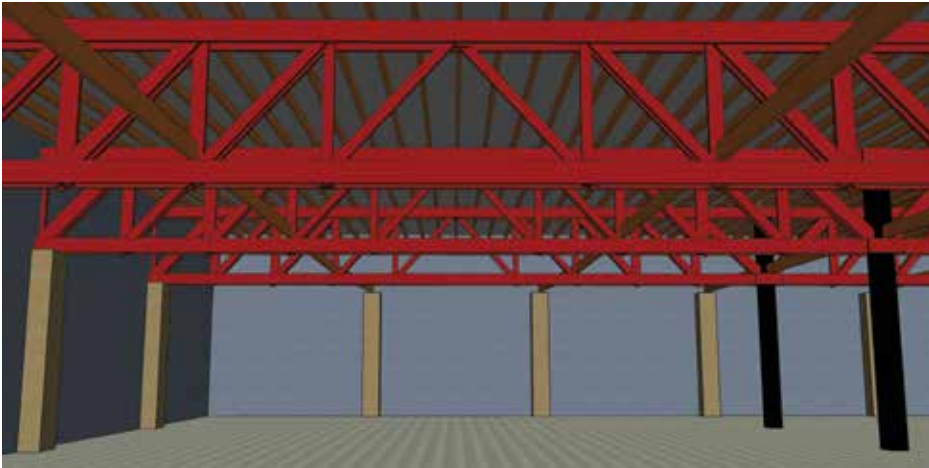
Figure 4. Interior view of the wood trusses in the building from Case Study three.

Again, this is a single-story industrial building. The overall construction of the building is a multi-wythe masonry bearing wall with integral piers and interior wood columns. The piers and interior wood columns support the wood trusses and span approximately 60 feet with 20-foot wood purlins spanning between the trusses. *Figure 4* (page 68) shows a 3D interior view of the building with the wood trusses highlighted in red.

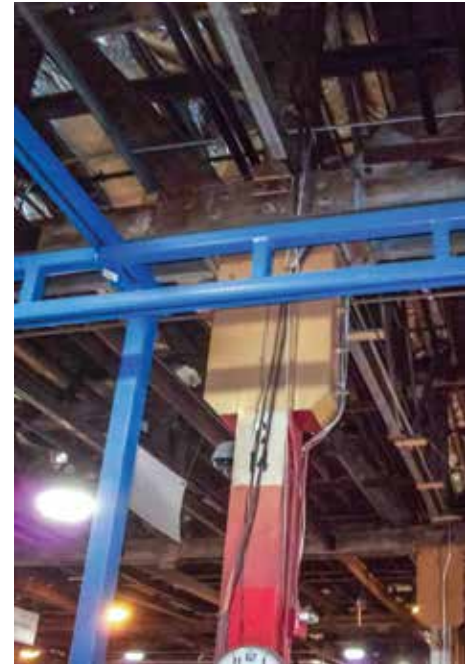
Figure 5. An example of the utilities in the building from Case Study three.

During the survey, typical defects, similar to the previous case study, were noted throughout the structure. Also, the structure was littered with existing utilities and crane runway beams as illustrated in *Figure 5* (page 68). The owner instructed the team not to disturb any of the existing utilities or crane beams, or disrupt the operation of the building. All of these existing
