## Dolphin Towers Condominium Remediation

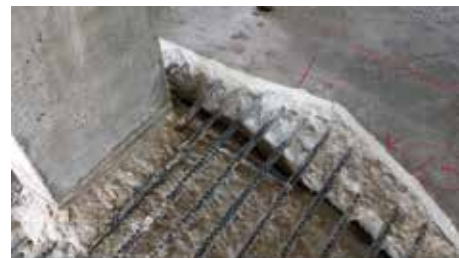
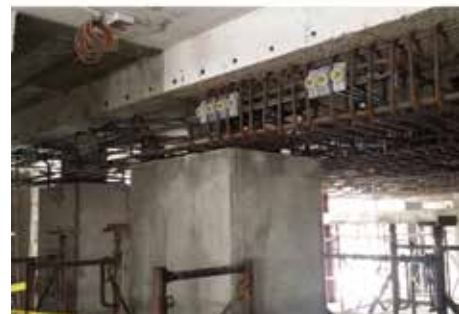
The strengthening of the failed 24-inch thick concrete transfer slab required the installation of continuous drop panels around the entire tower building footprint and under the new tower shearwalls, along with the enlargement of the garage tower columns and the installation of a bonded overlay over the entire fourth level transfer slab. Depth and size of drop panels were determined to eliminate punching shear and transfer slab overstress, and prevent excessive residual stress in the existing concrete slabs. Post-tensioning reinforcing was added to the drop panels to reduce mild steel reinforcing, reduce shear and residual stresses, and control deflection in the existing transfer slab. The design of the transfer slab considered the existing transfer slab, 15-inch drop panels, and 6-inch concrete overlay to be one composite section throughout the entire floor footprint. To assure that the drop panels, existing transfer slab, and overlay worked as a composite section, it was necessary to install shear lugs throughout the drop panel footprint anchoring these 3 elements together. The shear lugs consisted of (610) 6 x 3/4-inch steel channels installed in 8-inch diameter holes that were drill thru the existing 24-inch slab. Where new tower shearwalls stopped on top and at the bottom of the 4<sup>th</sup> level transfer slab, the horizontal shear stress and uplift were transferred to the new composite slab by installing rebar dowels in (86) 5-inch diameter cores drilled thru the 24-inch slab. The 8-inch diameter shear-lug holes and 5-inch diameter shearwall cores provided a place to pour the drop panel self-consolidating concrete which created a natural head pressure to assure full volume placement of the drop panel concrete. The bonded overlay included sufficient flexural reinforcing to resist all negative moments in the composite transfer slab.

To increase the existing foundation capacity, (168) 30-ton helical piles were installed and tied to the existing pile caps. MC designed

numerous eccentric pile caps to keep all new piles at the tower perimeter inside the garage footprint, allowing occupancy of the retail shops to remain undisturbed. Since access to the FP&L electric room was forbidden, MC designed a 2-story tall 60-foot long post-tensioned beam to transfer the overstress portion of the column and foundation in the electric room to the adjacent building columns which were strengthened for the additional load.
