STRUCTURAL PERFORMANCE

The 2015 Nepal Earthquake

Building Assessment and Masonry Construction Performance

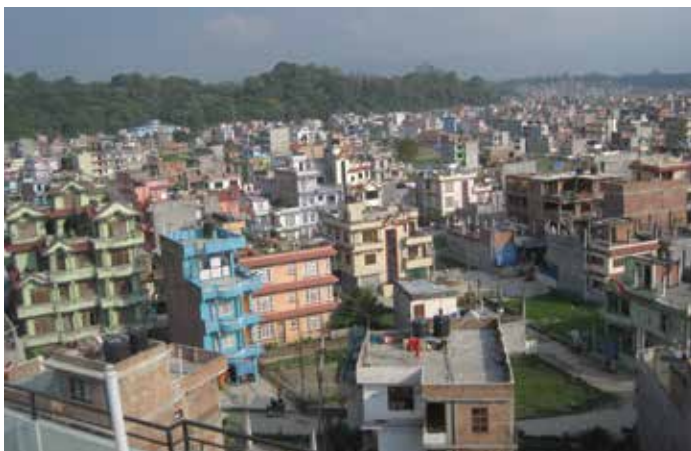
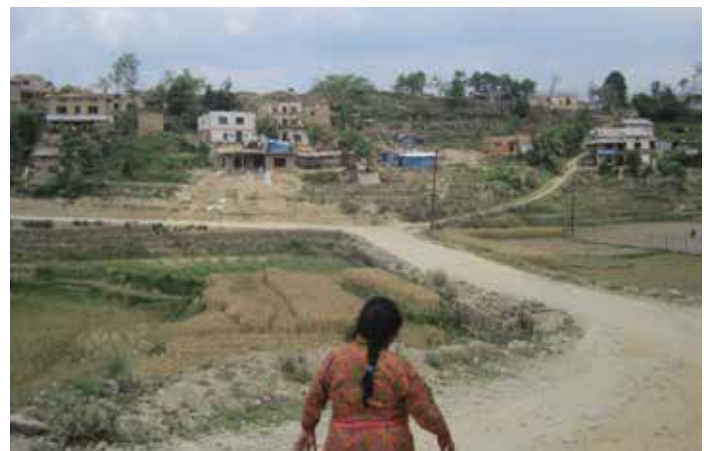
Figure 4. Building construction in urban and rural areas.

As seen in *Figure 4*, buildings in the urban areas exceed the three story requirement. In the rural areas, buildings are either rubble stone in mud mortar or adobe in mud mortar. Some of the multi-level construction has bamboo floors. The MRT covers rubble stone but not adobe construction.

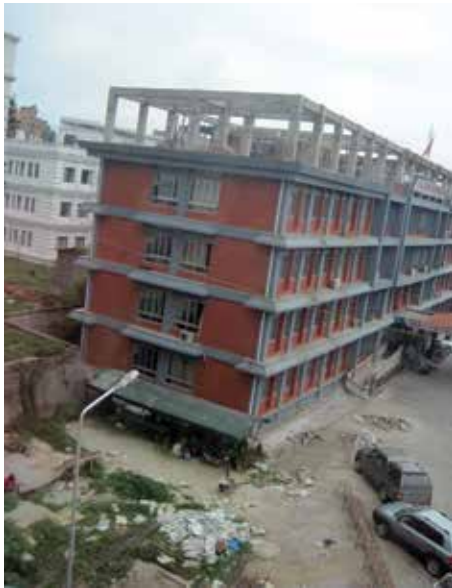
Figure 5. Brick in cement mortar infill in RC frame systems in Kathmandu.

Where the guidelines of the MRT were followed or where buildings were engineered, there was minimal damage to the infill brick systems as shown in *Figure 5*.

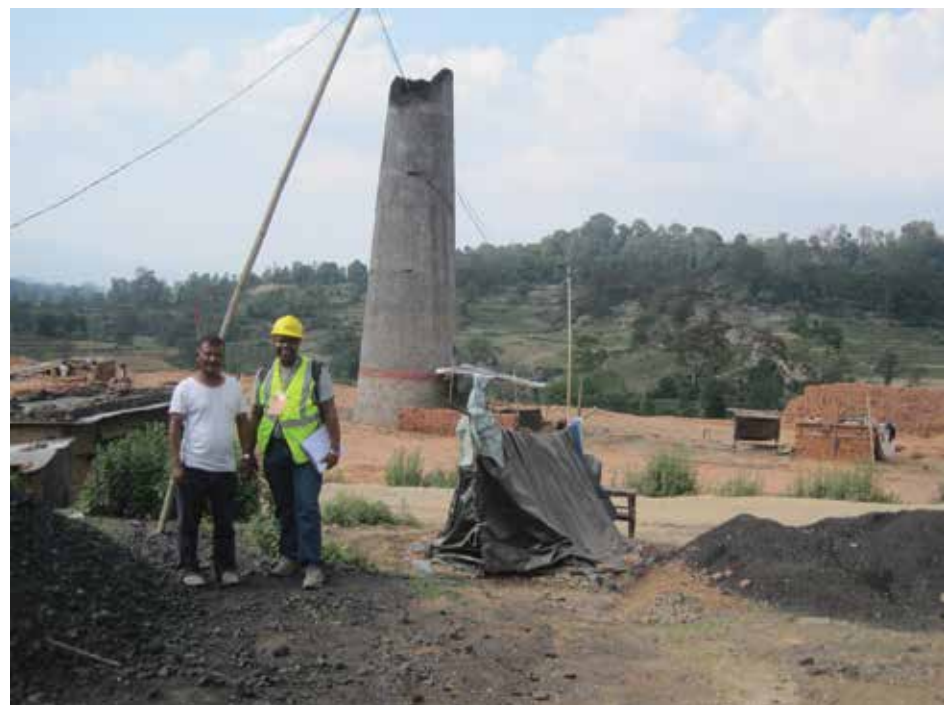
run. *Figure 6* shows a photograph at a brick plant site. The unreinforced brick kiln was also damaged by the earthquake.

Figure 6. Many adobe and brick plant sites are located in the Kathmandu Valley.

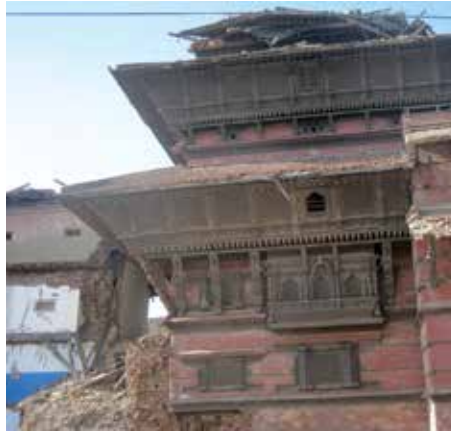
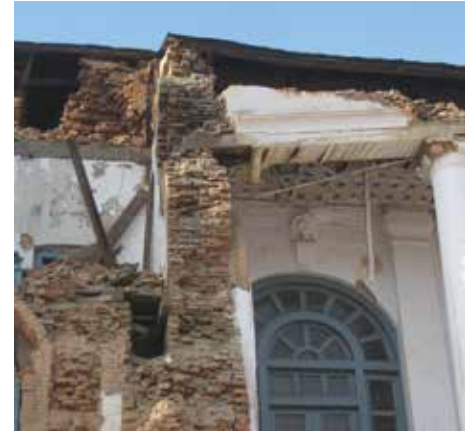
The residential and historical floor systems are either a) unreinforced mud or cement plaster over wooden planks and floor joists, or b) mud plaster on bamboo floor systems. The roofs consist of either a) fired clay tiles over wooden planks over wood roof joist with mud mortar, or b) corrugated metal deck over wood joists. The foundation systems consist of rubble stone. Bricks used as infill in the reinforced concrete frame systems were all unreinforced. The bearing wall brick and mud mortar buildings were heavily damaged, as seen in *Figure 7*.

Brick and adobe are the materials of choice and the only sustainable construction materials in Nepal, especially in the rural villages located in remote mountainous sites that lack adequate road access. Based on observations from the building assessments after the 2015 earthquakes, the multi-story brick and mud mortar buildings performed very poorly. The brick infills in RC frame buildings performed generally well. The dated historic monuments, palaces and temple structures, most of which are recognized as UNESCO heritage sites, performed poorly.

Figure 7. URM wall failure of the Kathmandu Durbar square.

- 5) Develop details and train Nepali professionals on how to repair the massive brick and mud mortar historic structures.
- 6) Provide recommendations for the implementation of regulatory processes for design-and-construction permitting of new construction and repairs.

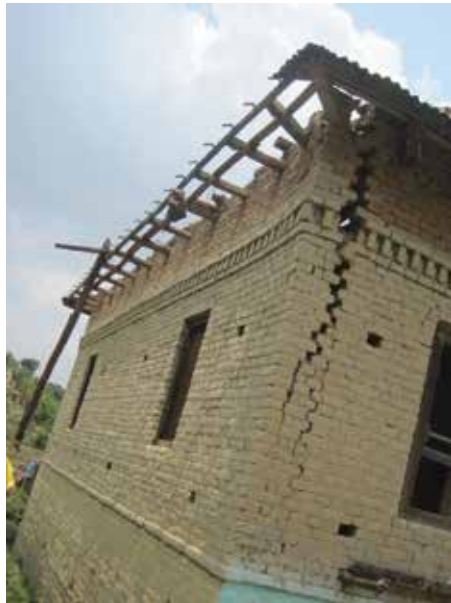
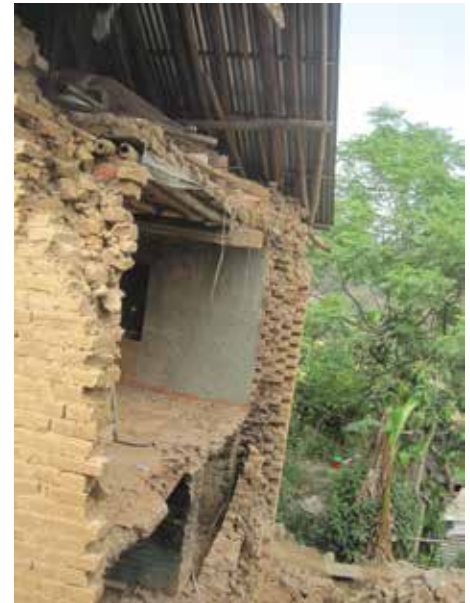
In URM buildings located mostly in the rural villages, failures were triggered by out-of-plane failure of the exterior walls due to a lack of positive connection of the floors and the walls, as shown in *Figure 8*. There was also disconnection of interior walls at the corners due to lack of proper connection details.

Figure 8. Out-of-plane failure of exterior adobe walls.

- 3) Develop details for adequately anchoring exterior walls of load bearing structures, including parapets to roof and floor diaphragms for new construction, and repair of existing structures.
