Robert F. Kennedy Bridge

SEISMIC EVALUATION AND RETROFIT DESIGN

By Edith Coco, P.E. and Qi Ye, P.E.

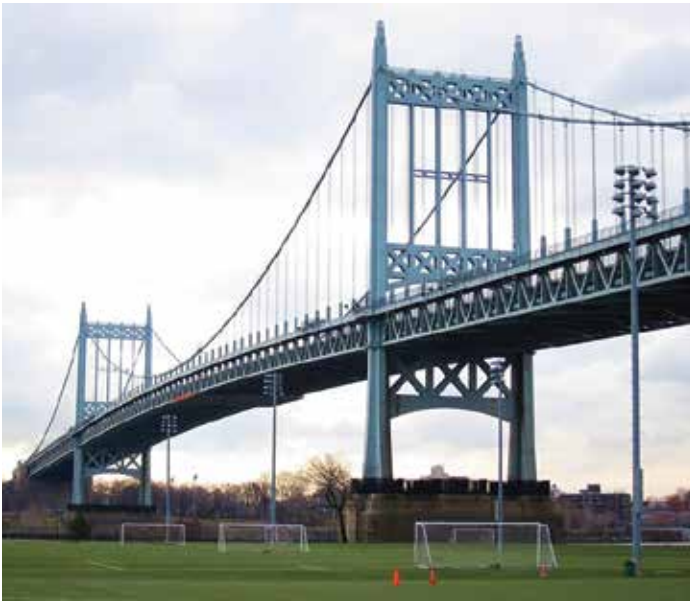
Figure 2. Suspended span. Courtesy of Thornton Tomasetti Weidlinger.

Othmar Ammann's Robert F. Kennedy Bridge (formerly the Triborough Bridge) is a complex of nearly two dozen bridge structures and approach viaducts and ramps, including the Harlem River Lift, the Bronx Kills Truss, and a suspended span over the East River (Figures 1, 2, 3 and 4). The historic bridge complex, one of the largest in the United States, connects the New York boroughs of Manhattan, Queens, and the Bronx, and carries 200,000 vehicles per day. As part of MTA Bridges and Tunnels capital program to ensure the safety of the bridge during earthquakes and strong winds, Thornton Tomasetti Weidlinger Transportation, in a joint venture with T.Y. Lin International, performed seismic and wind evaluations of these structures. This article discusses the seismic evaluation and conceptual retrofit.

Overall, the suspended span performed well for both Lower and Upper earthquake events and evaluation revealed minor allowable yielding to secondary members such as laterals.

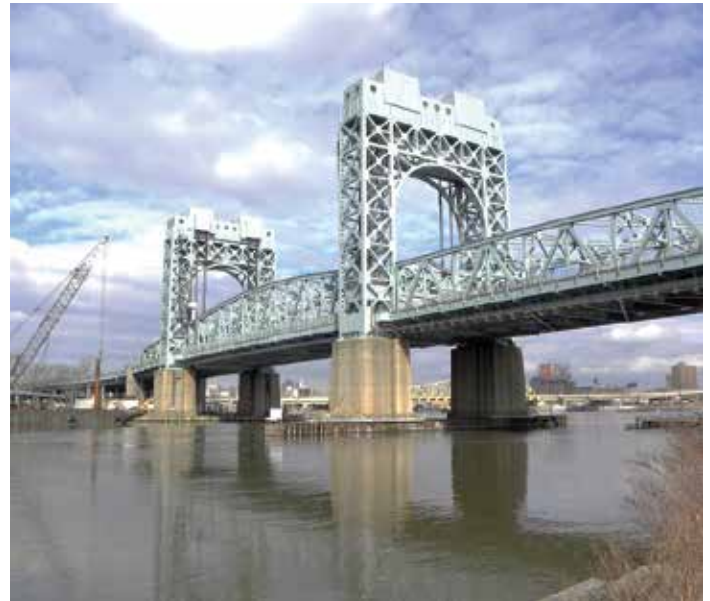
Figure 3. Harlem River Lift Bridge. Courtesy of T.Y. Lin International.

Vulnerabilities in the Harlem River Lift Bridge were primarily found in the existing steel structure and bearings.

It was recommended that some of the tower diagonals, counterweight guides, diaphragms, and rails be strengthened with steel plates or replaced. It was also recommended that existing riveted connections be replaced with high strength bolts. Some of the elastomeric bearings on the tower span were found to be vulnerable to lateral capacity and required replacement with higher strength bearings.

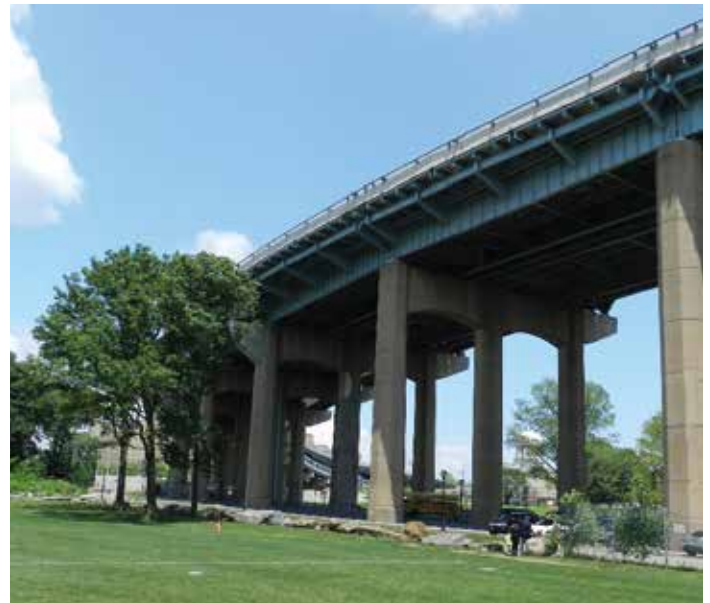
Figure 4. Ward's Island viaduct structure. Courtesy of Thornton Tomasetti Weidlinger.

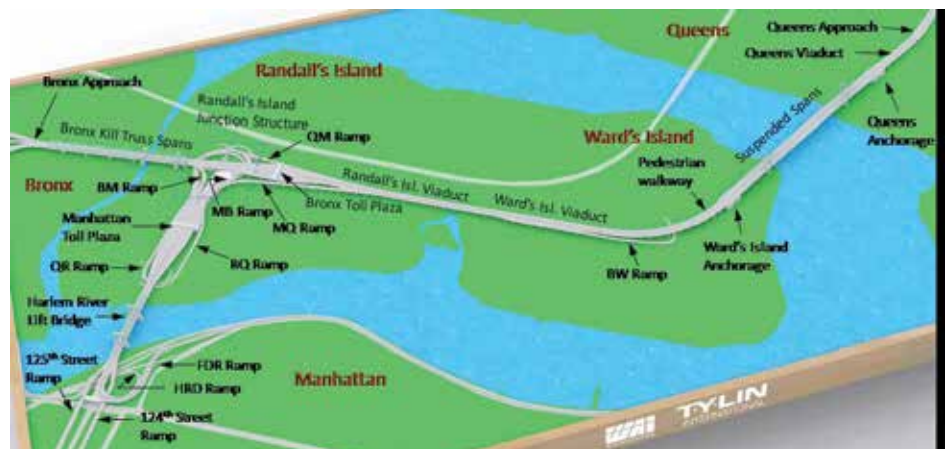
Figure 5. Robert F. Kennedy Complex. Courtesy of Thornton Tomasetti Weidlinger.

During the past 70+ years, the bridge has been reconstructed many times, significantly altering the bridge complex (Figure 5). Starting in the early 1990s, Triborough Bridge and Tunnel Authority (TBTA) initiated a long-term \$1 billion program to rehabilitate the bridge. The majority of these contracts were deck and bearing replacement. A thorough understanding of the history, geology and structural details of the bridge was vital for proper finite element modeling and analysis of the superstructure and foundations. The project team conducted extensive research to obtain all relevant drawings of the original construction of the bridge and subsequent modifications.

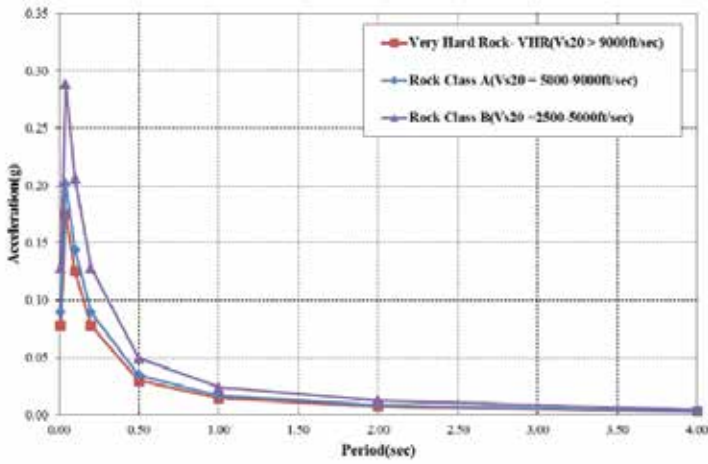
Figure 6. Rock-horizontal design spectra for New York Downstate Zone 1000-year return period. Courtesy of New York State Department of Transportation.

New York City's bridges are categorized as either "Critical", "Essential", or "Other" based on a bridge's importance and seismic performance objectives. Because the RFK Bridge is a vital link between the New York City boroughs of Queens, Manhattan, and the Bronx, it is categorized as Critical. In accordance with the 2014 New York City DOT *Seismic Criteria Design Guidelines*, the RFK Bridge must be analyzed and designed for two earthquake levels (Figures 6 and 7, page 27).

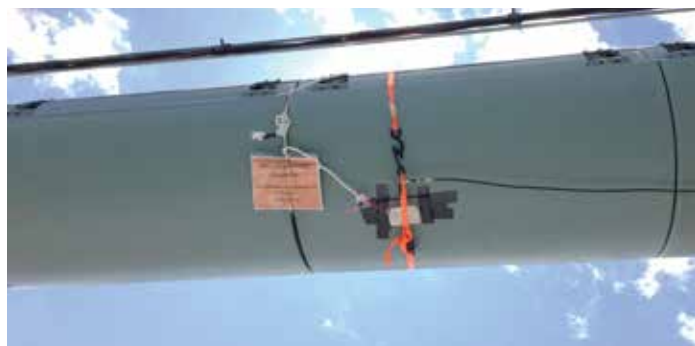
Figure 8 and 9. Tri-axial accelerometers attached to the bridge. Courtesy of Thornton Tomasetti Weidlinger.

A field vibration monitoring of the suspended spans, Harlem River Lift Span and Bronx Kills Truss was conducted to collect field measurements. Tri-axial accelerometers were deployed at different locations on the bridge to measure vibration responses in the longitudinal, transverse and vertical directions. They were mounted along the truss chords, cables, and towers (Figures 8 and 9, page 27). Measurements were used to identify the dynamic characteristics of the bridge including natural frequencies of vibration and associated mode shapes and damping ratios. These measurements were then used to help calibrate the finite element models of the bridge to reflect the actual behavior better.

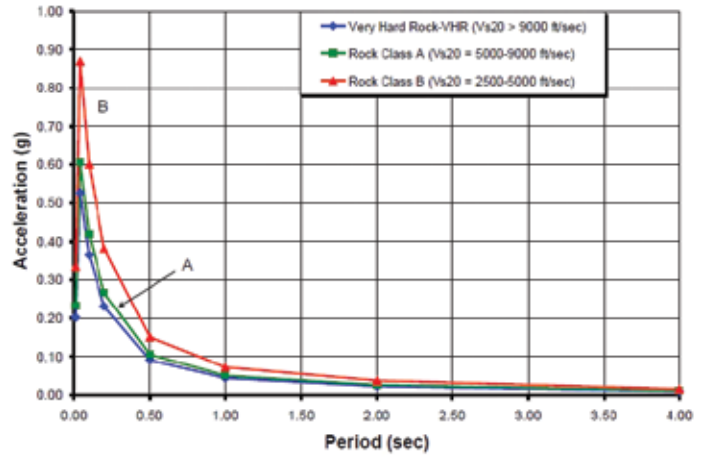
Figure 7. Rock-horizontal design spectra for New York Downstate Zone 2500-year return period. Courtesy of New York State Department of Transportation.
