STRUCTURAL PRACTICES

Development Along Old Party Walls

By Dan Eschenasy, P.E., SECB, FSEI

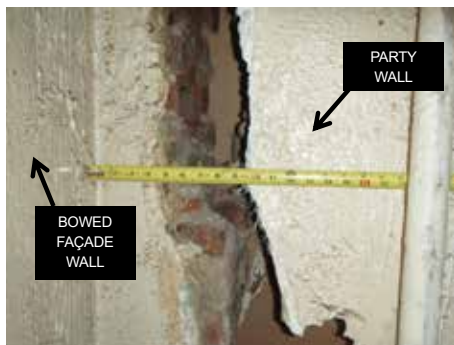
Figure 1. Crack in party wall.

that the facade was common to two attached buildings. The interior inspection revealed a 5-inch crack (Figure 1) that had developed along the line where the party wall used to be keyed into the facade. Each building was owned separately, and the owners could not reach an agreement to repair the crack. The fire separation was compromised and the collapse of the facade onto the street was imminent. As the engineers could not find a solution to arrest the evolution of the bowing, the facade was ordered demolished.

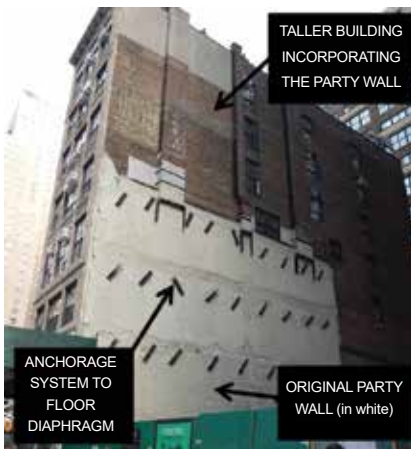
Figure 2. Building incorporating old party wall.

In older New York City neighborhoods, as a result of successive development on the same site, it is not uncommon to find party walls extending or incorporating older party walls (Figure 2). Depending on the shape of the original building, these remnant walls may not be continuous or may not span the entire length of the more recent wall, and may be missed by probes.

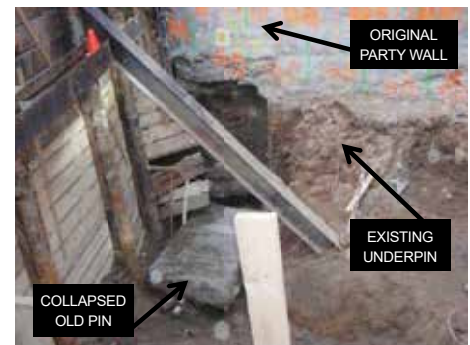
Figure 3. Old pin collapsed.

accommodate the deeper basement of the loft. In 2014, the remaining tenement was demolished and excavation for a new building commenced. The basement of this new development ran even deeper than the loft's basement, and an underpinning installation started. It appeared that the contractor was not fully aware that he was, in fact, undermining an older underpinning job. While he was digging, an old unattached pin overturned and collapsed with tragic consequences (Figure 3).

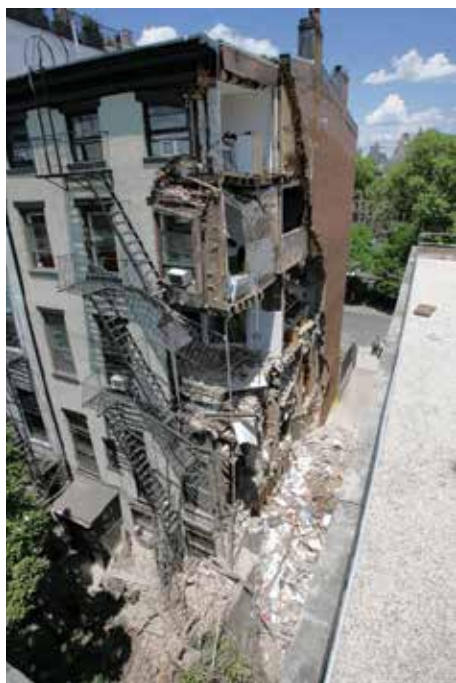
Figure 4. Wall collapsed due to lack of anchorage to the diaphragm.

Since 1968, the NYCBC required: "where the floor beams of the adjacent building bear on the party wall, the person causing the demolition shall ascertain that such beams are anchored into the wall and, where such anchorage is lacking, shall provide anchorage or otherwise brace the standing wall." The validity of this requirement was confirmed by several recent wall collapse investigations that determined that these party walls were not anchored when the adjoining building was demolished (Figure 4). As explained in the *Collapse of Masonry Structures under Non-Extreme Loads* [Eschenasy, Second Applied Technology Council's (ATC) & the Structural Engineering Institute's (SEI) Conference on Improving the Seismic Performance of Existing Buildings and Other Structures], forensic investigations determined that the collapses were not due to over-stress but to loss of stability.

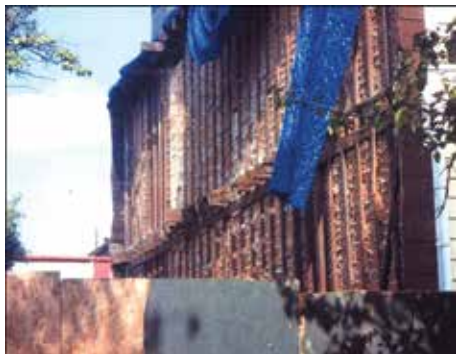
Figure 5. Noggin wall.

Demolition adjoining "nogging" party walls poses special difficulties. The noggin (or nogging) wall is an assembly where the space between wood studs is filled with random bricks (Figure 5). Building regulations up to 1916 allowed this type of construction to be used as a building separation. Today, there are still a good number of such walls that exist. Vinyl siding has been, and still is today, the owners' primary choice for weather proofing noggin walls. Investigations of several nogging wall collapses blamed significant rot of the studs resulting from rainwater that had penetrated behind the vinyl cladding. In contrast to regular wood stud walls where the air around the studs allows evaporation of the water, the bricks that are set tight against the studs preclude evaporation. Even worse,

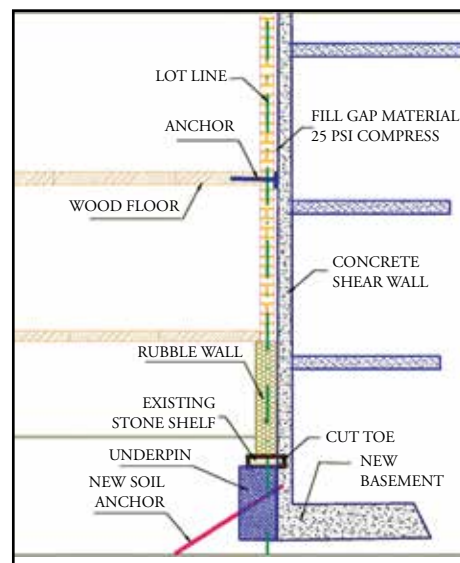
Figure 6. Typical lot line condition.

Typically, unreinforced masonry walls were supported by a continuous rubble stone wall that was approximately six inches wider than the wall above. Some weaker soils required this rubble wall be placed on an enlarged base – on a stepped masonry, stone, or concrete shelf – at least six inches wider than the wall above. Obviously, such enlargement encroaches on the intended location of the new foundation wall (*Figure 6*).
