A WORLD-CLASS MAKEOVER

Renovating a Hidden Treasure

By Russell Kehl, S.E., Melineh Zomorrodian, S.E., and Maria Mohammed, P.E.

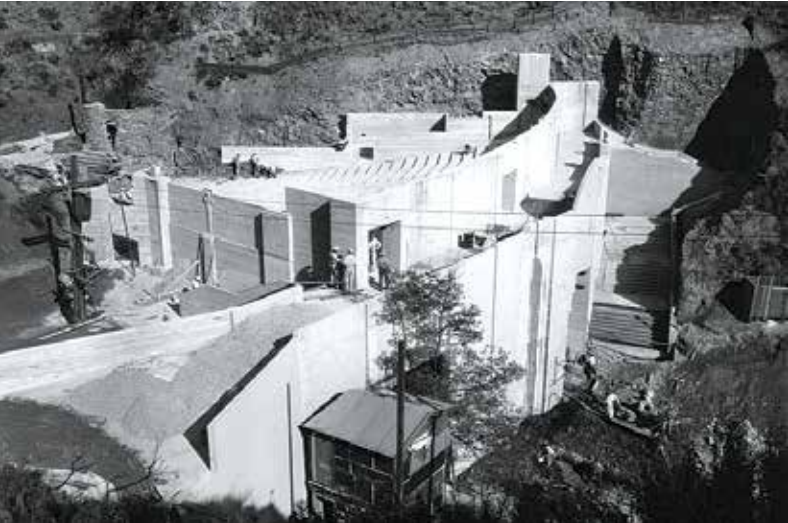
Figure 1. The theater reconstruction out of reinforced concrete (1931). Courtesy of the Los Angeles Public Library Photo Collection.

built as a wood framed structure in 1920 and destroyed by a brush fire in 1929, the Ford Amphitheatre was reconstructed out of reinforced concrete in 1931 (Figure 1). As the theatre structure aged, it became evident that improvements were needed. At the beginning of the renovation project, the team spent many hours on site trying to understand how the existing building structure fit within the site topography. The first challenge was understanding the existing building layout and structure since no original structural drawings were available. The lack of existing drawings meant the steel reinforcing in the concrete elements remained a mystery. The analysis of all existing concrete structural elements was a challenge throughout the project.

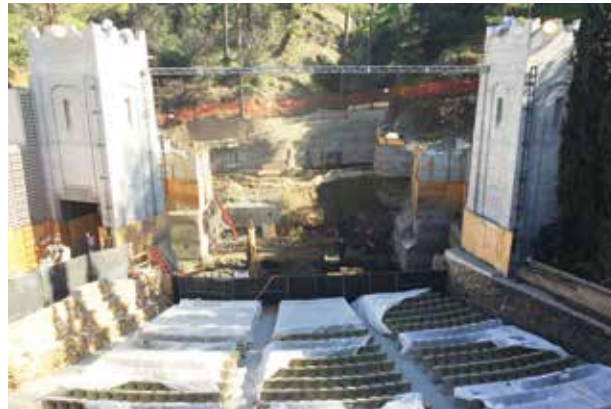
Figure 2. Construction of new stepped retaining walls behind the stage. Courtesy of Levin & Associates Architects.

The canyon hillside is the backdrop for the amphitheater stage where a series of stepped stone retaining walls behind the stage were failing. It became clear that rebuilding the retaining walls was necessary. A significant amount of time was spent working with the contractor to come up with a design and layout that could be built on the hillside, as the retaining walls needed to step down towards the stage following the steep slope of the canyon. Coordinating access to transport construction materials and heavy machinery required outside-the-box thinking. The final solution used a large crane to lift construction materials and machinery from the staging area over the existing concrete stage tower onto the canyon hillside where the retaining walls were being constructed (Figure 2).

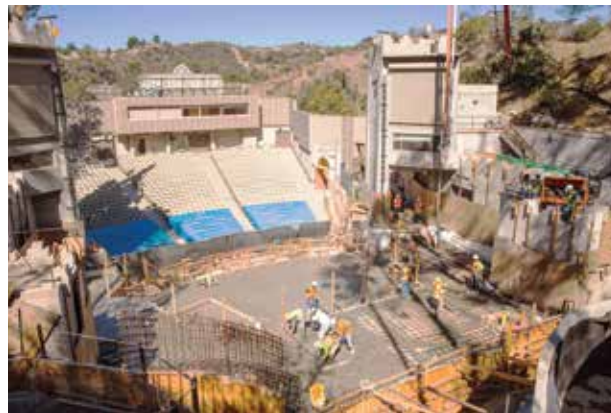
Figure 3. Construction of the new reinforced concrete stage. Courtesy of Levin & Associates Architects.

performers. The new reinforced concrete stage was constructed with concrete retaining walls around the perimeter (Figure 3). The new stage retaining walls resist surcharge loads from the existing stage-left and stage-right towers and the newly constructed hillside retaining walls. Several potholes were dug adjacent to the existing structure to discover the size and depth of existing footings to determine the surcharge loading from the structure.

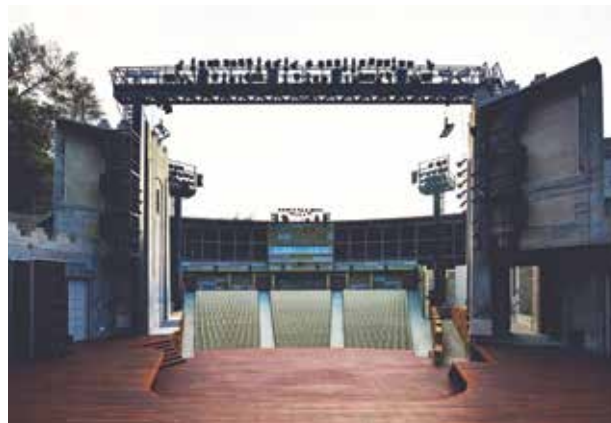
Figure 4. New sound wall and control booth behind the amphitheater.

To improve the experience of both performers and audiences, the team also designed a new sound wall and control booth behind the amphitheater, along with multiple new lighting towers located on either side of the stage and the seating area (Figure 4). The twenty-five-foot tall sound wall improved the acoustics of the venue and shielded the theater from Hollywood Freeway noise. Early in the design process, the decision was made to work with a design/build contractor to design the aluminum sound wall. By using aluminum, the weight of the sound wall was reduced significantly. However, the large wall area and narrow depth created substantial overturning forces due to wind and seismic loads. Structural Focus designed a new structural steel support system for the sound wall while coordinating with the Texas-based design-build engineer. The new frames support the sound wall over the existing twelve-foot-tall historic concrete wall behind the seating area. Support columns penetrate through the amphitheater concrete slab and extend into the space below. Locations of the new sound wall support columns above and below the amphitheater were coordinated to avoid disrupting the existing concrete framing below. Without original building drawings and with a limited exploratory investigation, assumptions were made about the layout of the existing building foundations during the design phase. This led to more coordination and modifications during construction.

There were several complexities associated with the design of the new lighting towers. In addition to catwalk lighting towers on either side of the new stage, cantilevered lighting towers were added on the right and the left side of the amphitheater seating area (Figure 4). The forty-five-foot-tall towers added significant foundation reactions to the complex hillside foundation system. The house-left tower required the construction of a new retaining wall below the amphitheater to resist surcharge loads.

A new proscenium truss spans sixty-five feet over the stage between the two existing concrete towers on either side (Figure 4). It is used

to support lighting fixtures, banners, two 3,000-pound speakers (one at each end), and other theatrical equipment. The truss is supported on new HSS 20x20 columns connected to the towers for lateral support. Locating the new supporting columns adjacent and inside the existing concrete towers required coordination with the design team to limit the impact on the interior space of the towers and the historic characteristics of the amphitheater.

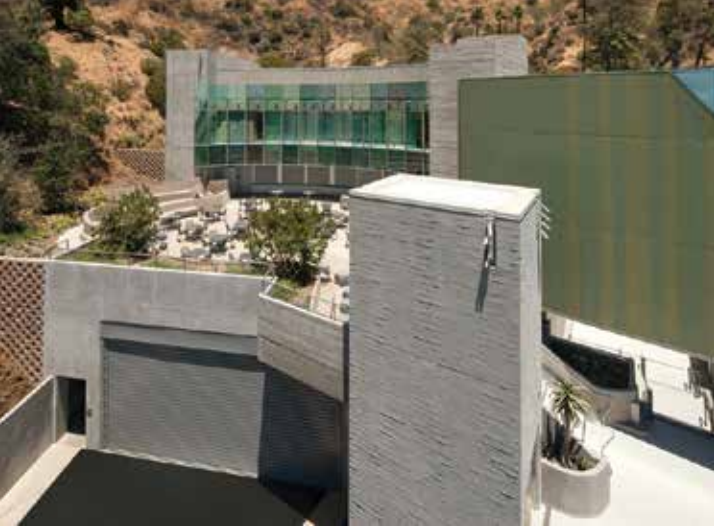
Figure 5. The new Ford Terrace building on the north side of the amphitheater. Courtesy of Tom Bonner Photography.

The new Ford Terrace building is tucked into the canyon hillside and constructed on the north side of the amphitheater with a seismic joint between the existing historic building and the new structure (Figure 5, page 28). A new stair and elevator tower between the amphitheater and the new structure provides access to both buildings. The three-story building includes a loading dock at the bottom with direct access to the stage, a terrace with a concession stand at the second level, and office space at the third level. The roof houses mechanical units for both the amphitheater and the Ford Terrace building (Figure 5). A mechanical screen wraps around the roof to hide the equipment.

Similar to the new stage retaining walls, lateral soil pressure from the hillside was accounted for during the calculation of structural loads on the Ford Terrace building. The new building was designed to be structurally independent from the existing amphitheater, but there are several locations where the two buildings touch and isolation joints were required. This included a slide bearing joint at an exterior stair and a joint between adjacent retaining walls. The accelerated project schedule required careful coordination between the depth of the new building footings and the new stair and elevator tower to avoid shoring and surcharge loading on the amphitheater retaining walls. Also, vertical clearance requirements for truck access to the loading dock located below the terrace slab required that the location of the concrete columns that support the terrace slab,
