# structural REHABILITATION

## Wood Bowstring Trusses

### Part 1: Investigation, Repair, and Rehabilitation

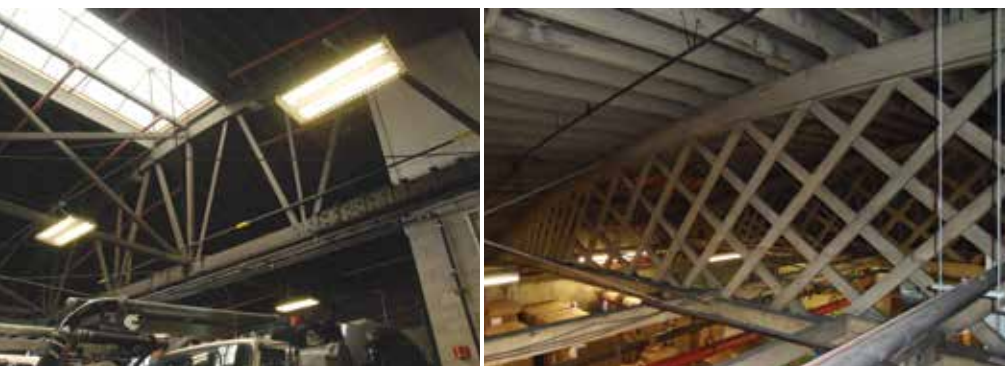
*Figure 1. Bowstring trusses in which web elements are discrete (left) and are a lattice system (right).*

Bowstring trusses typically feature a parabolically shaped top chord constructed of several wood elements (laminations) mechanically connected through the depth of the member. The bottom chord is often constructed of straight timber members with bolted splices. Both the top and bottom chords consist of two parallel members separated by a gap. The gap accommodates connections to vertical and diagonal web members which frame in between the chord members. The web elements are either discrete members or are a lattice system (continuous arrangement of web members) (*Figure 1*). The top and bottom chords are typically connected by a U-shaped

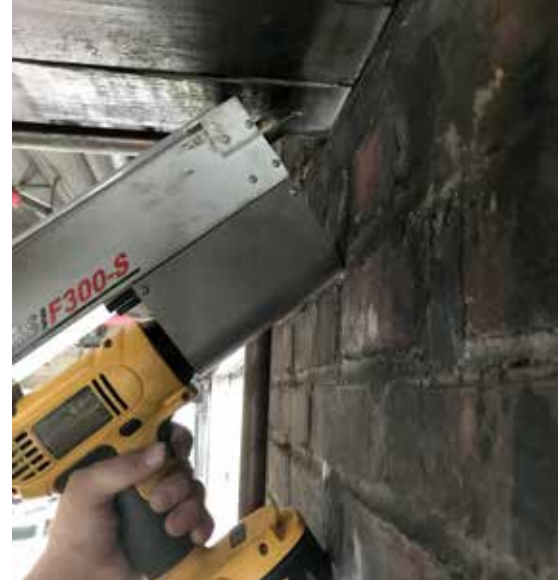
Figure 2. Resistograph test to determine the extent of deterioration at the bearing end of a bowstring truss embedded in masonry.

Often, decay in wood elements is hidden (material properties can be significantly affected without a change in appearance). Therefore, non-destructive techniques can and should be employed to supplement and confirm visual observations. Hammer sounding, surface pick tests, moisture-meter readings, and resistance to drilling with a resistograph are all methods both effective and relatively simple to implement. Resistograph tests are especially useful to determine the extent of deterioration (in many cases concealed) through the width and depth of large-sized members (Figure 2). These tests add time to the investigation; as such, their frequency (i.e., the number of tests) and location should be carefully considered to allow for a sufficiently representative sample.

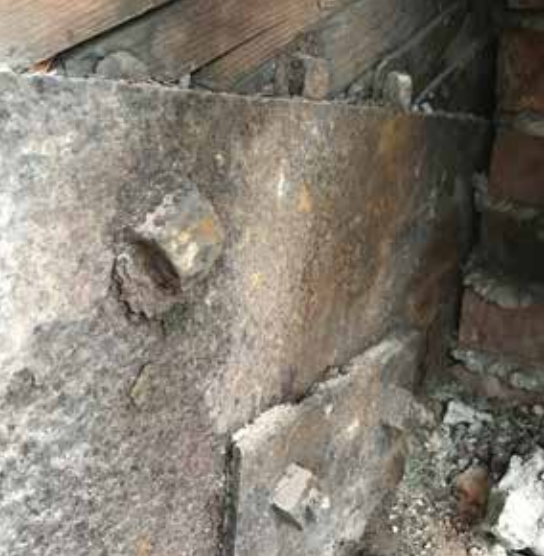
Figure 3. Exploratory probe opening at the bearing end of a bowstring truss embedded in masonry.

bearing ends may be embedded in masonry, connection details may be concealed by hung components, and existing paint (or other finishes) may impede identification of characteristics that affect stress grading (such as knots). Exposing these conditions may require making exploratory probes (Figure 3) and removing paint or finishes. The probing campaign should be carefully planned to minimize disruption to the existing operations.
