REBUILDING YEARS

Renovations *AT* Wrigley Field

By Benjamin Pavlich, S.E., Elaine Shapiro, S.E., Abhiram Tammana, P.E., and William D. Bast, P.E., S.E., SECB

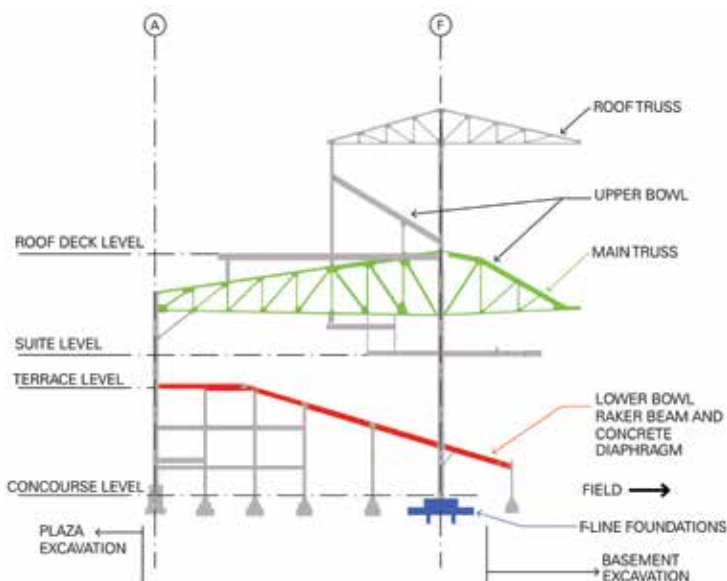
Figure 1. Typical cross-section of steel stadium structure.

The proposed improvements to the stadium required the transfer of additional loads through the columns to the foundations. Right off the bat, TT determined that the structural capacity of the existing typical “wedding cake”-style footings was not sufficient to support the new program and required strengthening. In addition to the higher loads, the new program also involved construction of a basement below the ground level on the field side of column line F and the plaza/office building on the street side of column line A (Figure 1).

The load above the terrace level, including the roof, upper deck, suites, and ramps, is carried only by the A-line and F-line columns, while a series of intermediate columns carry the load at the mezzanine and terrace levels. Most of the column footings not located on the A-line and F-line had to be enlarged to carry the additional vertical loads. Also, additional combined footings were required at new braced frame locations to complete the lateral load resisting system in the stadium.

The main trusses of the stadium span approximately 65 feet between the A-line column at the perimeter of the stadium and the F-line column adjacent to the concourse (*Figure 1*). A 30-foot cantilever projects past the F-line column towards the field. In the existing design, the trusses support the upper seating deck and roof above and the suites below. The renovation project includes expanding the suites and adding a roof deck open to fans during events.

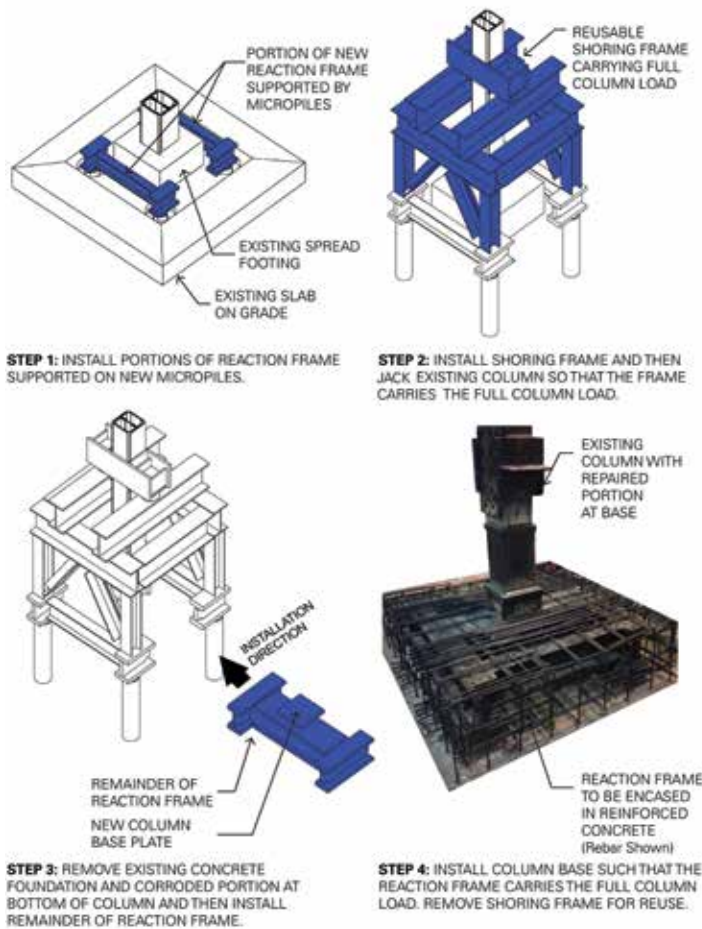
Figure 2. F-Line underpinning process.

Significant corrosion found at the base of the F-line columns required a different approach to strengthen the existing footings. To address the issue of corrosion and to strengthen the existing unreinforced F-line column footings at the same time, a reaction frame and a shoring frame assembly were used to temporarily support each column and transfer the load down to new micro-piles. Initially, the existing footings were selectively drilled to allow for the installation of the micro-piles that

provide support to the reaction and shoring frame assemblies. After the column was temporarily supported by the frames, the top of the existing footing was demolished to allow for repair of the corroded base of the column, and a new seat within the reaction frame was installed on which the column would bear. After the column was completely supported on the reaction frame, the shoring frame was removed and subsequently used at other F-line columns. The reaction frame assembly supporting the column was ultimately protected by embedding it in reinforced concrete. The different stages involved in the underpinning of the existing F-line footings are shown in *Figure 2*.

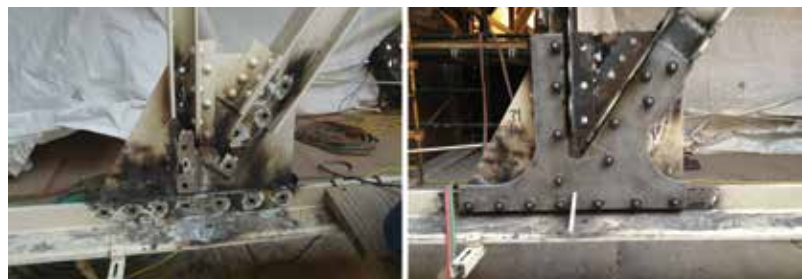
Figure 3. Truss node with truss members welded to gusset plate and rivets removed (left) and reinforced with new finger gusset plates and high strength bolts (right).

The original trusses consist of relatively light double- and single-angle members ranging from 2½ to 6 inches deep connected by rivets at gusset plates. Reinforcement was required for both the individual members and the nodal connections to support the larger suites and new roof deck. Member capacity was increased through various combinations of faceplates welded to the angle webs or existing flanges and flange plates added to create I-sections.

The existing truss members were welded to the gusset plates so that shoring would not be required to lead off the node reinforcement process. These temporary connections were analyzed for the loads expected during the construction season when the stadium would remain unoccupied, but could potentially carry snow loads. Next, the rivets were removed through a process honed by the ironworkers, contractor, and design team to be time efficient and to maintain as much original base material as possible (*Figure 3*). Each rivet head was cut off; the shaft was then heated with a torch; and finally, the remaining rivet material was hammered out. Once the rivets were removed, any damage from the torching process was repaired and new “finger” gusset plates, shaped to align with the geometry of the truss members, were installed on each side of the assembly and fastened with high strength bolts. These plates were thicker than a typical gusset plate located at the center of the double angle members but had a lower visual impact on the overall appearance of the trusses.

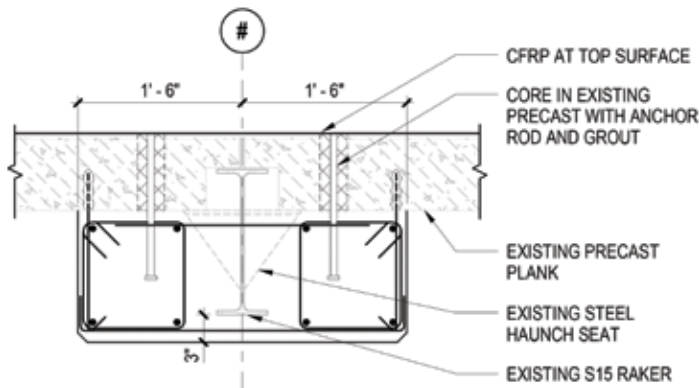
Figure 4. Schematic raker encasement detail.

The chosen solution was to create a concrete encasement around the steel raker beams supporting the CIP and precast concrete spans (*Figure 4*, page 28). In coordination with Chicago Landmarks Commission, the raker encasements were designed to be approximately 1 foot 6 inches deep by 3 feet wide utilizing CIP concrete. In addition to creating the diaphragm, the raker encasements allowed the design team to execute a triple play by addressing two other lingering design issues. First, due to increased loads imposed by other modifications to the stadium, the rakers themselves required strengthening. The raker encasements were designed to carry the full raker beam load, making the existing steel rakers redundant. Second, many of the precast planks had severe damage at their support points and required repairs. The raker encasements provided new end support for the precast planks by encapsulating the plank ends within the raker encasements.

Carbon fiber reinforcement was applied to the top side of the raker encasements to provide a complete load path to transmit diaphragm forces in tension. Compression forces were transmitted through non-shrink grout which was packed in the joints between precast planks.
