Preserving History

Rehabilitating the Culver Line Viaduct with Composites

By John P. Busel

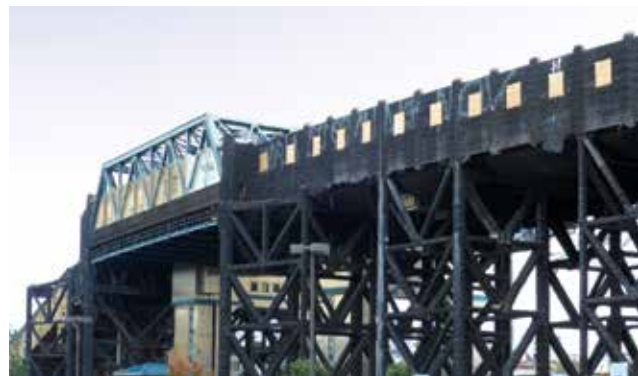
Culver Line Viaduct before.

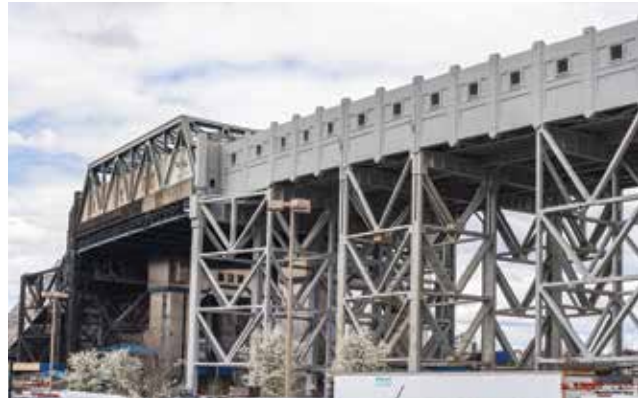
Culver Line Viaduct after.

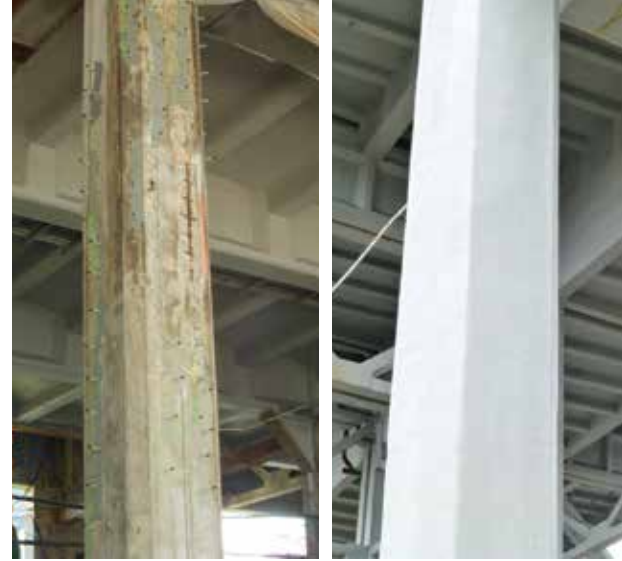
Culver Line Viaduct pillar before. Pillar after.

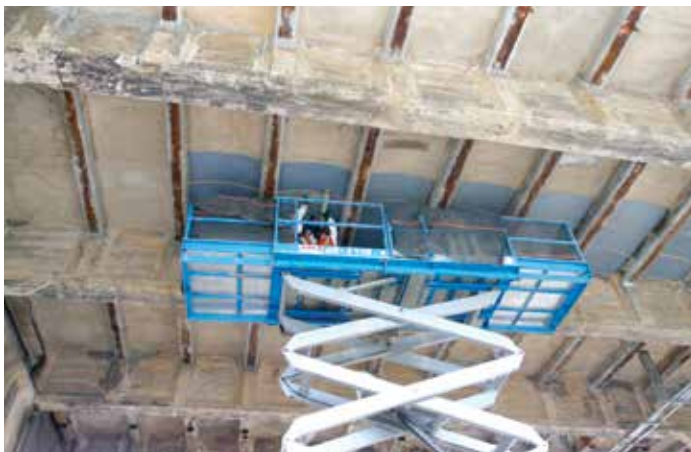
Culver Line Viaduct in progress.

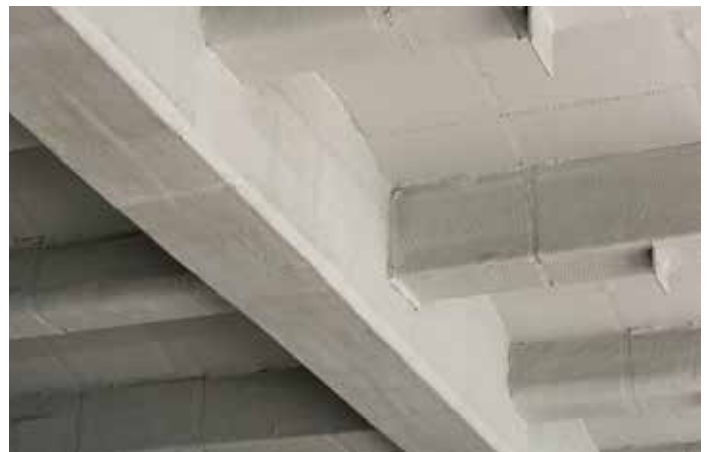
Close up of Culver Line Viaduct.
