Improving School Buildings in Indonesia

An International Collaboration

By Lizzie Blaisdell Collins, P.E., S.E.,
James Mwangi, Ph.D., P.E., S.E.,
and Mediatrich Triani N.

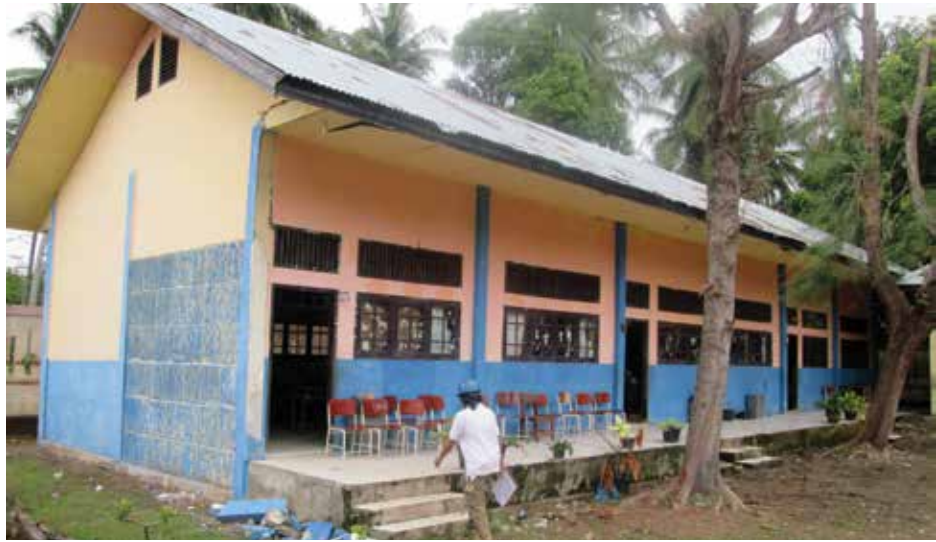
Typical classroom building – Note the lack of confining elements at door and window jambs, lack of ring beam at the side wall, and very minimal length of wall pier in the longitudinal direction.

Unfortunately, for the observed school buildings of this type in Indonesia, some of the reinforced concrete elements are missing and they are better described as *partially confined* than fully confined. Confining elements are typically placed at wall intersections but are rarely installed at door and window jambs as would be required for good performance. Wall piers between openings are

effectively unconfined in these cases and have essentially no more ductility than an unreinforced masonry wall. Often, lintel beams are not installed over window and door openings, leaving the masonry panel above to rest on the wood framing of the opening. In some cases, the required ring beam, or confining beam at the top of the wall, is also missing, leaving the masonry wall panel unbraced at the top and very susceptible to toppling under out-of-plane loading.

In addition to missing key confining elements, problems with configuration and construction quality are frequently observed in these school buildings. The longitudinal walls along the front and back consist mostly of openings for doors and

windows, leaving very few short wall piers to resist earthquake loads. The buildings also typically lack an effective diaphragm, as the light-framed roof is not detailed to act as a diaphragm and not well-connected to the building walls. This is especially problematic in cases where the building has a masonry gable end wall, which remains poorly braced over a much taller height than the rest of the building.

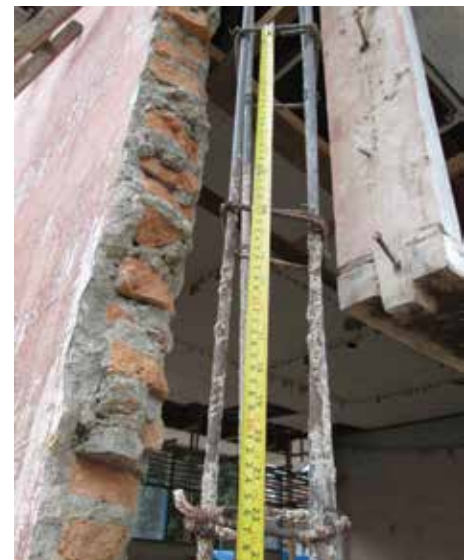
Typical inadequate reinforcing in damaged school buildings.

Most of the classroom buildings of this type are built by local builders who may have more experience in construction of smaller non-engineered buildings, like houses, and construction activities are not typically observed by the designer or inspected by local authorities in detail. It is common for smooth reinforcing bars to be used in the concrete elements, for the brick strength to be low, for the concrete quality to be poor, and for construction details like adequate concrete cover, reinforcing hooks and splices, or mortar quality and placement to be overlooked.

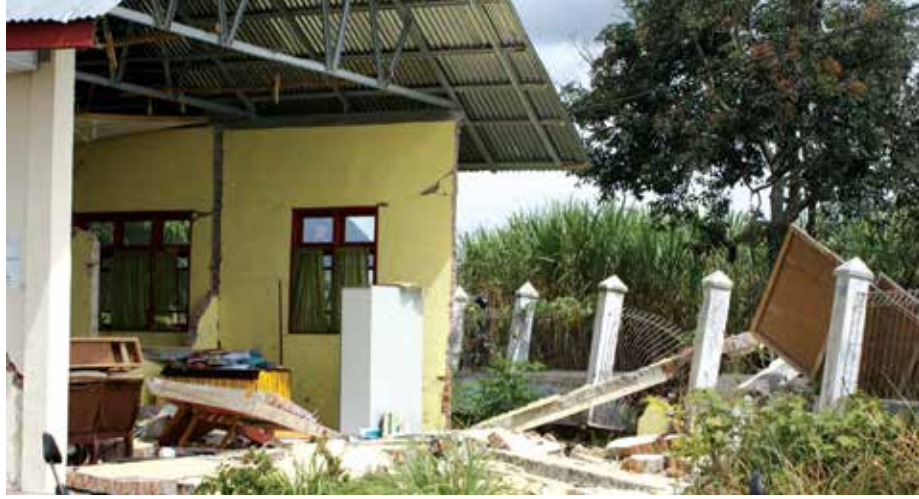
Collapse of gable end wall in a classroom building. Courtesy of Educational Department Aceh Tengah.

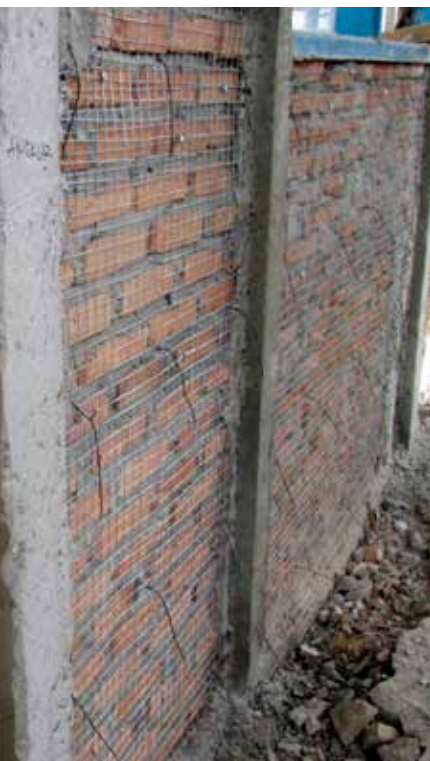
Installation of the mesh plaster overlay during pilot construction.

- Infilling select wall openings in the longitudinal walls to create sufficient length of the wall and installing confining elements at their boundaries.
- Overlaying walls with steel wire mesh and cement-plaster and, in some cases, rebuilding the wall pier to be thicker masonry to improve in-plane and out-of-plane strength.

The construction started in January 2016 on one of the two buildings and the second building was completed in May 2016. Most of the retrofit techniques were familiar to the local builders, except installing the mesh-plaster overlay; however, the required level of construction quality was higher than the builders were accustomed to and this led to some delays. For new techniques, like the wire mesh overlay, extra care was taken in the detailing and on-site supervision of the mesh installation, which the builders were able to master after an initial period of familiarization.

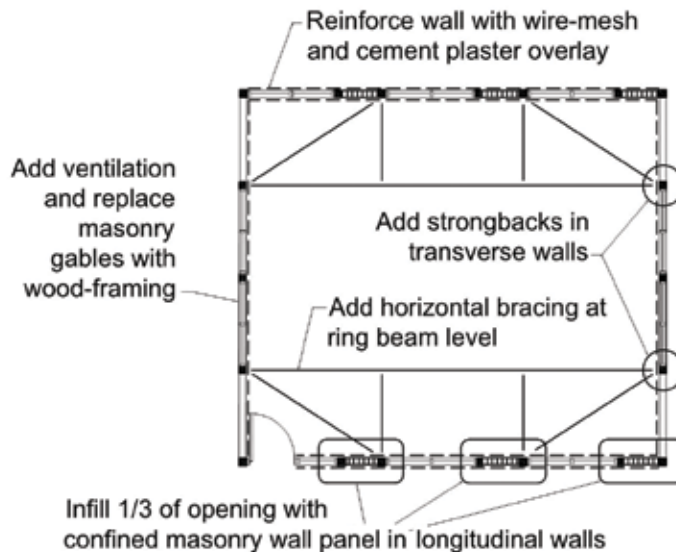
Plan view of the retrofit scheme.

The authors selected a shear wall system for the retrofit, although several other schemes were considered including a moment frame system and a cantilevered column system. The resulting retrofit scheme targeted life-safety performance for the code-prescribed design earthquake and was composed of several key components:

- Adding reinforced concrete strongbacks to the transverse walls for out-of-plane bracing.
- Installing a new continuous ring beam at the top of the wall.
- Installing a horizontal bracing system just above ceiling level connected to the ring beam to act as a diaphragm.
- Eliminating any unreinforced masonry above window and door openings by extending the opening upwards to the ring beam and filling the space with light-weight materials instead.
- Eliminating the masonry gables and replacing them with light-weight materials.

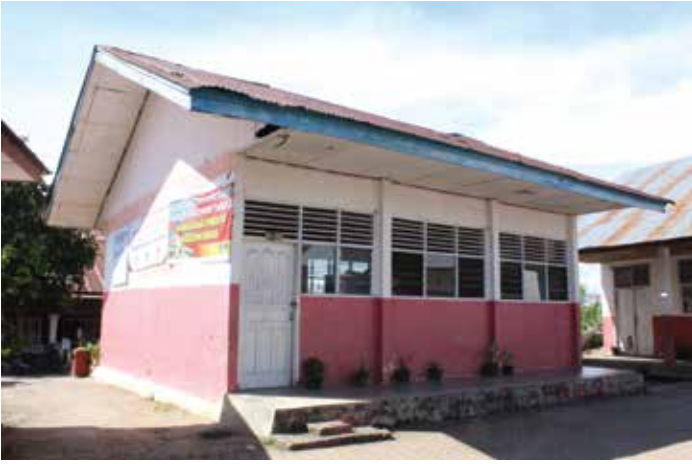
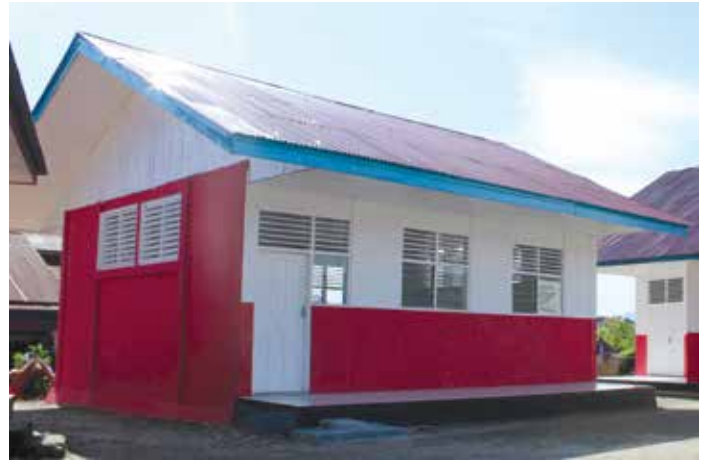
One of the classroom buildings before and after retrofitting.
