RESTORING the Historic Gateway to Reading, PA

By Kamlesh Ashar, P.E., Brian Teles, P.E., and Michael Urban, P.E.

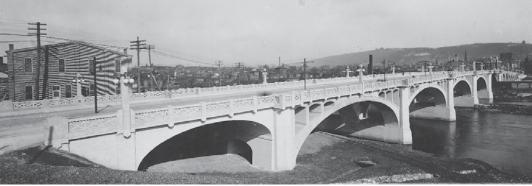
The project team first identified the character-defining and aesthetic features of the bridge; namely, the open-spandrel and closed-spandrel arches with architectural detailing throughout.

The most notable change is the reconstruction of the reticulated balustrades (right) with outlooks, which were closed in the 1950s due to deterioration.

In consultation with stakeholders early in design, the project was to restore the bridge's original architectural detailing by using the original bridge drawings as a guide. The most notable change is the reconstruction of the reticulated balustrades with outlooks, which were closed in the 1950s due to deterioration. The reticulated balustrades were constructed using a combination of precast and cast-in-place elements to allow for utilities and to ensure the complex balustrade geometry could be constructed to a very high quality, which the contractor (J.D. Eckman, Inc.) successfully executed via their on-site precast facility built specifically for this project.

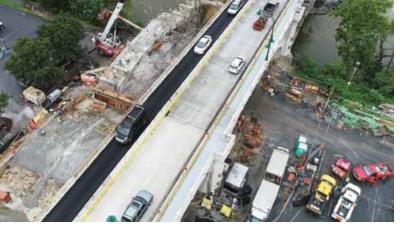
A new crashworthy barrier at the curb allows for reticulated balustrades and sidewalks narrowed from 11 feet to 7 feet to allow for adequate geometrics for bridge inspections.

easily be converted later into bike lanes. A new, crashworthy barrier at the curb allows for reticulated balustrades and sidewalks narrowed from 11 feet to 7 feet, allowing adequate geometrics for bridge inspections.
